How has the Port Radium Remediation Project made the site safer for people, animals, and the environment?

The Port Radium Site is a former uranium and silver mine located on a peninsula along the eastern shore of Great Bear Lake in the Northwest Territories, 440 kilometres north of Yellowknife and 265 kilometres east of the Dene community of Délı̨nę within the Sahtú Dene and Métis traditional lands. The site was decommissioned in 1982 to the standards of the day.

Remediation, completed in 2007/08, has made the site safer for people, animals and the environment.

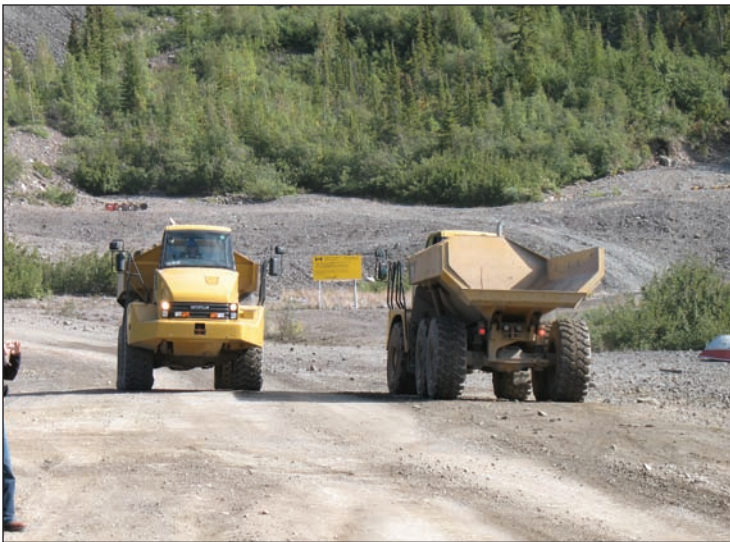
Remediation work at the Port Radium site, August 2007

Remediation work at the site included:

- Improving drainage to reduce leaching of silver, copper and uranium into soils and surface water around the immediate site
- Reducing gamma levels by covering waste rock and tailings
- Removing small amounts of hydrocarbons and asbestos residue
- Covering exposed waste materials, or moving them to a landfill onsite
- Closing mine openings

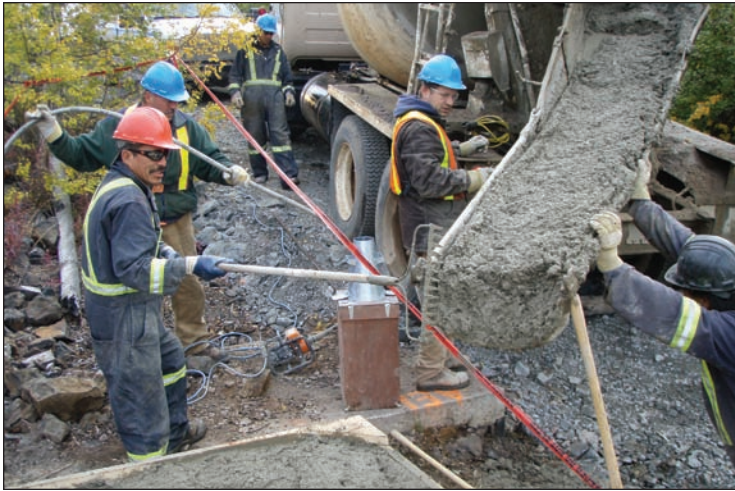
Pouring concrete to cap a mine opening, Port Radium, 2007

- Covering vertical mine openings with a concrete cap
- Filling in horizontal openings with rock. In areas where this was not possible, fencing was placed around the areas.
- Demolishing foundations of old buildings, and covering those level with surrounding area
- Removing the dock at Inner Labine Bay, and regrading
- Moving scrap metal to a landfill on site
- Demolishing old wooden structures on site such as the Cross Fault Lake head frame, wooden sheds, and cabins

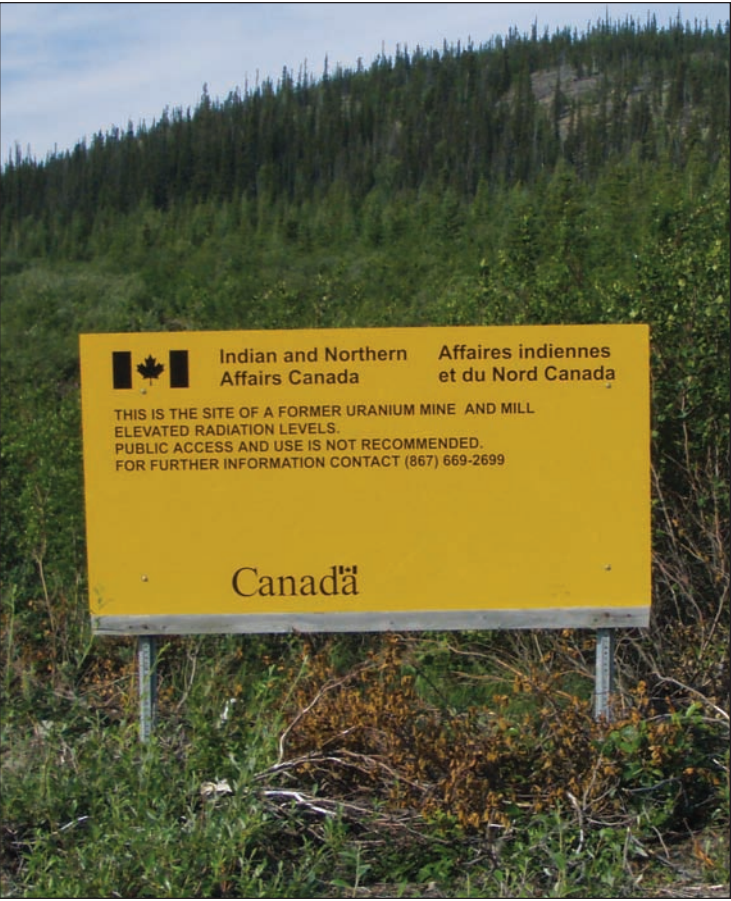
Sign at the Port Radium site, notifying visitors that the site is subject to a Waste Nuclear Substance License

In addition, the site is covered by a Waste Nuclear Substance License, from the Canadian Nuclear Safety Commission, and is being monitored by them forever. INAC must file reports every year with the Commission. Signs will remain posted at the site to let people know that access is restricted. Community members have been told of the site restrictions, as have others, such as industry and exploration companies operating in the area.

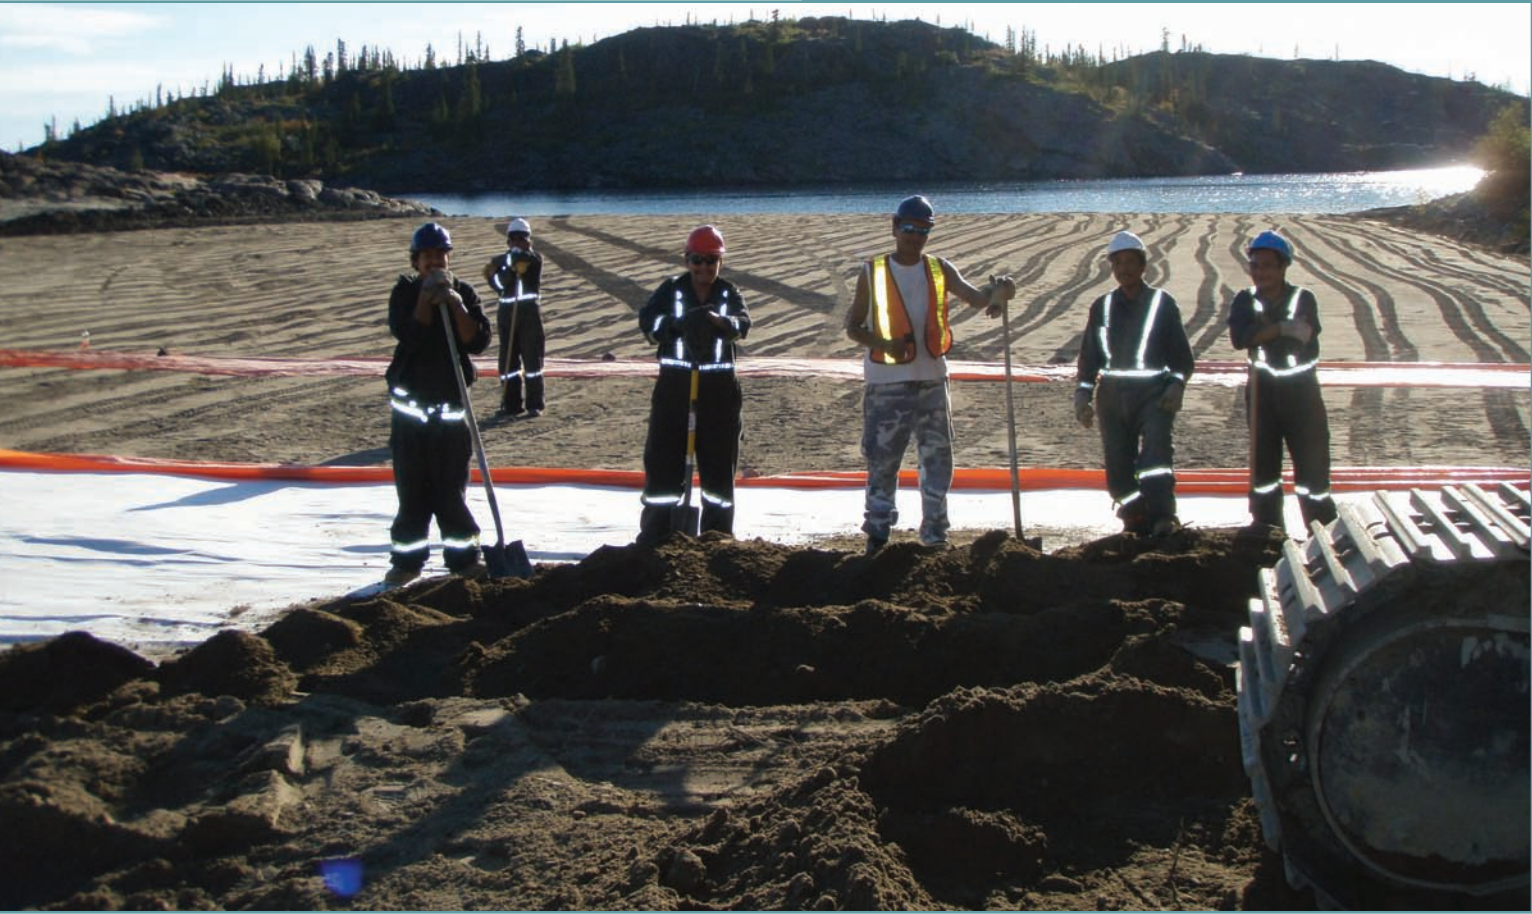
Workers laying the geotextile liner at the Silver Point Tailings Area, July, 2007

To fix the problem, the pools were filled in with clean tailings and native soils. A layer of geotextile liner was then placed over the entire tailings area to prevent water from entering the tailings. Then, the liner was covered with rock to protect it.

This rock-covered geotextile will keep rain and other moisture from getting to the tailings underneath, and keep heavy metals from flowing into Cobalt Channel.
