TP 6980E
(03/2015)

Issue 3/2015

Canadian Aviation Service Difficulty Reports

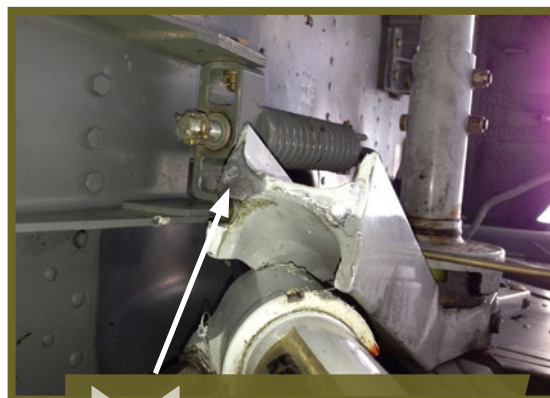
The DAH concluded that this type of failure was induced through fatigue cracking which was originated by pivot bore corrosion as seen in figure 2.

FIGURE 2: Evidence of corrosion and previous crack area

Alert Service Bulletin 340-32-001 was issued to all Convair 340, 440, 640, 580, and 5800 operators on December 5th, 2013 calling to perform a high frequency eddy current (HFEC) inspection around the mounting holes of the down-latch lever.

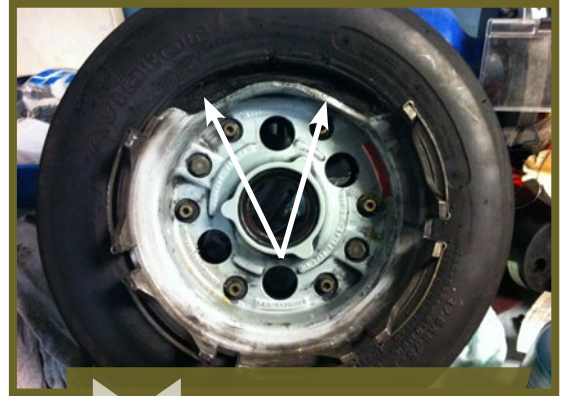
During a post-flight inspection, the crew noticed a flat tire and then noticed a large portion of the inboard wheel rim half was missing. There were no signs of overheating, sudden stops, excessive braking or skid marks on the tire or brake assembly.

Wheel rim half section missing

Learjet service manual 3-90C captures an eddy current inspection requirement at each servicing/overhaul of wheel rims for the 36A model and it is suspected that at the last overhaul of the wheel rim halves, this required inspection might have missed the initial damage.

The wheel assembly was replaced with a serviceable part and the aeroplane was returned to service.

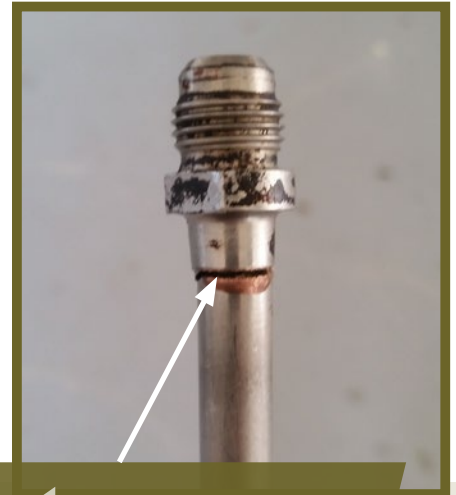
After arrival, the flight crew conducted a post flight inspection of the aeroplane and noted a significant oil leakage on the left engine cowlings. There were no in flight indications of a problem throughout the approximate 4.5 hour flight. The oil level could not be seen through the oil tank sight glass. Oil was added and it was determined that the engine had lost 3.5 liters of oil during the flight.

Further inspection revealed the number 6 bearing oil scavenge tube assembly had ruptured at the flare solder joint. A post service bulletin tube assembly was installed with all new associated hardware and seals. No further leaks were discovered and the aeroplane was released for service.

Oil scavenge tube assembly rupture at the flare solder joint

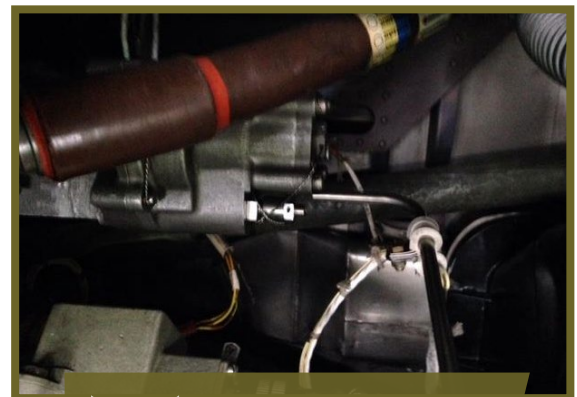
While in cruise, the flight crew observed the number 2 engine parameters slowly dropping. At 12% torque, a decision was taken to shut down the engine and divert to a nearby airport. An emergency was declared and the aeroplane landed without further incident. Maintenance was dispatched on site and found that the P3 pressure sensing tube was fractured just behind the overspeed governor fitting where it connects to the hydromechanical unit and the propeller overspeed governor.

The tube was replaced and engine runs were performed before returning the aeroplane to service. A maintenance historical review indicates that the tube was removed and reinstalled a few days earlier during a replacement of the engine fuel pump. It is likely that the line was overstressed during installation.

Broken P3 line at fitting on overspeed governor

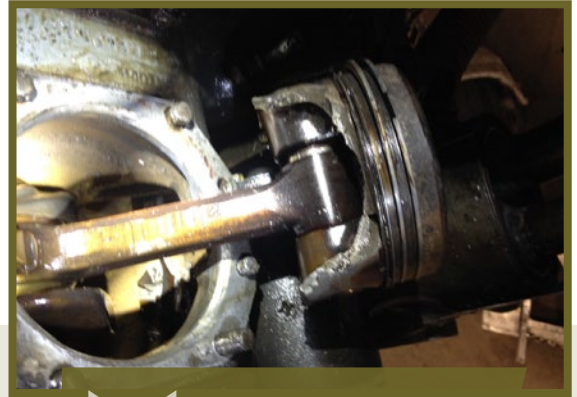
The aircraft in which the student pilot and instructor were aboard, suffered engine failure on final approach. Upon investigation, it was found that the number 2 cylinder studs broke off where the cylinder mounts onto the engine case. The piston skirt was broken and the cylinder separated from the engine. The cause of the damage is still unknown.

Fretting was noticed between the engine case halves but it was not evident if that occurred before or after the incident. A loss of torque on the through studs can cause fretting between engine halves, further reducing the torque. This can result in through stud failure.

An engine case, piston and connecting rod with catastrophic damage

Transport Canada Civil Aviation has no specific recommendation related to this event other than to remind operators and maintainers to strictly follow manufacturer's maintenance and inspection instructions per manufacturer's service information letters and other publications.

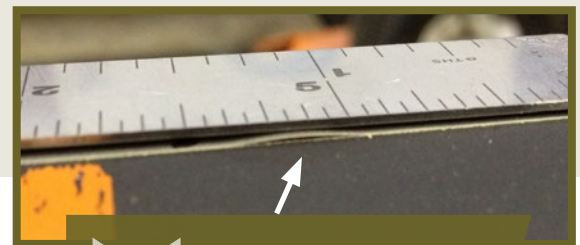
Rotor blade upper surface abrasion strip debond area dimension reference

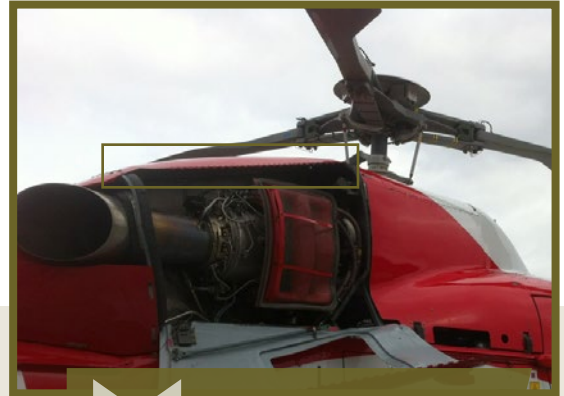
After completing a two hour line patrol, the aircraft landed to refuel. A walk around check of the aircraft revealed that the number two engine cowl was still latched but hanging off the side of the aircraft with the top hinge pin missing. It is suspected that the hinge pin departed in-flight and upon landing, the cowling fell open.

Engine Cowling latched with missing upper hinge pin

This could have been catastrophic if this happened in flight. An inspection for security of the pin prior to flight is imperative; appropriately rated maintenance personnel will be able to assist by ensuring that the pin is secure. Airbus Helicopters has been made aware of this service difficulty report.
