Aviation Safety

Letter

Issue 4/2002

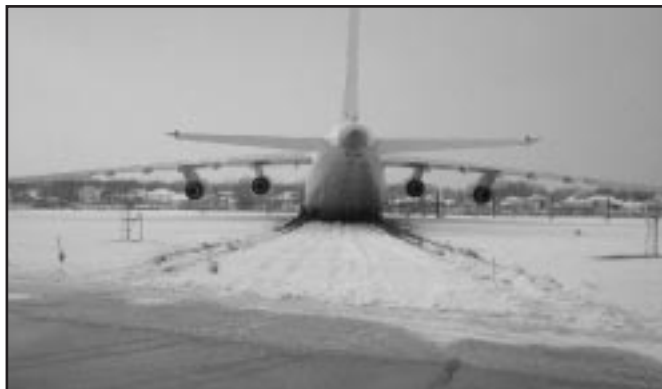
TSB Final Report A0000279—Runway Overrun

On December 18, 2000, an Antonov 124-100, was chartered to pick up 40 t of auto parts from Windsor, Ontario, for delivery to Oostende, Belgium. The crew conducted an instrument landing system approach to Runway 25 at Windsor Airport, and the aircraft touched down an estimated 3400 ft past the runway threshold, at about 23:33 EST (eastern standard time). During the landing roll, the aircraft overran the runway and stopped approximately 340 ft past the end of the runway, 20 ft from the airport boundary fence. There were no injuries, and the aircraft sustained minor damage. Emergency response services responded approximately 40 s after the aircraft stopped.

1. The aircraft touched down 3400 ft past the threshold of Runway 25 and could not be stopped in the remaining 4450 ft.
2. Because of the weather minima on Runway 07, the aircraft was landed with a 4-kt tailwind component on Runway 25. The aircraft was about 20 ft higher and about 6 kt faster than recommended when it crossed the threshold of Runway 25. Consequently, the aircraft touched down well beyond the normal touchdown point.
3. The runway was covered with a trace of loose snow, which reduced braking friction and lengthened the landing roll.
4. The Canadian runway friction index (CRFI) report of 0.30, issued to air traffic control by the airport maintenance specialist, was not passed to the AN124 flight crew. This resulted in the flight

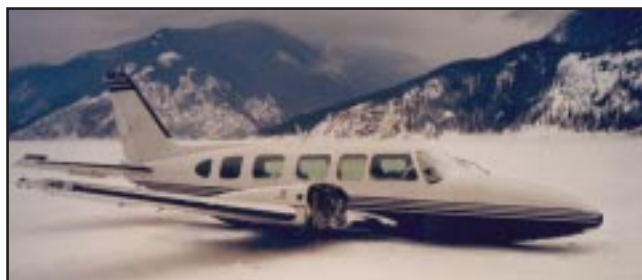
TSB Final Report A00P0019—Controlled Flight onto Ice

On February 7, 2000, the pilot of a Piper PA-31-350 Navajo Chieftain encountered an area of heavy snow and reduced visibility while on a visual flight rules (VFR) flight from Bear Valley, British Columbia, logging camp to Tsay Keh. The pilot was unable to maintain visual references and executed a

180° turn in an attempt to regain visual flight. Shortly after completing the turn, at about 10:55 PST (pacific standard time), the aircraft collided with the ice on the Peace Reach Arm of Williston Lake, British Columbia. The pilot was the sole occupant of the aircraft and received serious injuries. There was no fire. The aircraft was destroyed during the collision.

2. While the pilot was attempting to regain visual flight, he allowed the aircraft to descend and it struck the ice surface. The weather and surface conditions were such that it would have been virtually impossible to visually detect the ice surface.

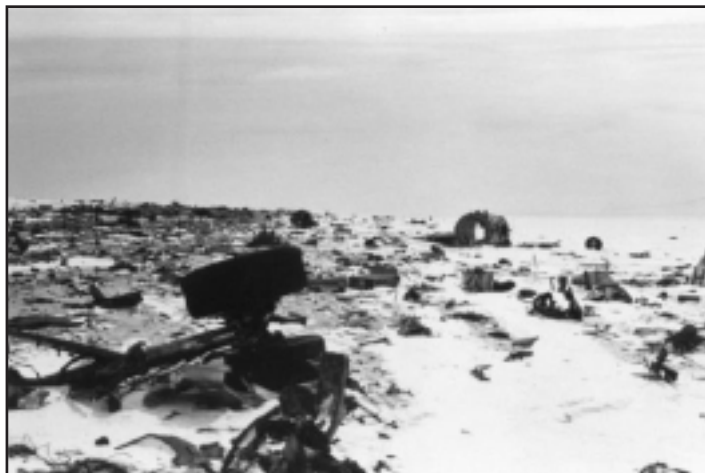
Photo: New Zealand Transport Accident Investigation Commission

Wreckage trail looking North.
