- 5 **Lime Preparation at
18th-Century Louisbourg,**
by Charles S. Lindsay
- 47 **Louisbourg Guardhouses,**
by Charles S. Lindsay
- 101 **A Survey of Louisbourg
Gunflints,**
by T. M. Hamilton and Bruce W. Fry

Canadian Historic Sites:
Occasional Papers in Archaeology
and History – No. 12

Lime Preparation at 18th-Century Louisbourg

The equipment and techniques used in the preparation of lime for mortar in 18th-century Louisbourg are studied against the background of contemporary practices in France. Two basic types of French kilns and lime-burning techniques are identified, as are two methods of slaking the burnt lime. Parallels for all these structures and techniques are found at Louisbourg.

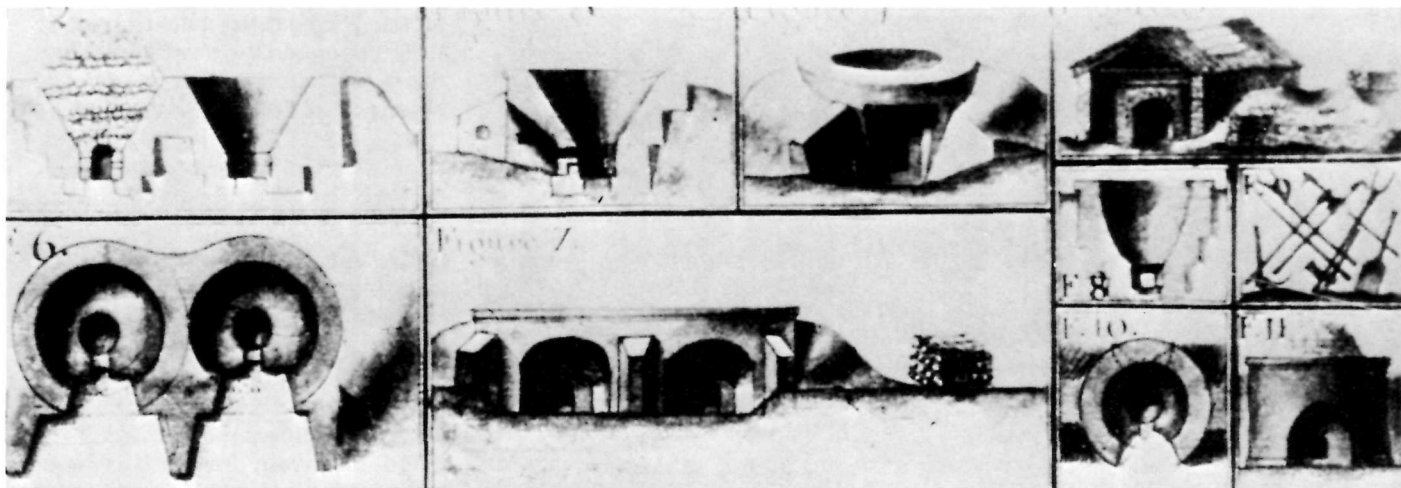
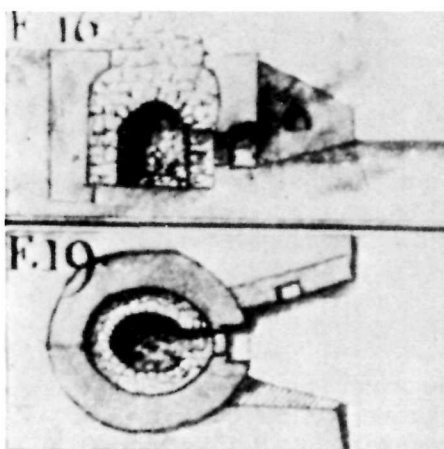
1 Eighteenth-century French lime-kilns (Figs. 2-11, 16, 19) illustrated by Masse. Described as "king's kilns," they purportedly are drawings of actual existing structures. (*Bibliothèque du Génie.*)

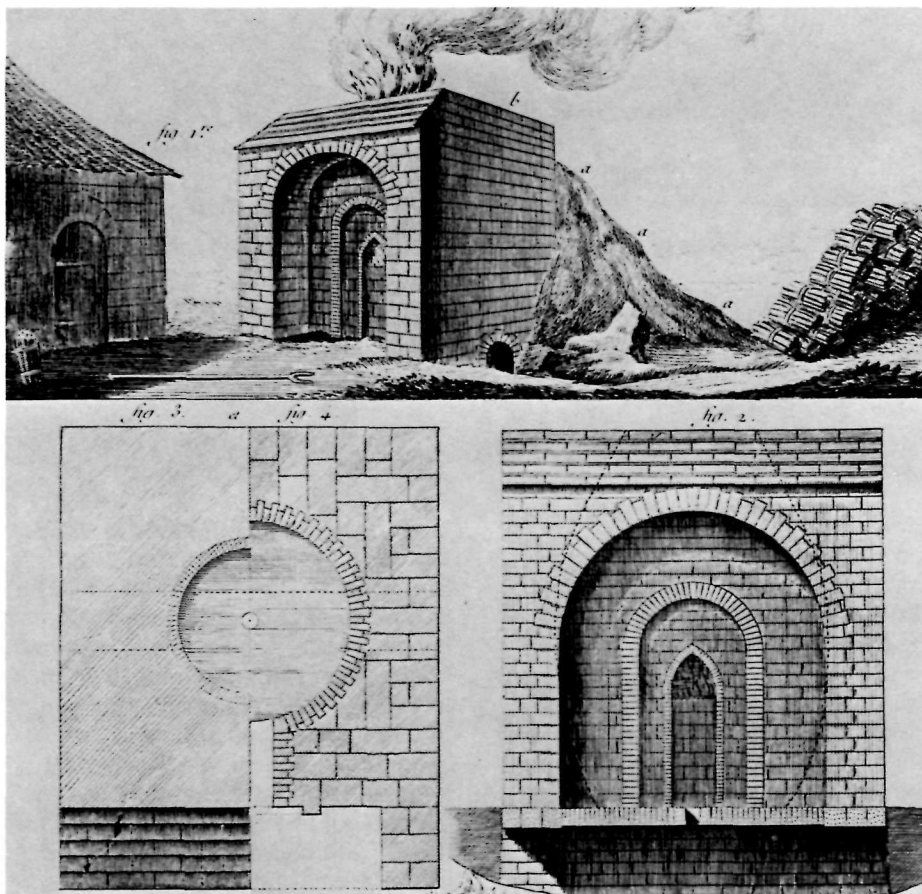
2 An idealised version of a flare kiln having a sub-floor air channel. (*Encyclopédie*, s.v. "Agriculture et Economie Rustique, Four à Chaux.")

In Diderot's idealized kiln there was a stone-lined channel running beneath the floor of the kiln to supply air to the fire through holes in its arch (Fig. 2). Diderot called this an *ébrasoir*. De Ramecourt recommended that more kilns should have such a flue, but by 1820 when *Architecture rurale* was published, it was noted that all the simpler kilns still lacked this feature.¹⁰ The Masse illustrations, drawn in 1728, do not show this flue on any kiln, so one may assume that its introduction came later, and its widespread adoption did not occur until the 19th century.

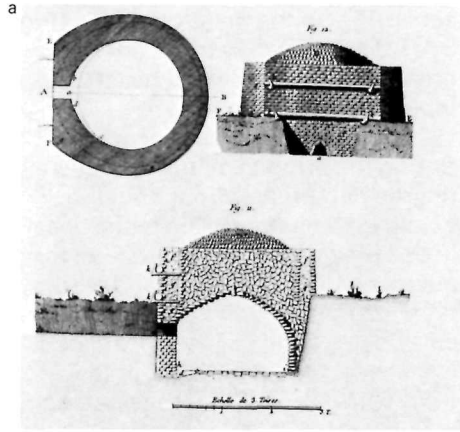
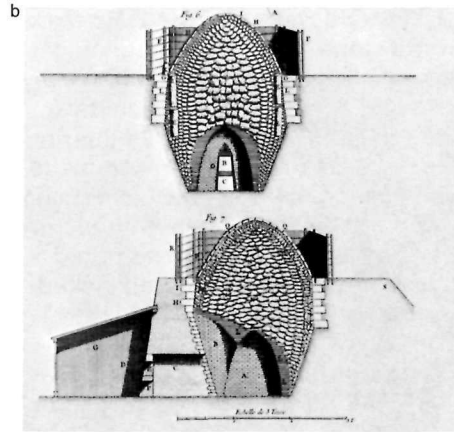
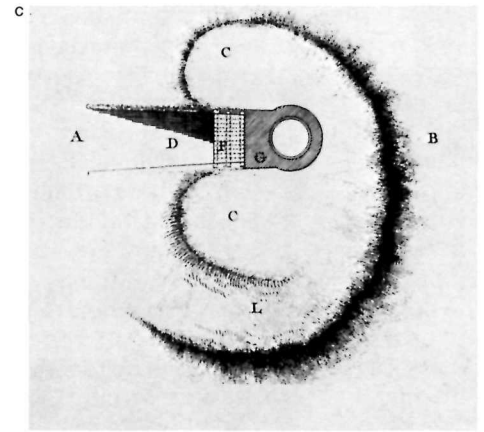
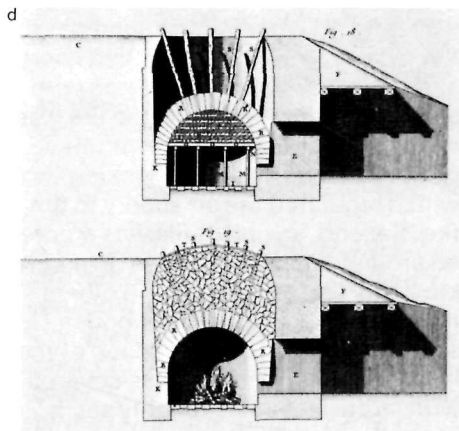
3 Flare kilns from *a*, Provence; *b*, Lorraine; *c* and *d*, Champagne. *a*, *b* and *d*, illustrate various methods of loading flare kilns; *c*, shows in plan the common practice of building the kiln into the side of a hill (C) with a ramp (L) for access to the top. (*Fourcroy de Ramecourt, L'Art du chautournier* [Paris: n.p., 1766], Pl. 3, 4, 5, 6.)

The flare kiln was loaded so as to leave a gap at the bottom for the fire. In Provence this was done by selecting flat stones for the construction of a corbelled dome (Fig. 3, a). In Champagne, large stones were selected and placed radially on a dome-shaped mass of fagots supported on stilts (Fig. 3, d). Once the fire was started, the stilts would burn away, but by that time the weight of the limestone had stabilized the arch.

set upright in the mass of stones (Fig. 3, d). These quickly burnt out and created flues to draw the heat to the top of the kiln.

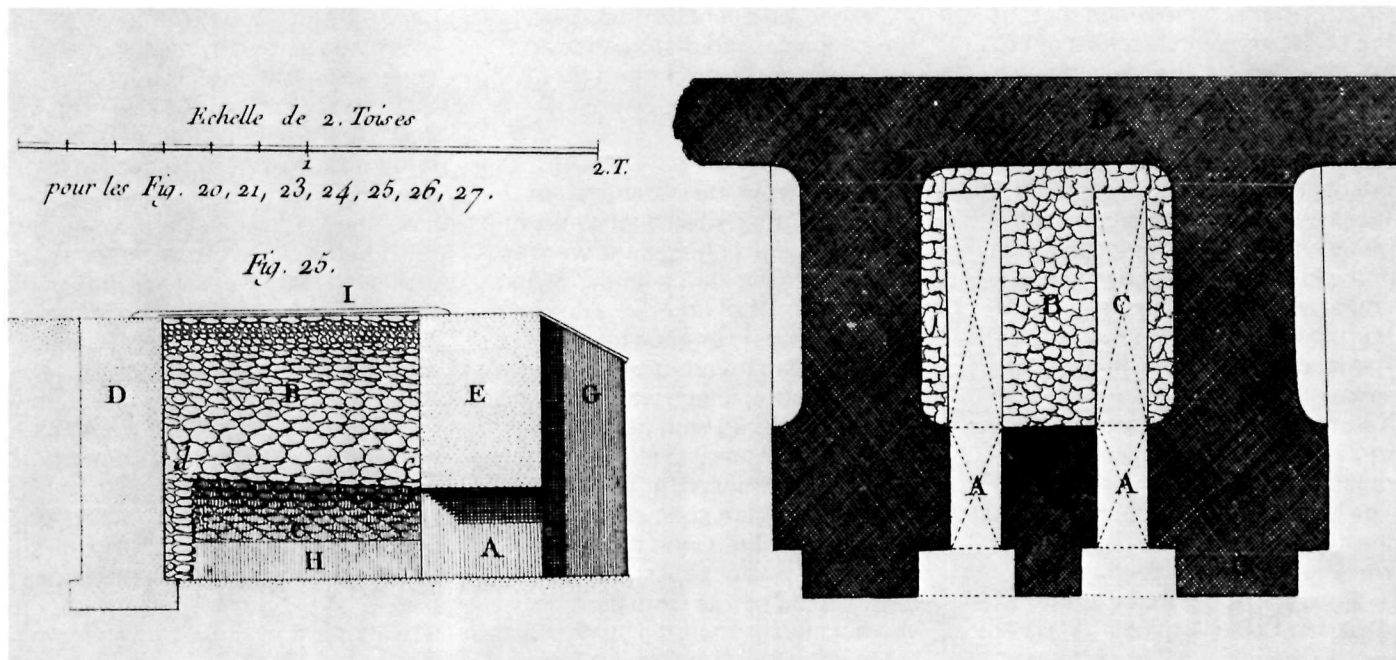
4 Cross-section and plan views of a type of flare kiln, found in Alsace, with a rectangular furnace and two openings for fueling fires set beneath the two tunnel arches of limestone. This type of kiln was designed to ensure more even burning throughout the load of limestone.
(Fourcroy de Ramecourt, L'Art du chauxfournier [Paris: n.p., 1766], Pl. 7.)

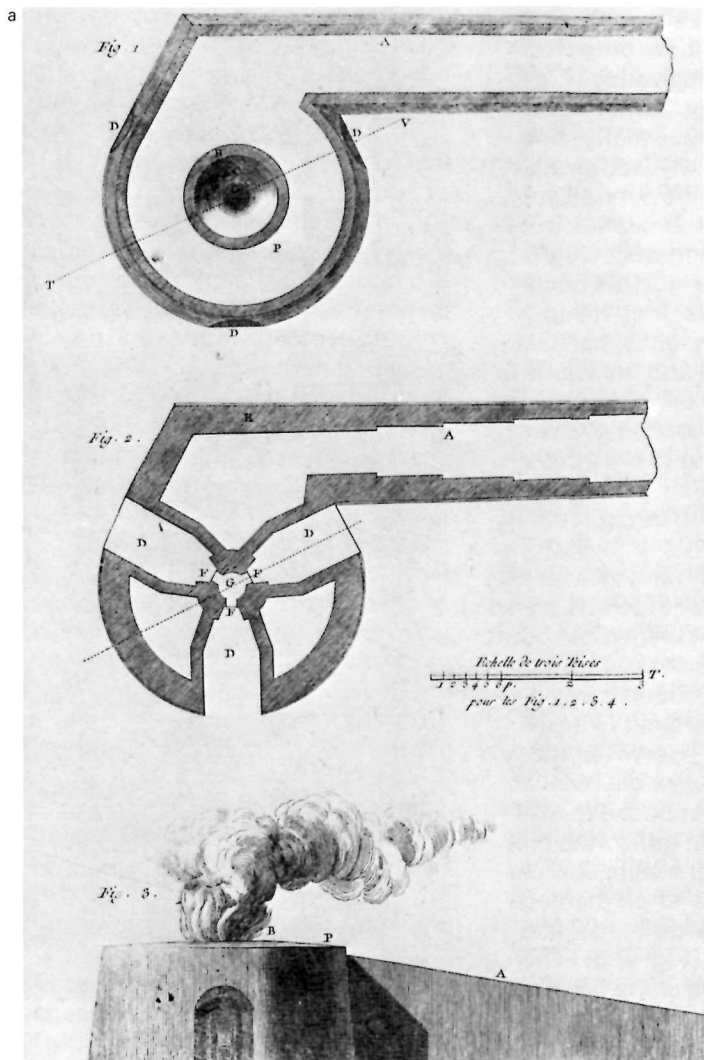
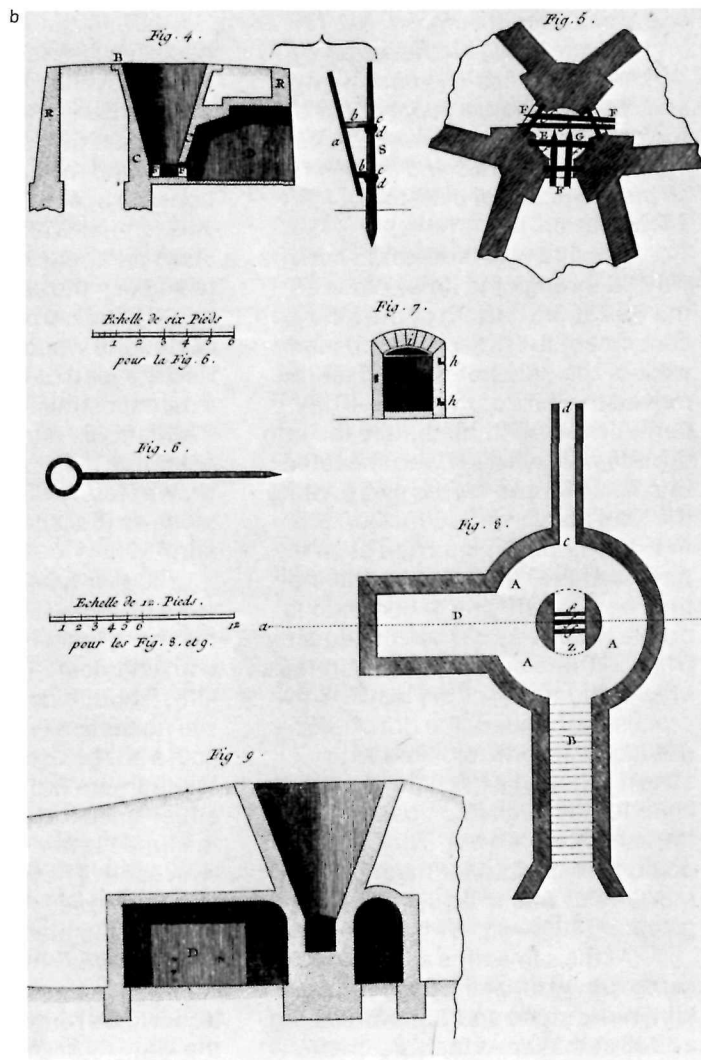
5 A running kiln from Flanders. *a*, plans and elevation; *b*, Fig. 4, cross-section; Fig. 5, enlarged plan view of the *cendrier* with the iron bars in place; Fig. 6, a rod for removing the burnt lime; Fig. 7, one of the doors to the *cendrier*; Figs. 8 and 9, plan and cross-section

through a similar kiln with an encircling tunnel for access to the drawholes. (*Supplément à l'Encyclopédie, s.v. "Chautournier."*)

De Ramecourt believed that the best type of running kiln was found in Flanders. His description of it was copied verbatim into the supplement of Diderot's *Encyclopédie*, together with a reproduction of the illustrations (Fig. 5), which show a double-walled circular kiln approximately 11 *pieds* high with a shallow loading ramp built at a tangent. The interior of the kiln was an inverted cone, 7 *pieds* in diameter at the top, decreasing to 20-28 *pouces* at the *cendrier* or ash-box which was 15-17 *pouces* deep (Fig. 5, 4, G). Around the base of the kiln there were three drawholes, 12-13 *pouces* wide, closed by metal doors that opened into the

cendrier (Fig. 5, 5, F). Access to these was gained by means of short covered passageways which ran through the body of the kiln (Fig. 5, 2, D). In those kilns that were built into the side of a hill, access to these passageways would necessitate excavating long sunken pathways into the hillside. To avoid this expensive task such kilns were frequently built with a circular covered corridor around the kiln wall giving access to all the drawholes (Fig. 5, 8, 9). The drawhole arches were supported by iron bands since they were subject to damage when the lime was being drawn off (Fig. 5, 7, i). At springer level each of the drawholes had an iron bar running across the opening and anchored in the masonry jambs (Fig. 5, 7, e). Other iron bars were laid across these iron bars spanning the *cendrier* to form a grille on top of which the fuel and limestone were placed (Fig. 5, 5, E). To load this type of kiln the limeburner *arranges three or four armfuls of well dried wood [on top of the grille] which he covers with a layer of three or four pouces of coal in pieces the size of a fist....*

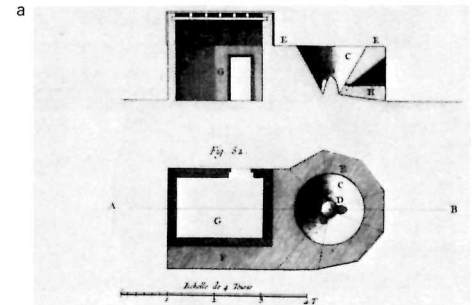
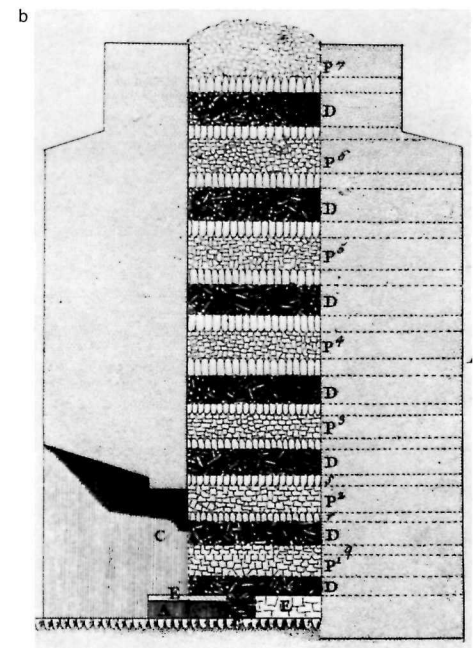
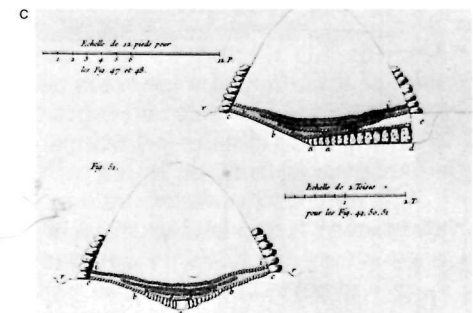
6 Running kilns from a, the Rhône valley, with a pillar occupying the *chendrier*; b from Mézières; c, from Maubenge, a simple type that was operated as a hybrid flare/running kiln. (Fourcroy de Ramecourt, *l'Art du chauffournier*, [Paris: n.p., 1766], Pl. 14, 15.)

De Ramecourt stated that he had seen kilns similar to those from Flanders in the Rhône valley (Fig. 6, a). They were more simply made from local fieldstone, usually sandstone, and mortar was used as a bonding agent, but the over-all shape was similar with the exception of a short pillar occupying what would have been the *chendrier*. This pillar served two purposes: first, it supported the wooden planks that carried the load of fuel and limestone in a manner similar to the iron bars in the Flanders kilns; second, it channeled the burnt stone to the three drawholes by dispersing the mass of stone as it descended through the kiln.²⁶

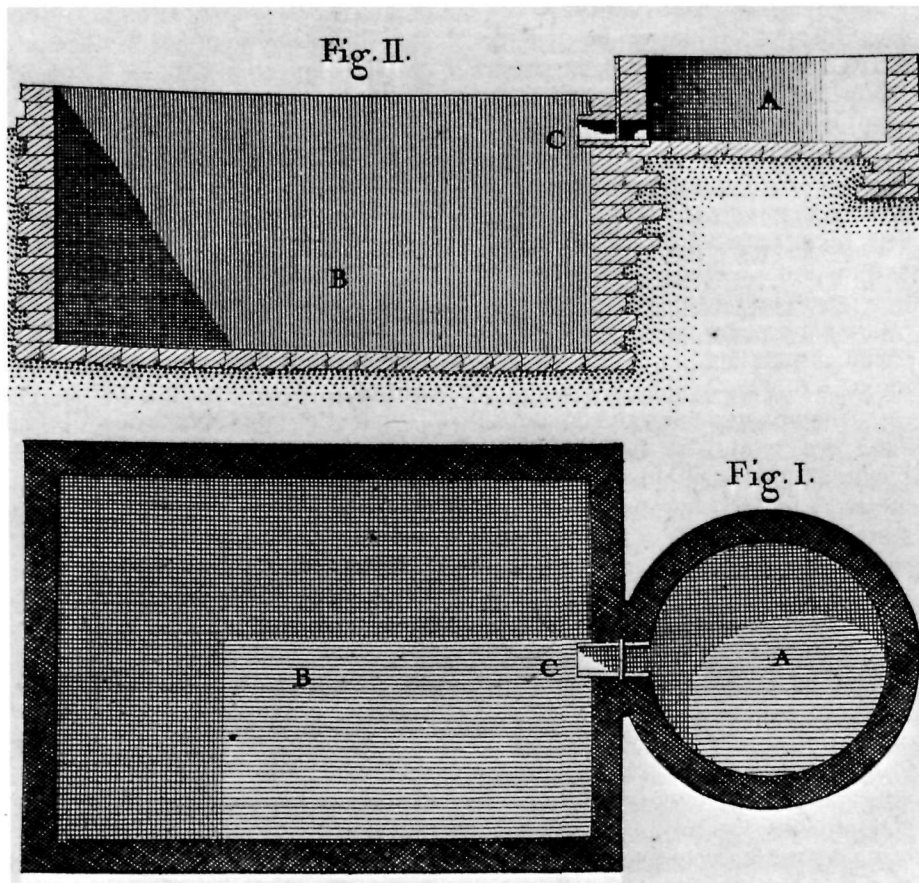
7 Plan (Fig. I) and cross-section (Fig. II) of slaking and storage pits. The lime was slaked in the smaller circular pit (A), then run off through a channel (C) to a large rectangular storage pit (B). (*Jacques Françoise Blondel, Cours d'architecture [Paris: Desaint, 1771-77], Vol. 5, Pl. 64.*)

7 joined by a channel. The smaller, which is at the same time higher, is used for crushing the quicklime, and retaining the lumps found there; the larger is intended to serve as a sort of reservoir, designed to contain a load of slaked lime proportionate to the

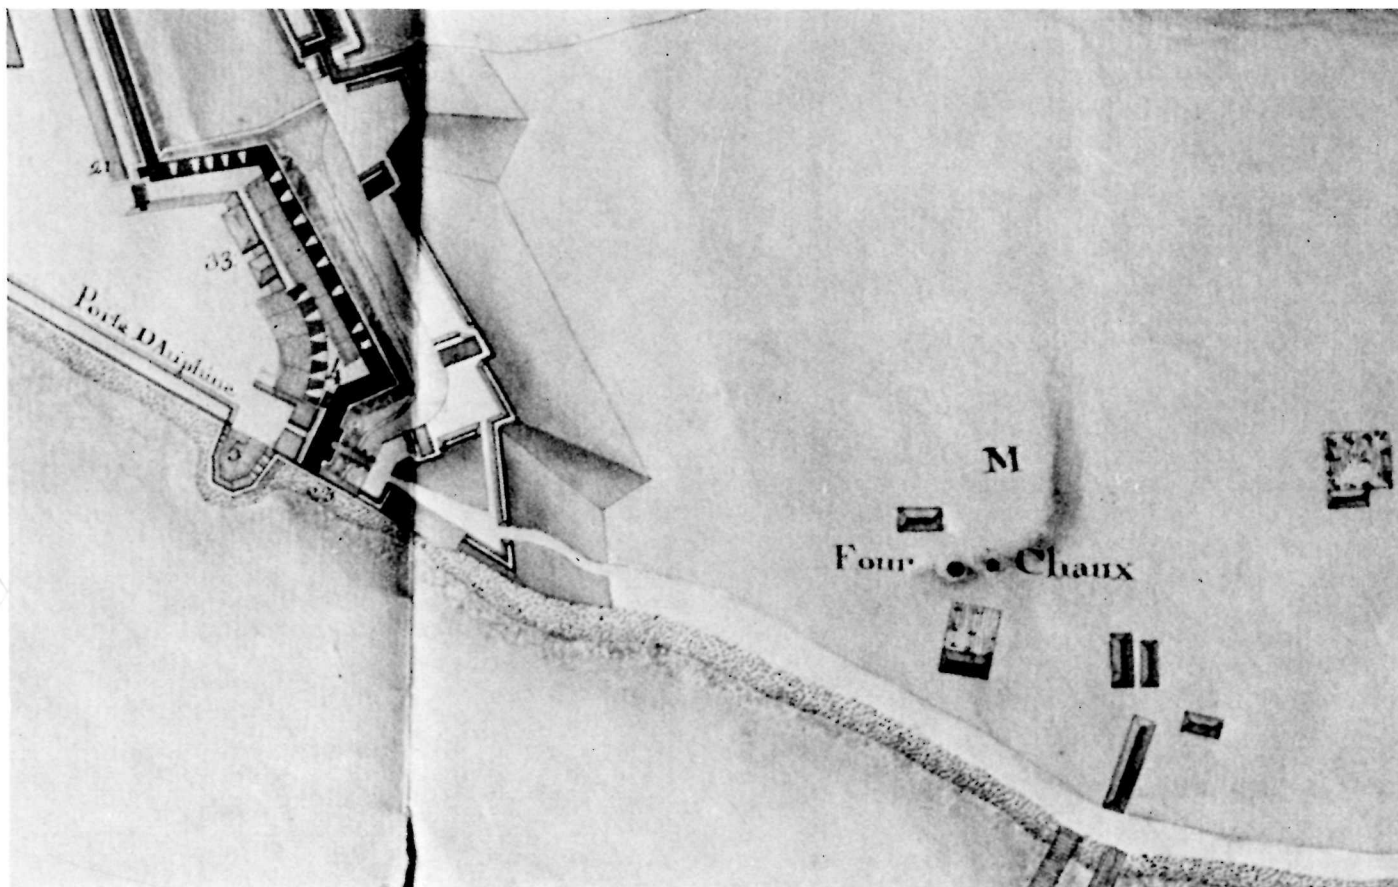
8 Plan of part of the *faubourg* in 1757 with the Dauphin demi-bastion on the left. The kiln was probably built to supply lime for construction work at the Dauphin Gate in 1755-56. From a plan entitled "Louisbourg en l'Isle Royale." (Original source unknown; copy on file at Public Archives of Canada.)

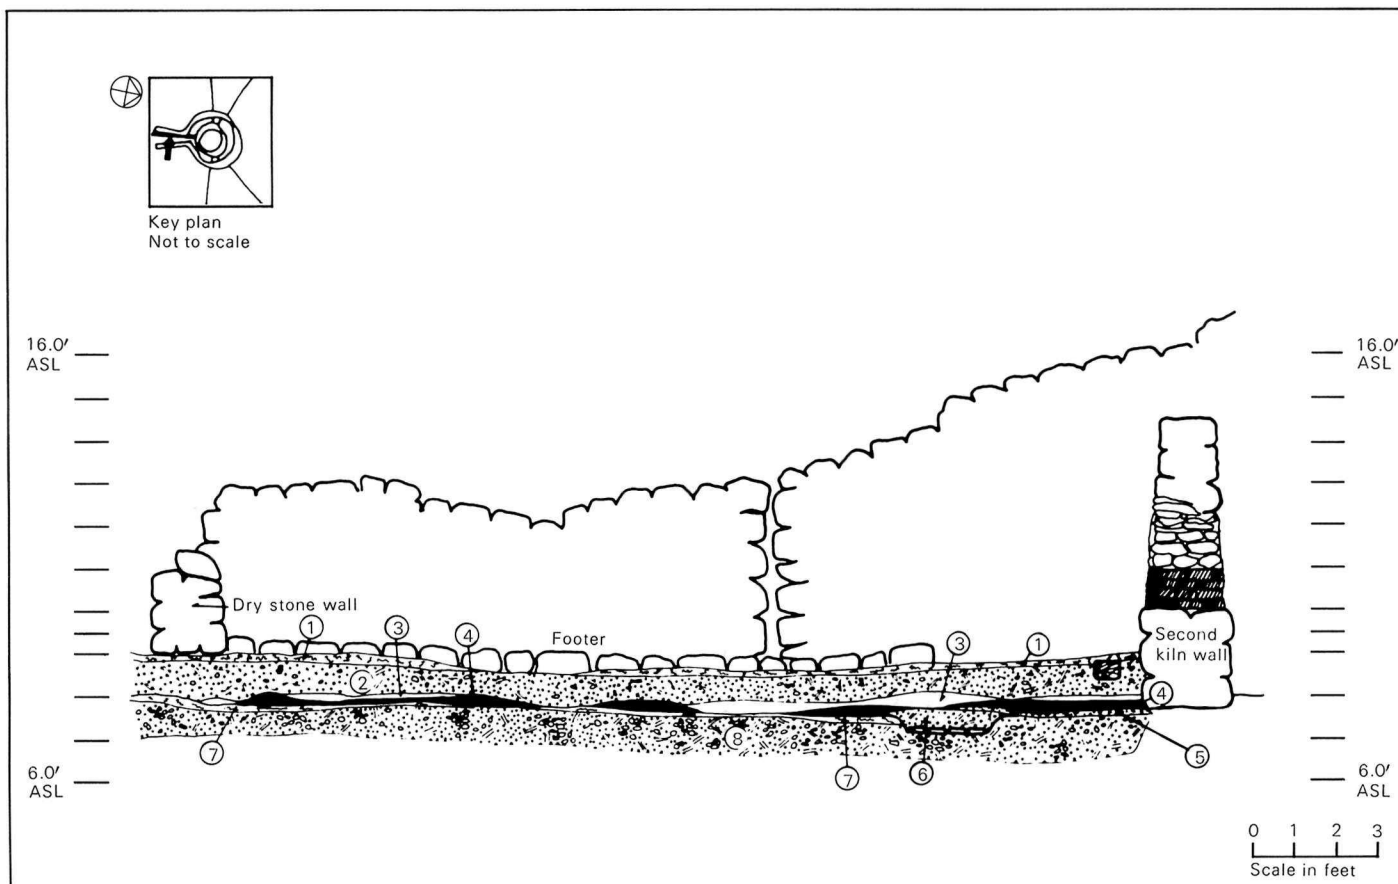
12 Section along the southeast passageway. 7, mortar-destruction layer (1758); 2, red, stony, clay loam fill for floor of passageway of second kiln (redeposited C horizon); 3, lenses of lime (probably represent dropping when first kiln was being emptied); 4, coal and burnt organic matter (remnants of fuel used in first kiln); 5, burnt, orange/red surface of undis-

turbed C horizon (floor of first kiln); 6, stoneless, red, clay loam fill over sill of first kiln (redeposited, cleaned C horizon); 7, mortar (construction surface of passageway to first kiln); 8, red, stony, hard-packed clay loam (undisturbed C horizon).

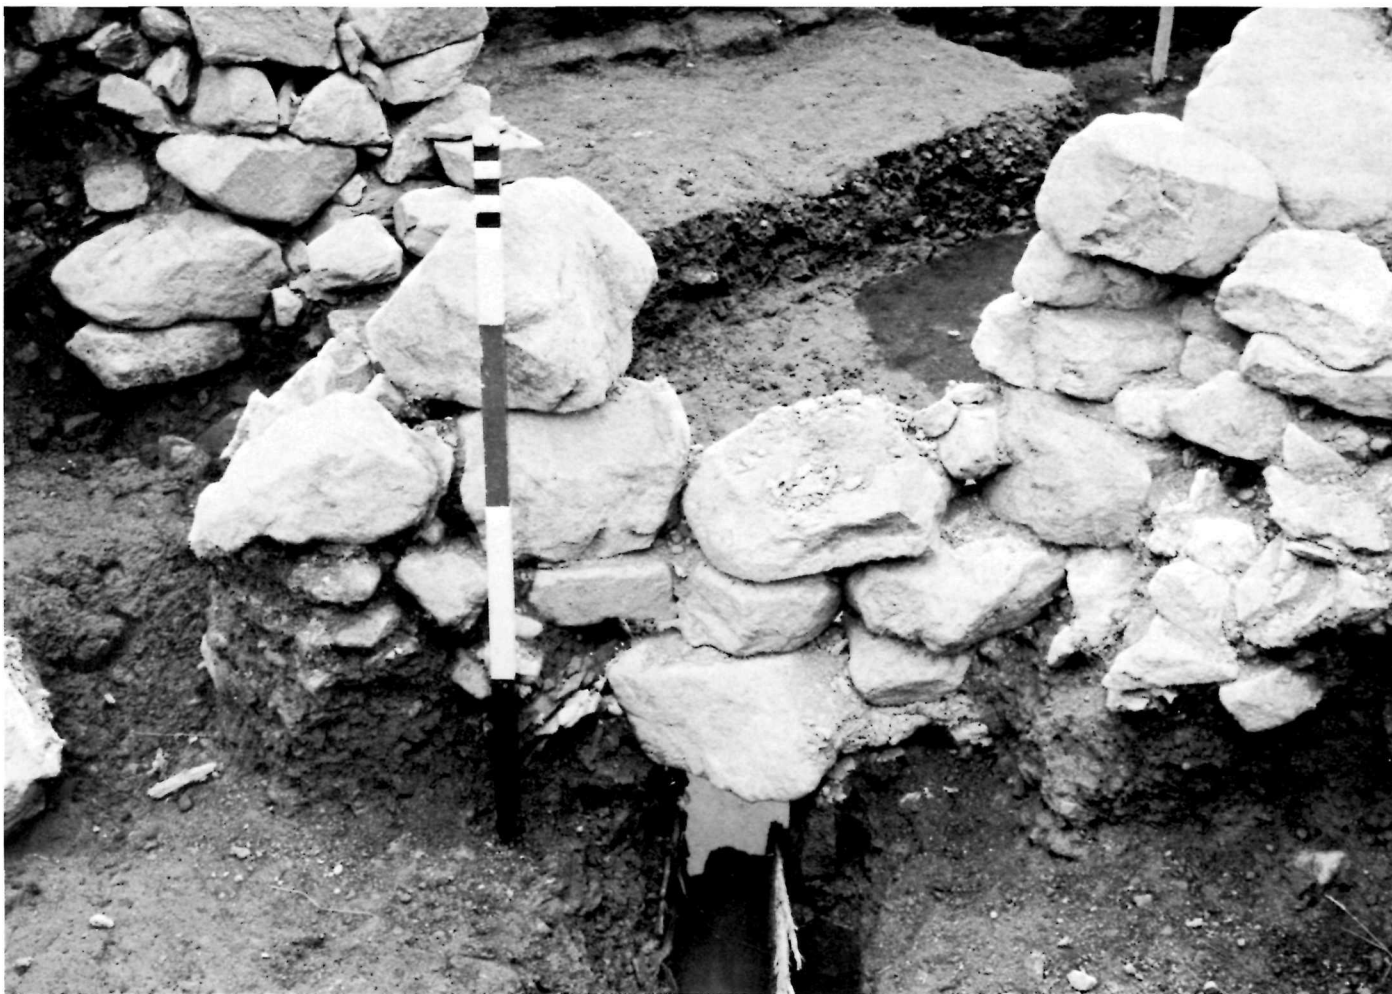
13 Wooden drain leading from the southeast passageway. The dry stone wall across the end of the passageway can be seen running over the drain.

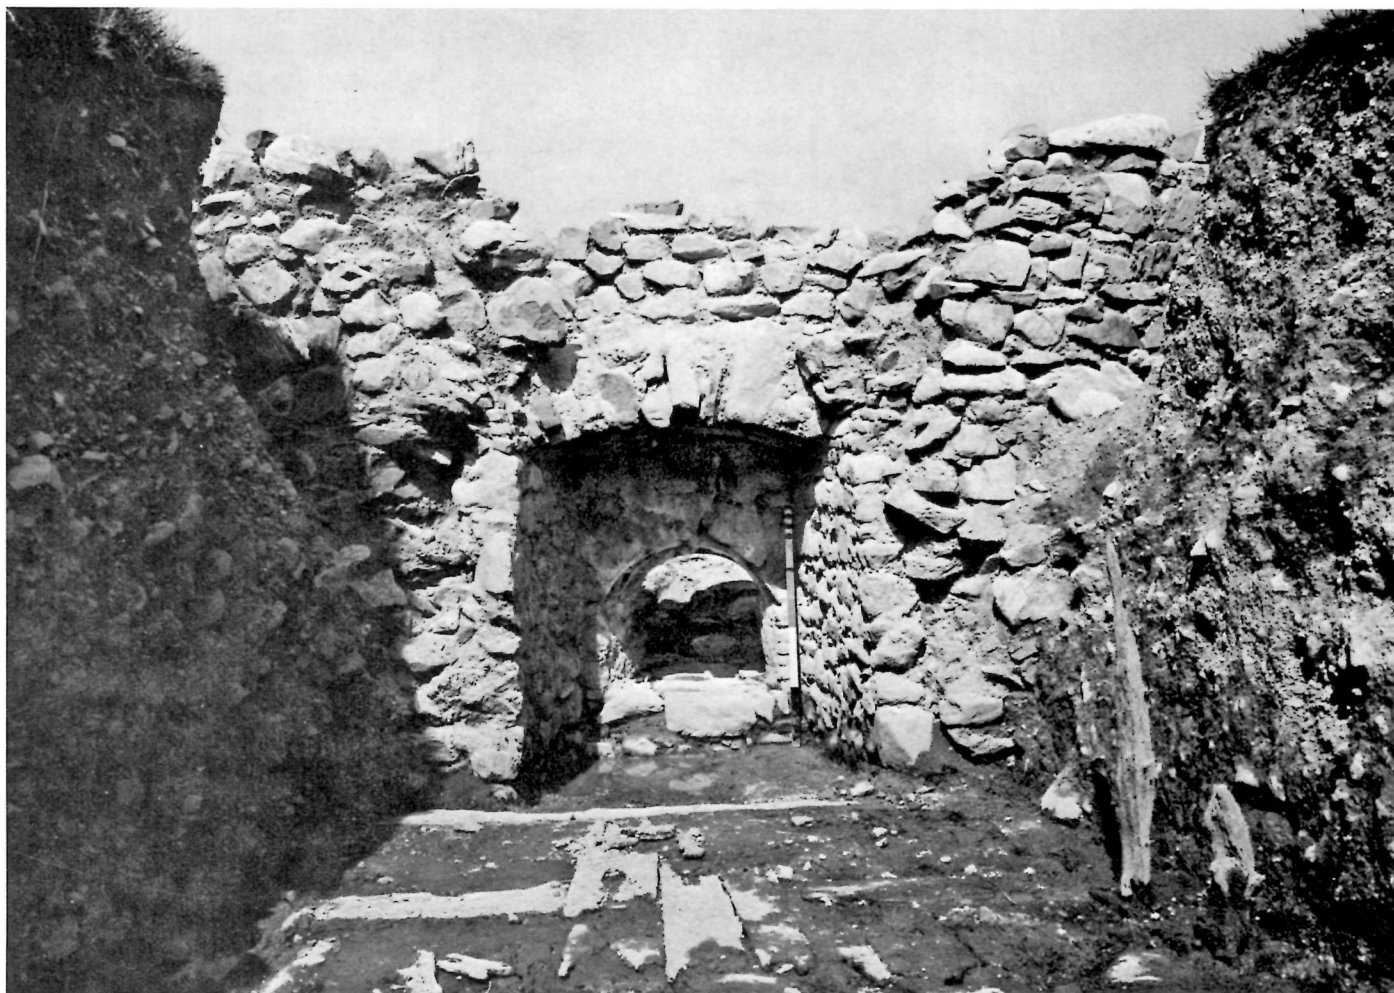
15 The west passageway, alcove and drawhole of the second kiln. The vertical sides of the excavation are the sides of the original passageway.

Both the north and west drawholes (Figs. 14, 15) were substantially similar and therefore will be considered together. In both, the actual opening was 3.25 ft. wide on the outside, narrowing to a width of 2.3 ft. at the inner edge. Both openings were 2.5 ft. high and both set in a wall

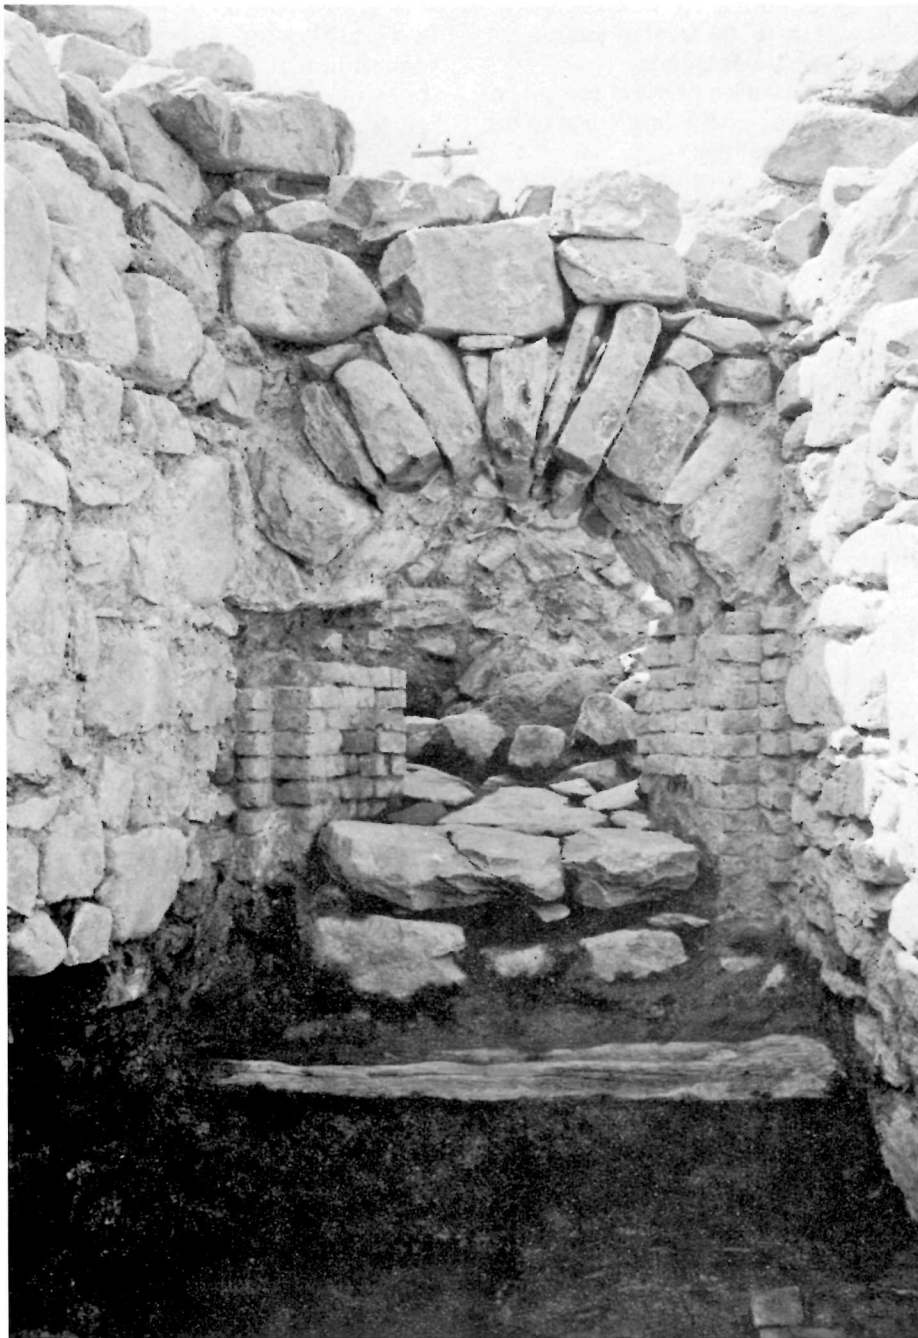
16 The southeast drawhole of the second kiln.
There are no iron bars supporting this arch.

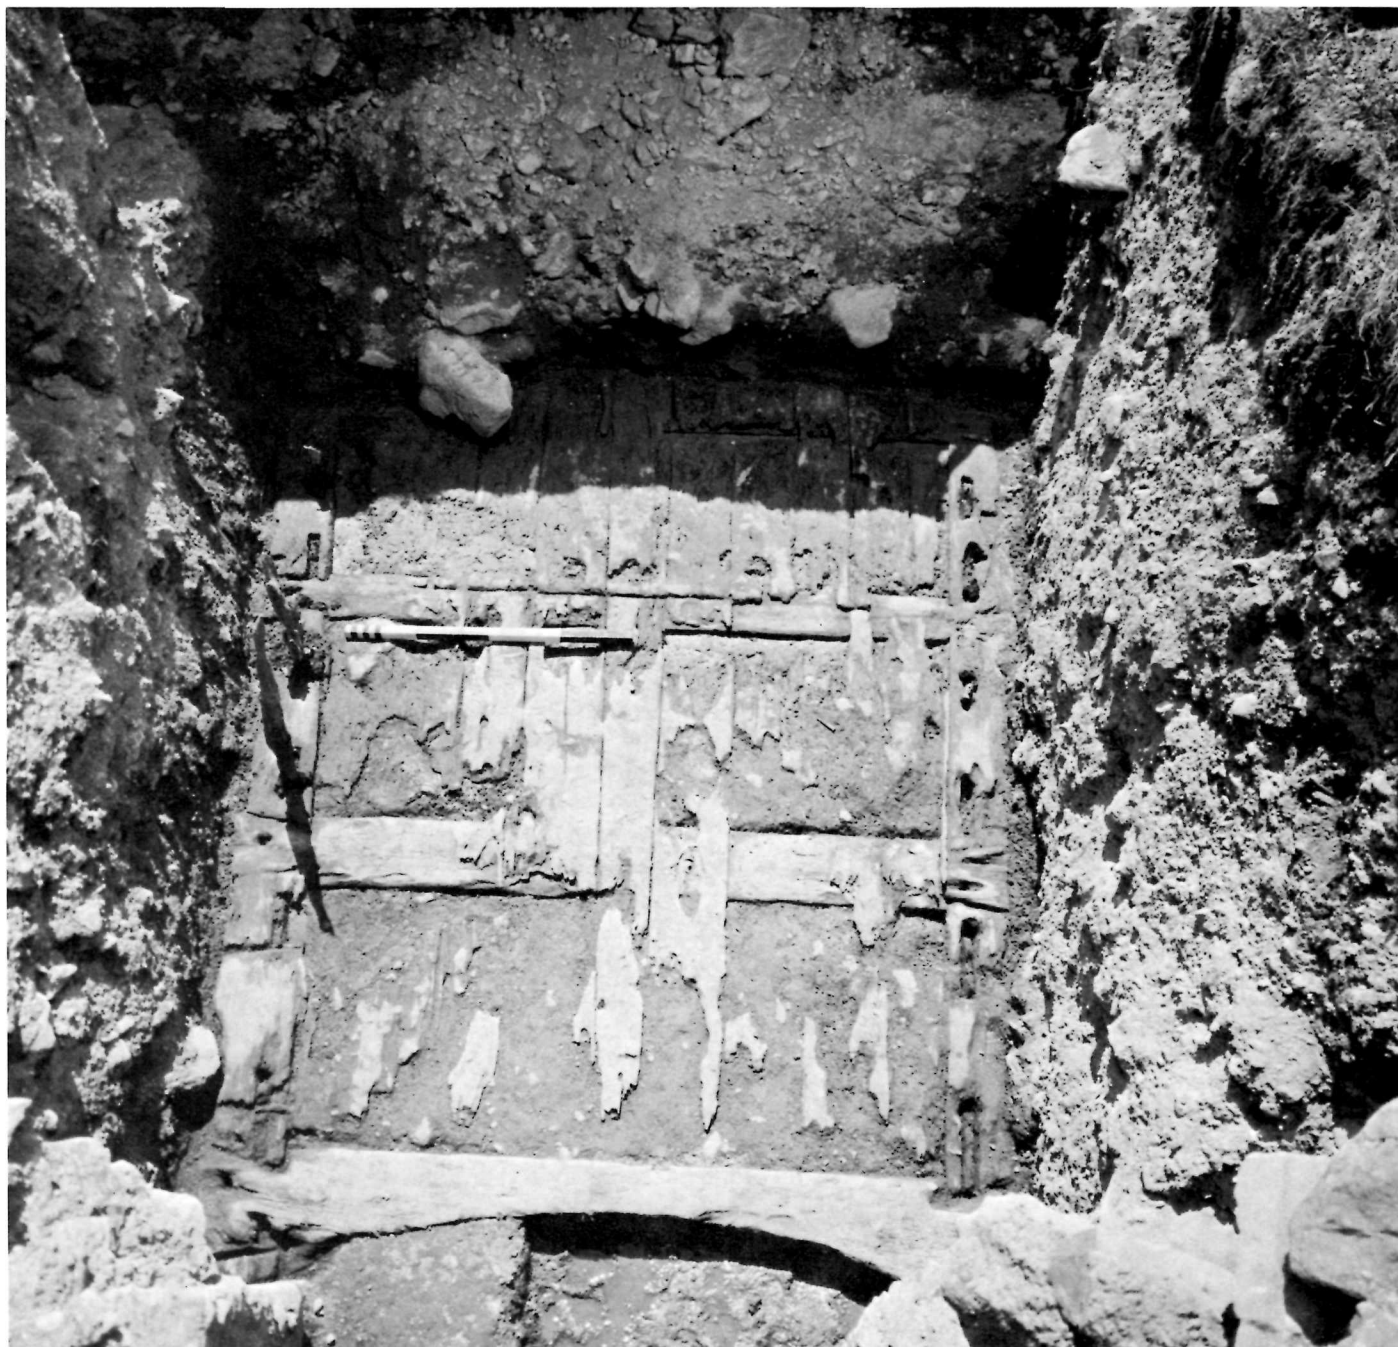
19 Part of the wooden floor of the west passage-way.

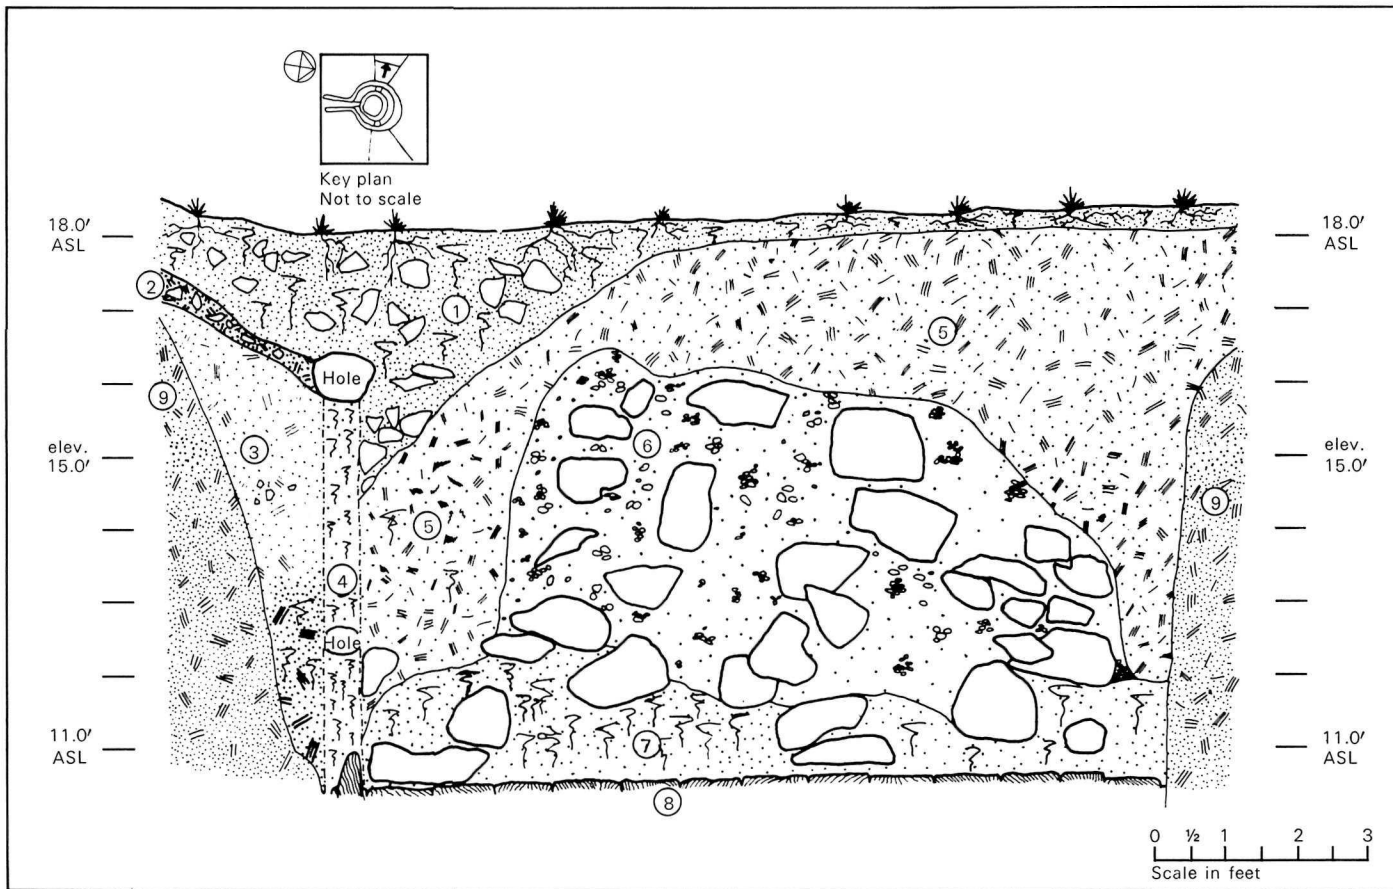
20 Section through the west passageway. 1, turf and humus (topsoil); 2, dark brown organic layer (buried turf line? original bank surface); 3, light brown sandy loam, traces of organic matter near base (fill behind wood revetment); 4, black organic matter (profile of decomposed wood revetment); 5, clay-loam, patches of organic matter, burnt in places; 6, mass of

beach gravel, rocks; 7, black organic matter mixed with sand; 8, planking on floor of passageway; 9, yellow, hard-packed, stony, sandy loam, weathered C horizon (vertical edges represent sides of passageway).

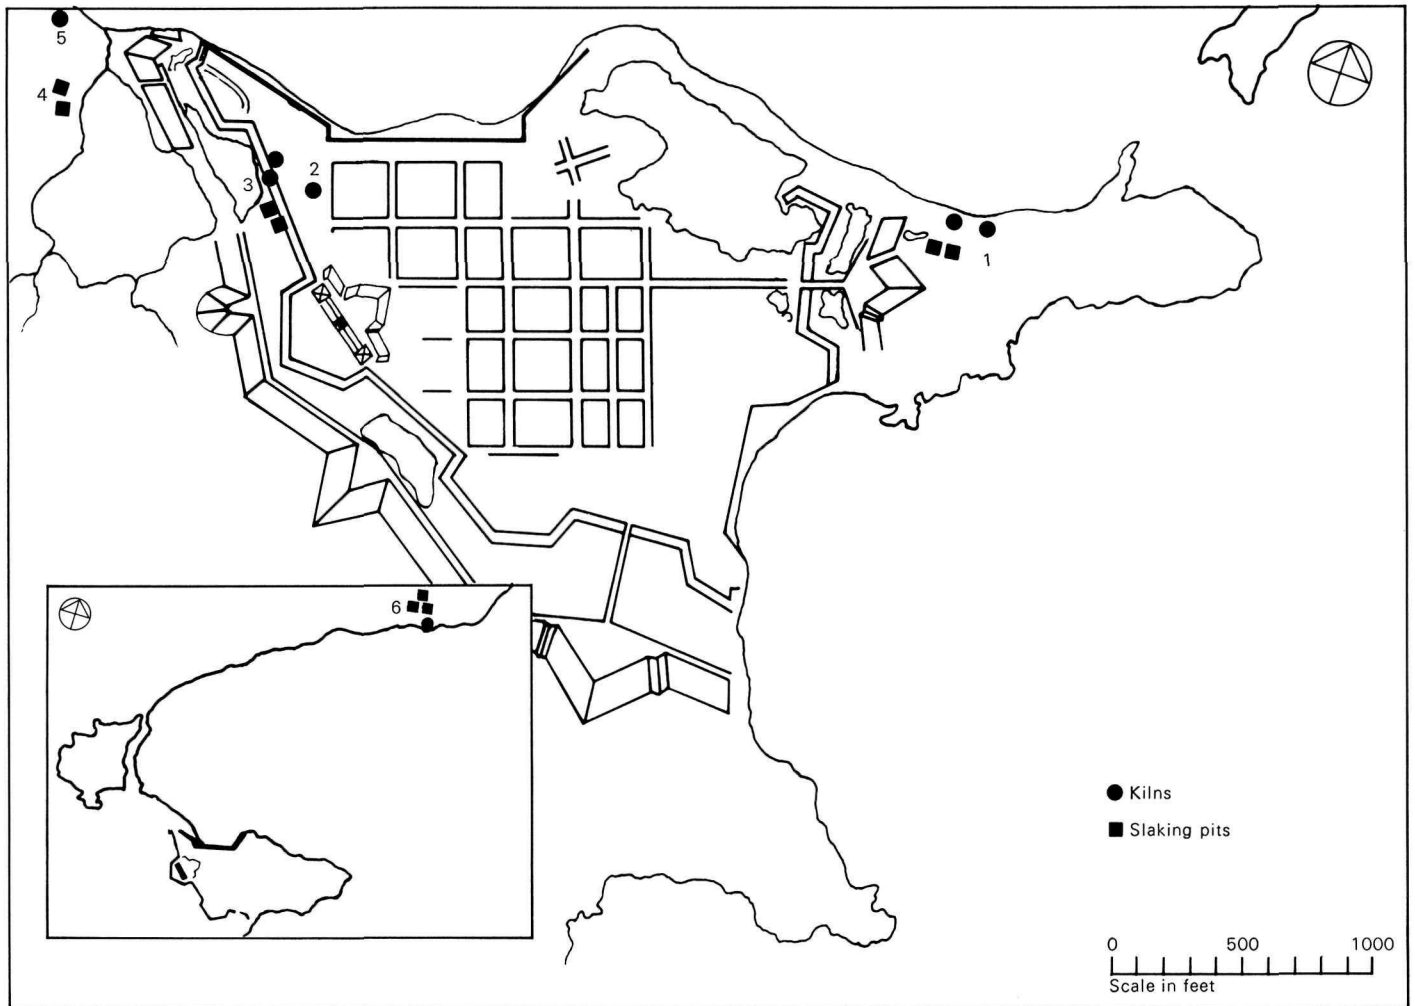
22 Distribution map of lime-kilns and slaking pits at Louisbourg. 1, Rochefort Point kilns and slaking pits; 2, kiln near Block 46; 3, King's-Dauphin Curtain kilns and slaking pits; 4, possible slaking pits for Faubourg kiln; 5, Faubourg kiln; 6, Royal Battery kiln.

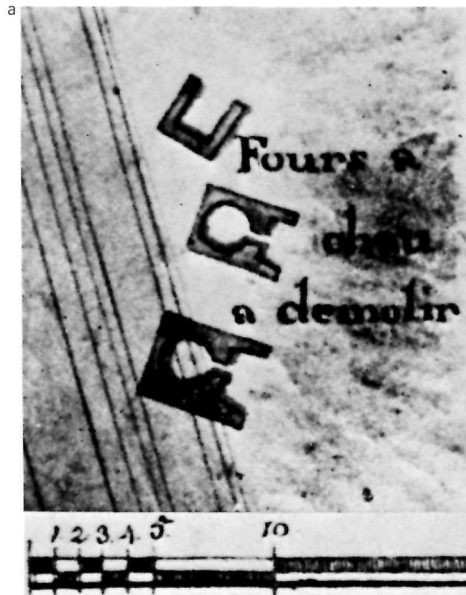
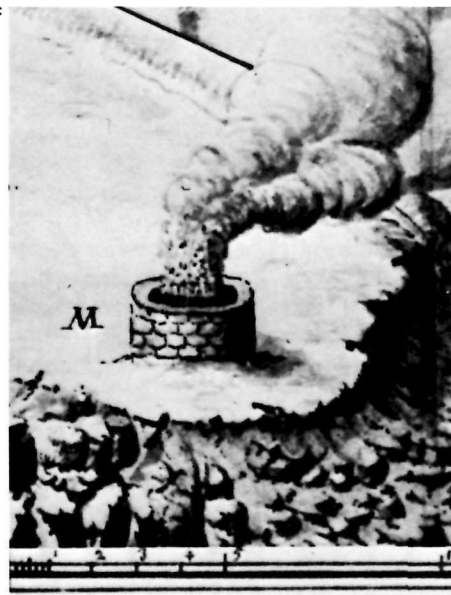
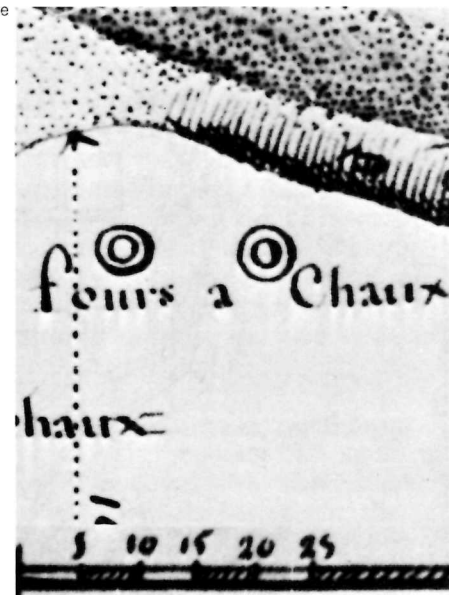
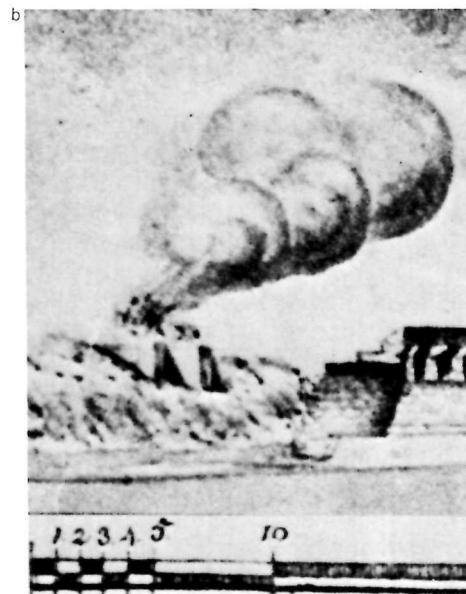
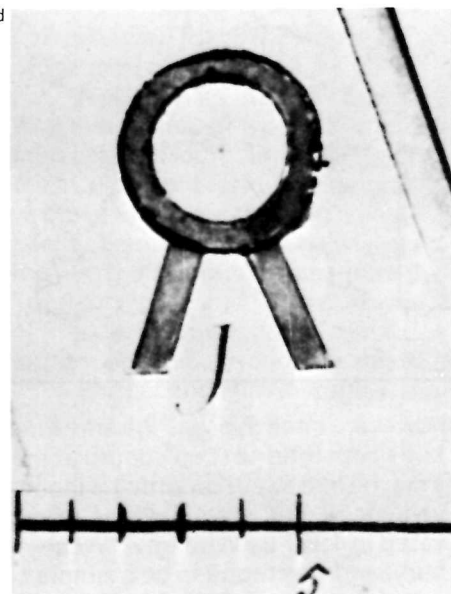
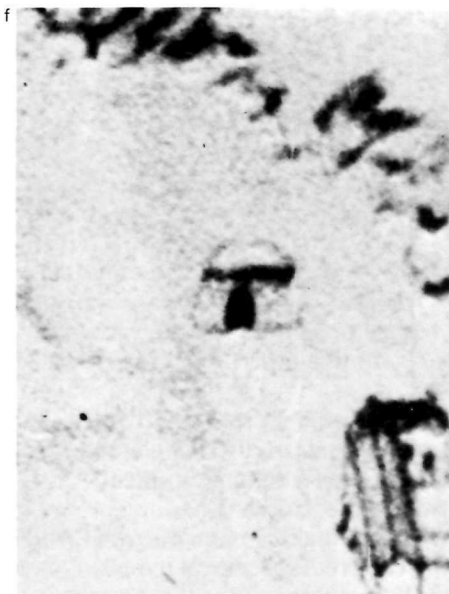
Batterie Royale Avec Ses Environs Pour Servir au Projet de 1726" (*Archives Nationales*); *d*, shows the kiln west of Block I. Taken from a plan entitled "Partie de la Ville de Louisbourg" (*Archives Nationales*); *e*, shows the lime-kilns at Rochefort Point. Taken from a plan entitled "Louisbourg 1752: Plan de la Pointe à Rochefort" (*Archives Nationales*); *f*, shows one of

the Rochefort Point kilns. Taken from a plan entitled "Plan du Cap breton dit Louisbourg Avec ces environs Pries par Lamiralle Bockoune le 26 juillet 1758" (*Library of Congress*).

open-topped structure built into the southeast side of the hill and, by the addition of banks around the upper parts of the wall, mostly subterranean. Its appearance was probably very similar to the kiln at the Royal Battery which shows the top 6 ft. of the wall above ground (Fig. 25, c). Leading from an opening on the southeast side, away from the prevailing wind, there was a sunken, stone-lined passageway with a wooden drain emerging from the end.
