- 5 **Lime Preparation at
18th-Century Louisbourg,**
by Charles S. Lindsay
- 47 **Louisbourg Guardhouses,**
by Charles S. Lindsay
- 101 **A Survey of Louisbourg
Gunflints,**
by T. M. Hamilton and Bruce W. Fry

Canadian Historic Sites:
Occasional Papers in Archaeology
and History – No. 12

Lime Preparation at 18th-Century Louisbourg

The equipment and techniques used in the preparation of lime for mortar in 18th-century Louisbourg are studied against the background of contemporary practices in France. Two basic types of French kilns and lime-burning techniques are identified, as are two methods of slaking the burnt lime. Parallels for all these structures and techniques are found at Louisbourg.

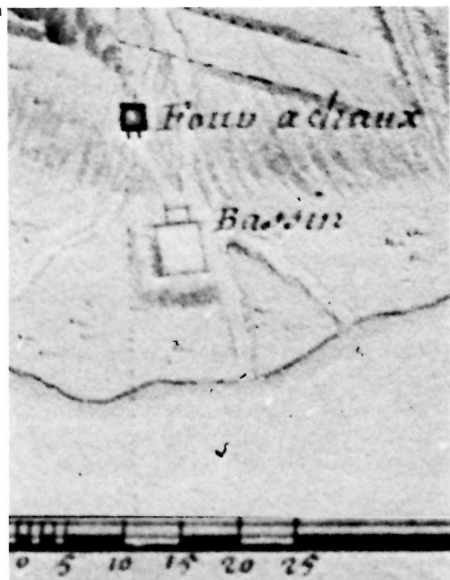
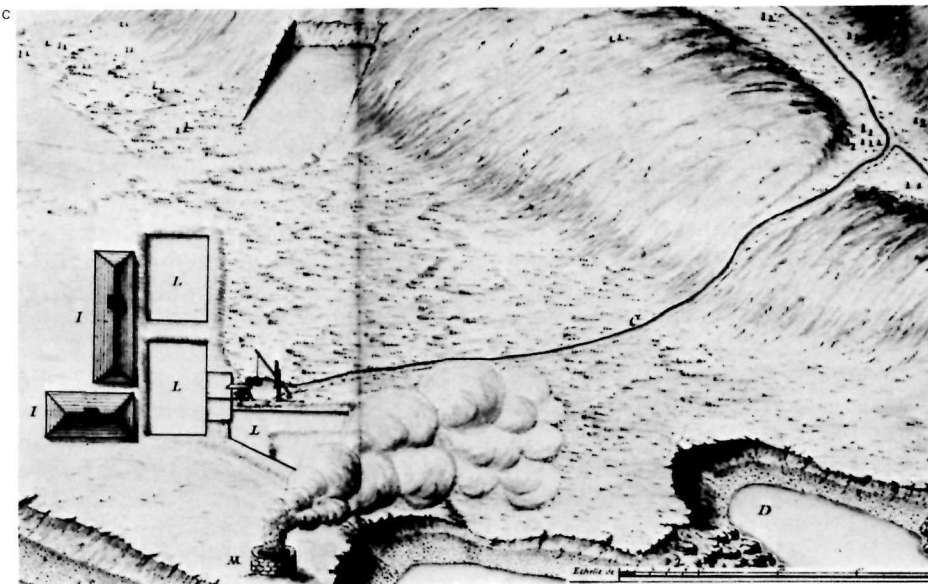
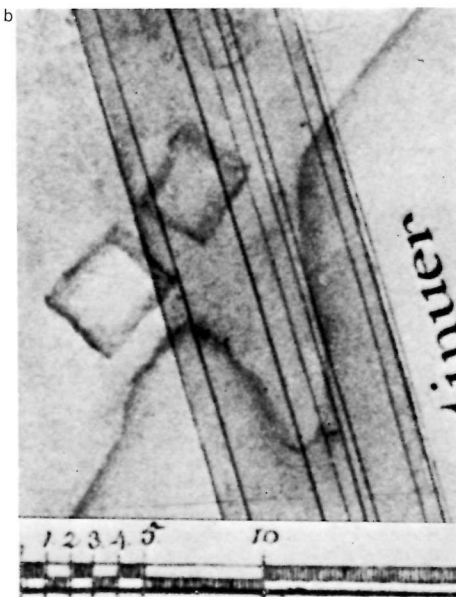
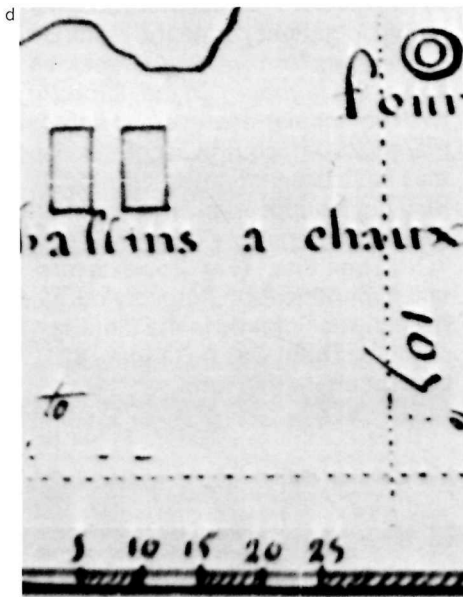
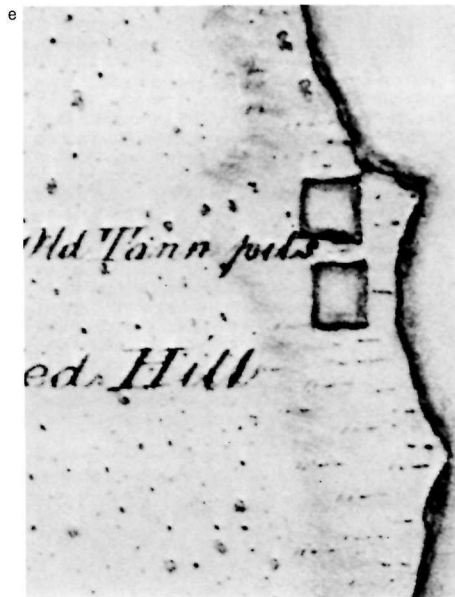
té en Jaune du Revêtement du Quay du Port de la Ville de Louisbourg à l'isle Royale. 1731" (*Archives du Génie*); c, shows two slaking pits and three storage pits at the Royal Battery. A stream (C) has been canalised to run water to a small pond near the slaking pits from which the water was hoisted by bucket into a chute which directed it into the slaking pit. Taken

from a plan entitled "Plan de la Batterie Royale Avec Ses Environs Pour Servir au Projet de 1726" (*Archives Nationales*); d, shows two pits for the Rochefort Point kilns. Taken from a plan entitled "Louisbourg 1752: Plan de la Pointe à Rochefort" (*Archives Nationales*); e, shows two pits described as "Old Tann pits" near the pond outside the Dauphin demi-

bastion. They were probably lime-slaking pits, since there was no tannery at Louisbourg. Taken from a plan entitled "A Plan of Louisbourg Survey'd and Drawn for His Excellency the Honble. Major General Thos. Gage Commander in Chief of His Majesty's Forces in America," 1767 (*Public Archives of Canada*).

1) A plan drawn in 1720 shows a lime-kiln astride the King's-Dauphin curtain line with a storage pit and a slaking pit (Fig. 25, *a*). The larger pit, approximately 28.0 ft. by 24.0 ft., is joined to the smaller pit at its southern end. This arrangement is precisely that described by Blondel, the smaller pit being the place where the

slaking was carried out and the larger one being a reservoir. Water for slaking could be obtained from the nearby pond. A later plan, drawn in 1731, shows two large pits and no small slaking pit (Fig. 25, *b*).

2) A plan drawn in 1725 of the lime-kiln and slaking pits at the Royal Battery again shows small pits for slaking connected to larger storage pits (Fig. 25, *c*). In this case there are two large (30 ft. by 20 ft.) conjoined rectangular storage pits to the west of the two small slaking pits, and one irregular storage pit to the east. There does not appear to be any connecting channel between the two rectangular

3) A third plan drawn in 1752 (Fig. 25, *d*) shows two pits approximately 150 ft. from the two kilns near Rochefort Point. The pits are both the same size, beside each other, and without slaking pits attached. This simplicity is probably to be attributed to the schematic nature of the plan.

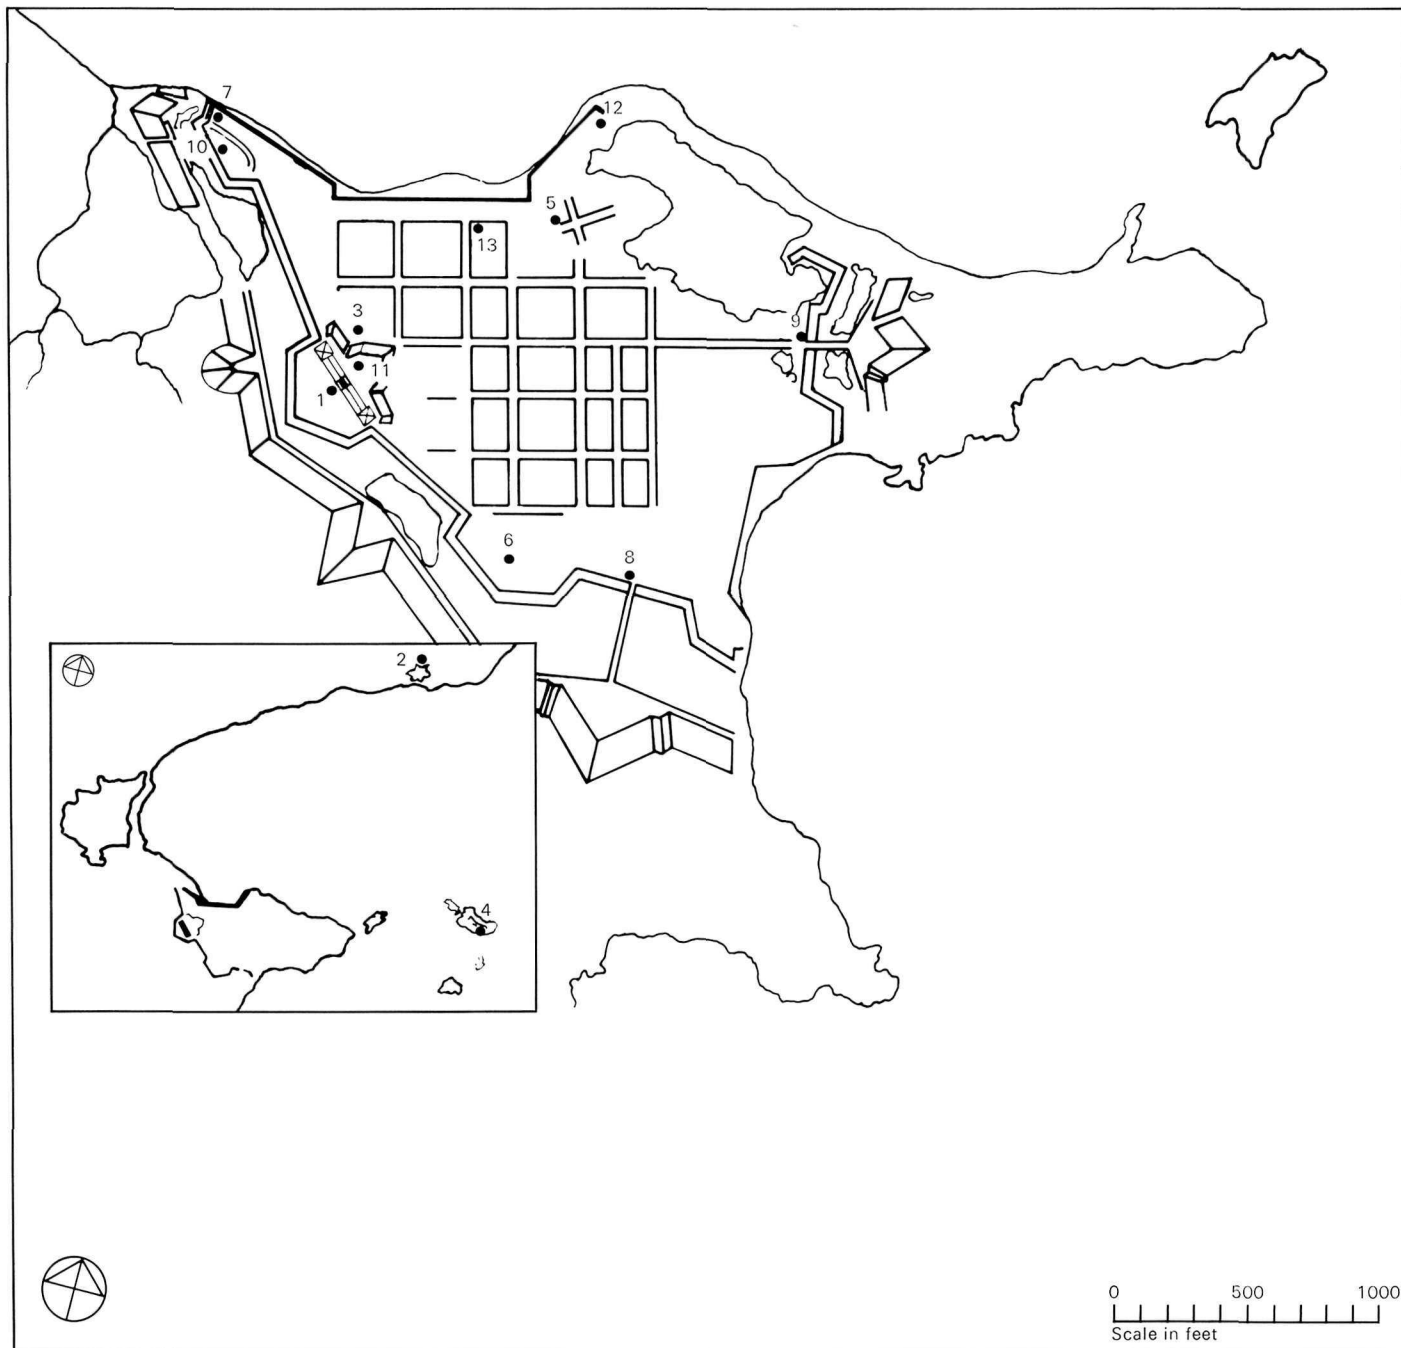
1 Distribution map of Louisbourg guardhouses.
 1. Citadel Barracks Guardrooms; 2. Royal Battery Guardrooms; 3. Early Barracks Guardhouse; 4. Island Battery Guardhouse; 5. Ile du Quay Guardhouse; 6. Queen's Bastion Guardhouse; 7. Dauphin Gate Guardhouses; 8. Queen's Gate Guardhouses; 9. Maurepas Gate Guardhouses; 10. Dauphin Bastion Guardhouses; 11. Place

d'Armes Guardhouse; 12. Pièce de la Grave Guardhouse; 13. English Guardhouse.

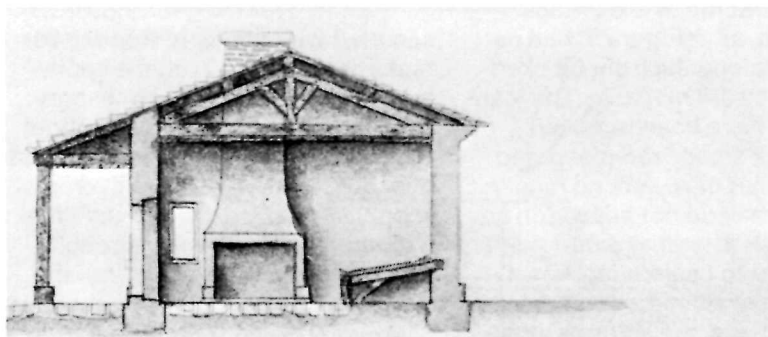
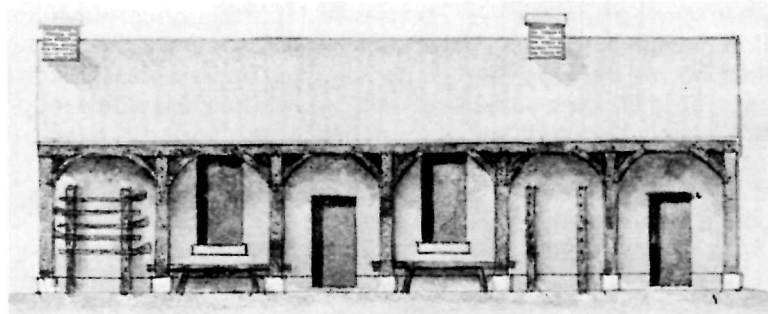
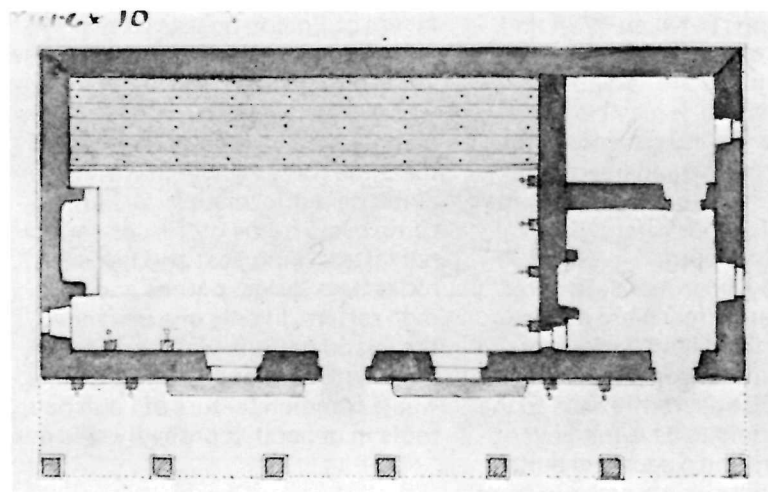
2 French guardhouse, from a plan entitled "Profils et Elevations de divers desseins de Corps de Garde." (*Bibliothèque du Génie.*)

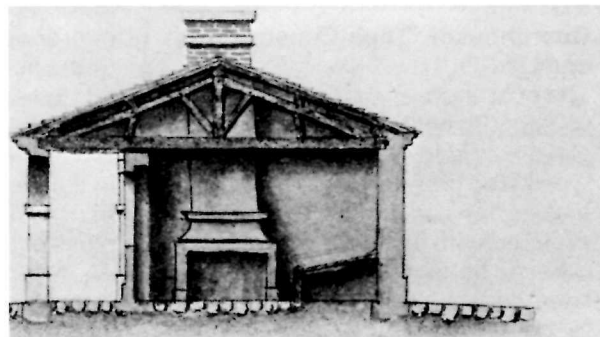
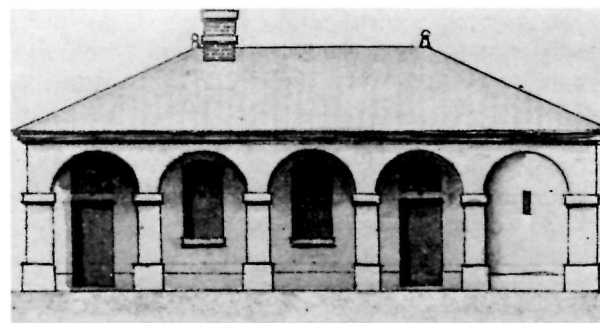
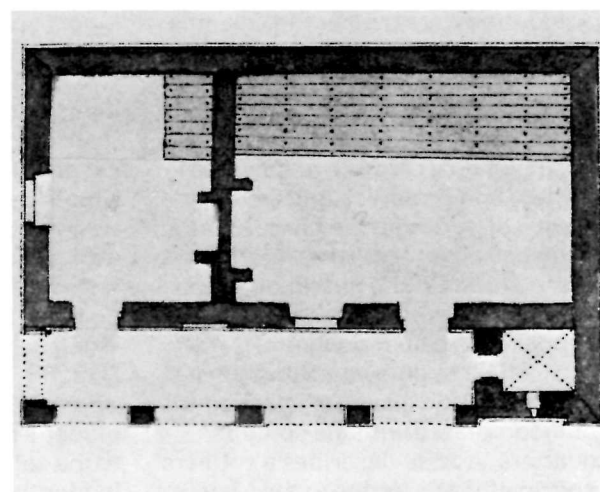
3 French guardhouse, from a plan entitled "Profils et Elevations de divers desseins de Corps de Garde." (*Bibliothèque du Génie.*)

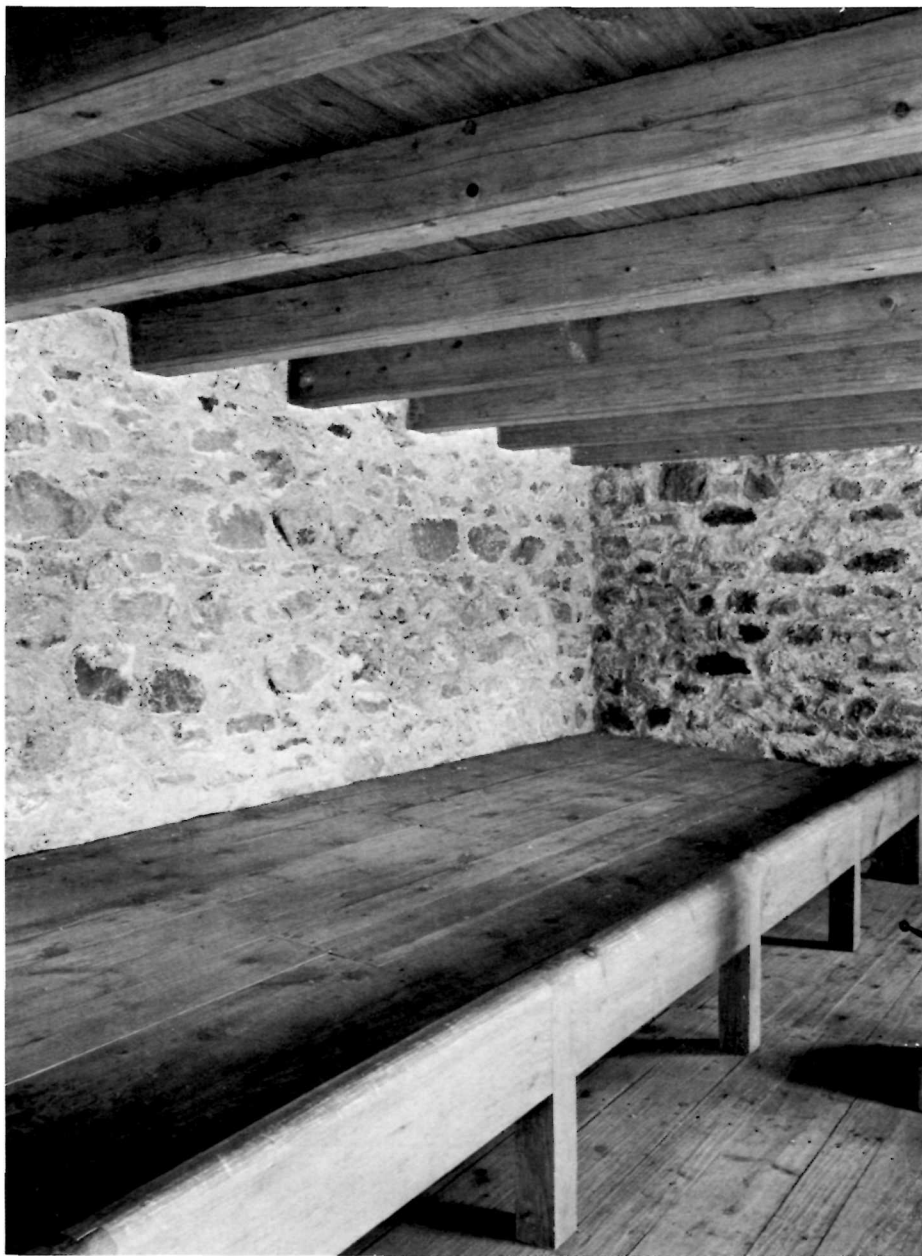
it. The rather plain construction of the furniture in contrast to that in the officers' quarters can be seen in Figure 11.

Almost all the soldiers' quarters contained arms racks. The amount was given either by number (Franquet's 1753 list) or by running length (1750 repair estimates). The repair estimates sometimes mention pegs for the racks,²⁰ presumably similar to those shown in Figure 11. The illustration shows that the rack consisted of two uprights held to the wall by masonry anchors, with matching rows of holes in each post. Pegs were placed in these holes and the guns laid horizontally across them. Figure 4 shows these racks attached to the walls in the plan view of a guardhouse. In addition one is shown, with guns on it, in the elevation of the front of the guardhouse, attached to the outside of the wall.

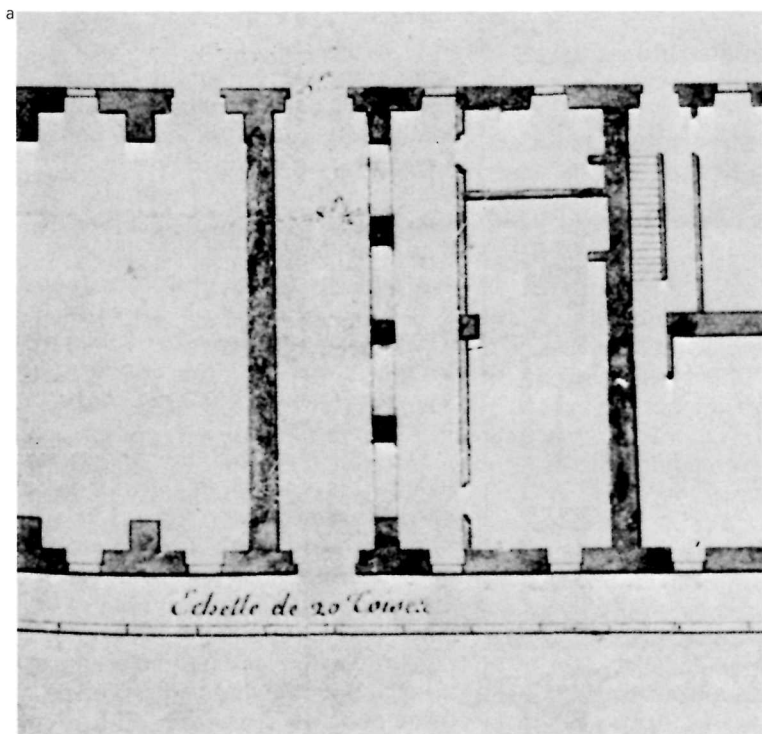
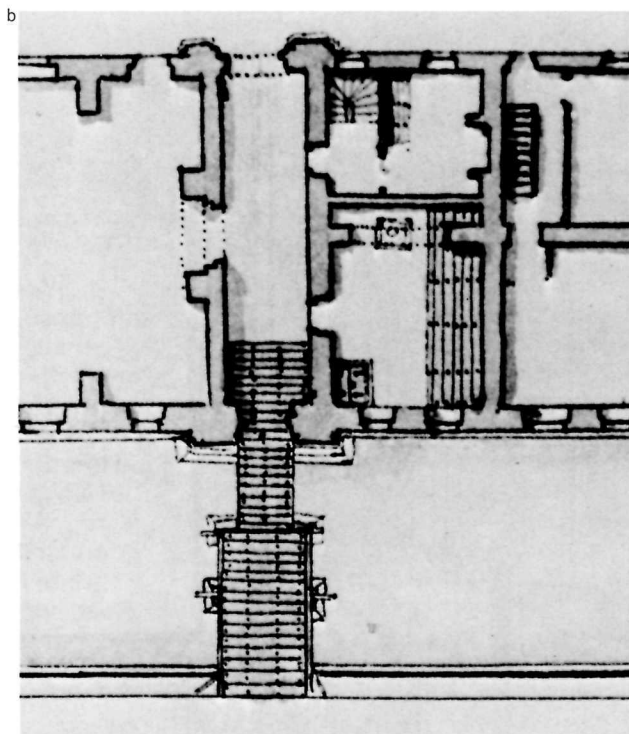
13 Historical plans of the King's Bastion barracks guardrooms. *a*, 1724, showing the dividing wall between the rooms in the unlikely position of intruding into the officer's fireplace. From a plan entitled "Plan du rez de chaussée du corps de Caserne et du Bastion du Roy 1724." (*Archives du Génie*); *b*, ca. 1725, after the modifications which removed the arcaded wall and substi-

tuted a masonry front wall for the original wooden one. The dividing wall is now in a more practical position. From a plan entitled "Bastion du Roy faisant partie de l'enceinte de La Ville de Louisbourg." (*Bibliothèque Nationale.*)

As shown on the earliest plan the dimensions of the officer's quarters were 13 *pieds* by 7 *pieds*. However, since this plan shows the wooden dividing wall between the officer's and soldiers' quarters intruding into the officer's fireplace, these dimensions should be regarded with caution. Following the alterations, which included removing and replacing the south and east walls and creating a vestibule for the winding stairway, the resulting room was 10 *pieds* by 13 *pieds*. With the modified arrange-

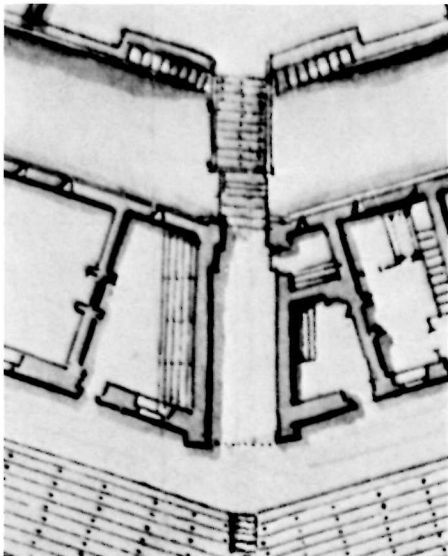
14 Historical plan of the Royal Battery barracks guardrooms (undated). The soldiers' quarters are to the left of the passageway and the officer's quarters share the right side with the cell. From a plan entitled "Batterie Royale de 40 canons . . . dans le por de Louisbourg a Lisle Royale." (Original source unknown, copy in the Public Archives of Canada.)

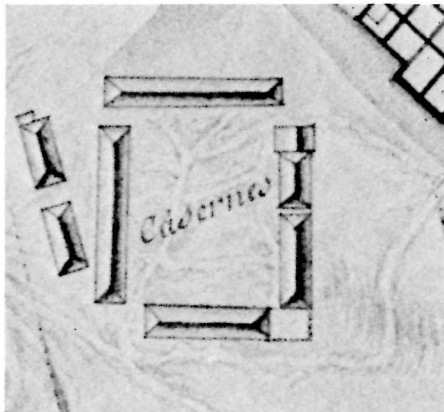
15 Historical plan of the early barracks guardhouse, 1720. This plan shows one of a number of configurations for the guardhouse. It is located at the top right of the barracks square with the cell and dungeon adjoined to one end. From a plan entitled "Plan De Louisbourg Avec Ses Augmentations faites pendant l'année 1720." (Archives du Génie.)

The early barracks guardhouse first appears in historical plans in 1720 (Fig. 15) where it forms part of the east side of a square bounded on the other three sides by barracks. It was built to replace an earlier guardhouse-prison situated in Block 16. This earlier building had proved to be inadequate, since prisoners had escaped from it in 1717; therefore, the decision was made in 1718 to build a new guardhouse-prison the following year.¹ The building enjoyed only a short life since the barracks and guardhouse were demolished about 1723 to make way for the glacis of the townside Place d'Armes of the King's Bastion. Although much of this area has been excavated, no trace of this guardhouse has been found.

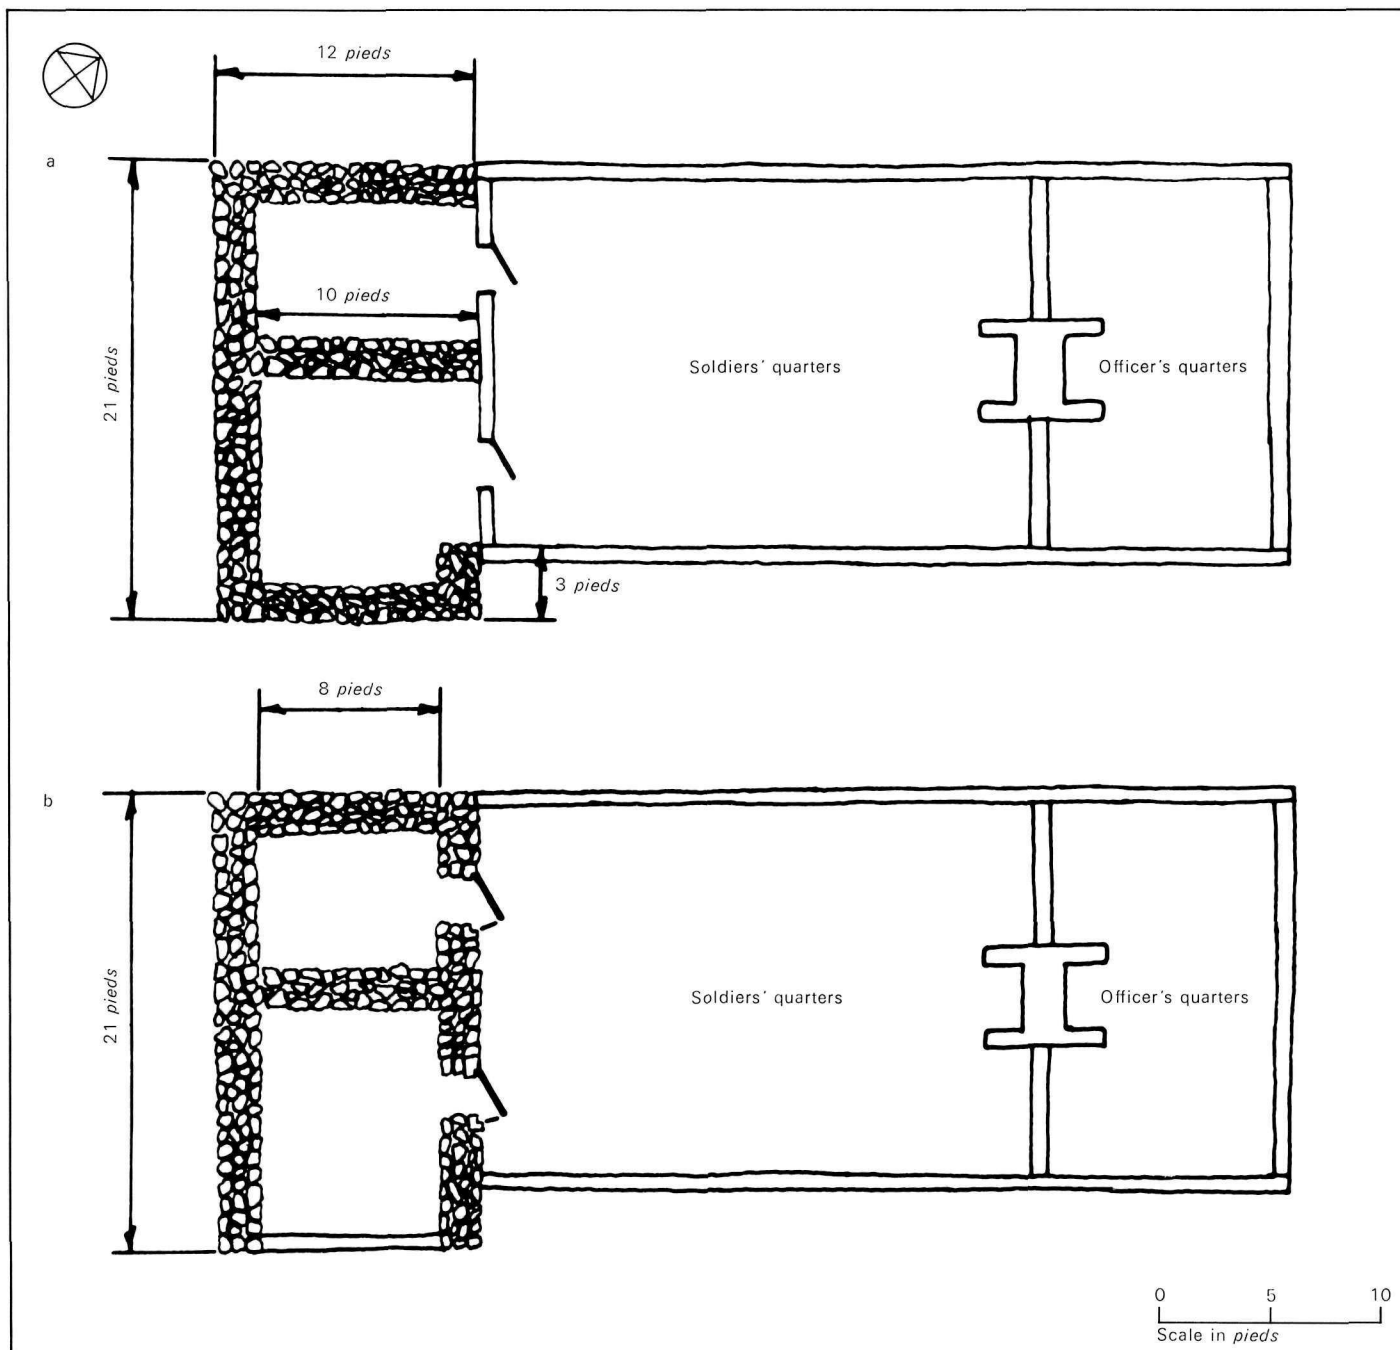
16 Hypothetical ground plans of the early barracks guardhouse/prison. *a*, shows masonry exterior walls for the prison with an interior wooden partition to the guardhouse; *b*, shows a wooden east wall on the prison. Both arrangements fit the specifications closely, but *a* seems more logical.

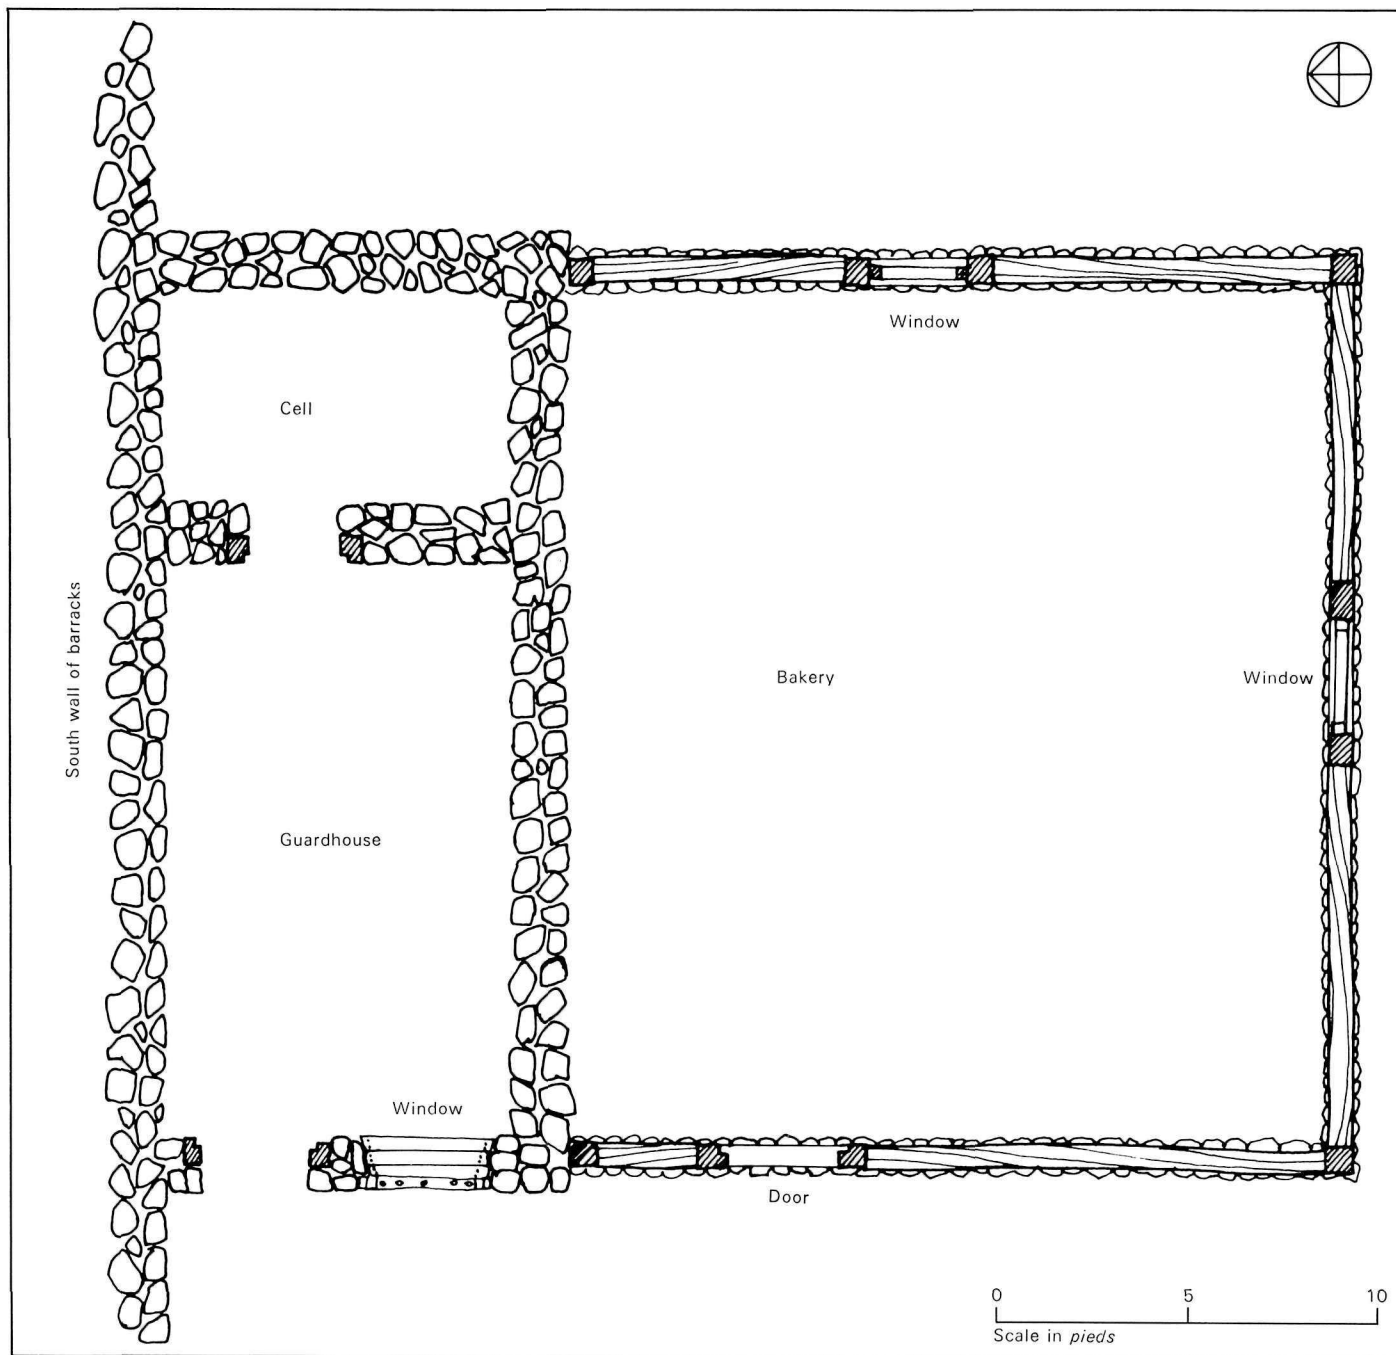
- 18 Hypothetical ground plan of the Battery Island barracks guardhouse. This arrangement fits the *toisé* measurements closely. The only major possible alteration is to reverse the positions of the guardhouse and cell.

3)	Ceiling of guardhouse, cell and bakery:
	Length, 32 <i>pieds</i>
	Width, 24 <i>pieds</i>
4)	Plank revetment around the bakery, guardhouse and cell:
	Total length, 33 <i>pieds</i>
	Average height, 8 <i>pieds</i>
5)	Foundation for the bakery:
	Total length, 64 <i>pieds</i>
	Thickness, 1 <i>pied</i>
	Average height, 1 <i>pied</i>
6)	The hip:
	Average width, 12 <i>pieds</i> 6 <i>pouces</i> (half the width of the roof)

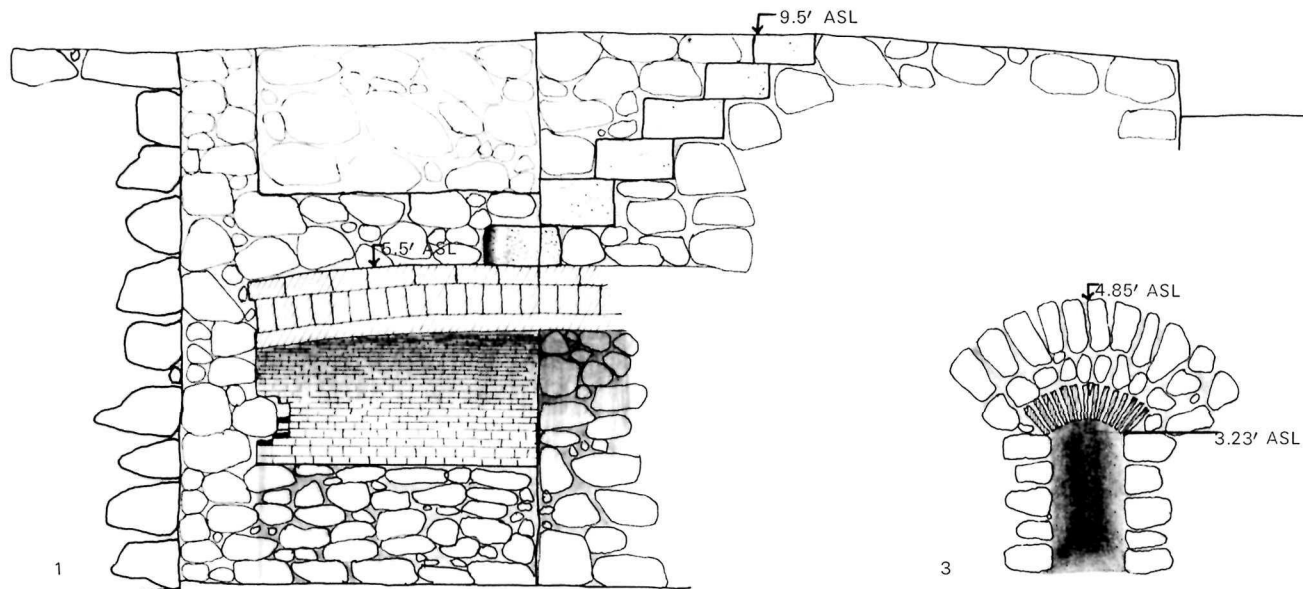
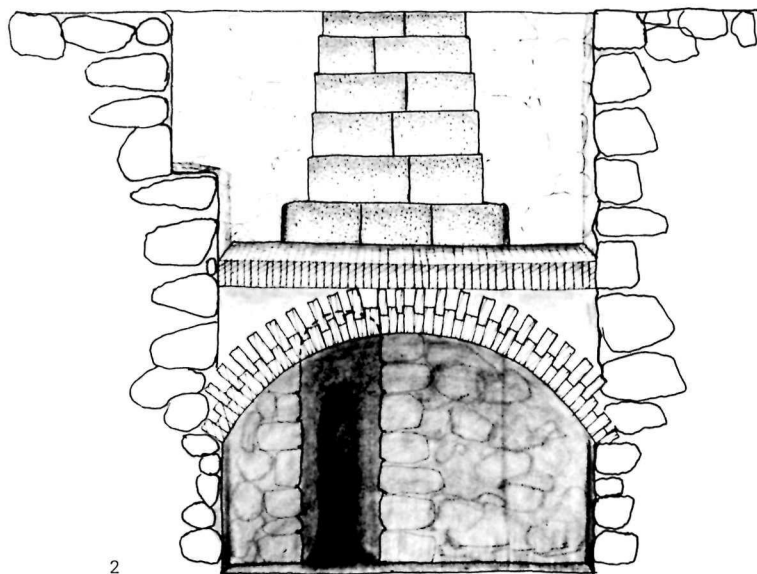
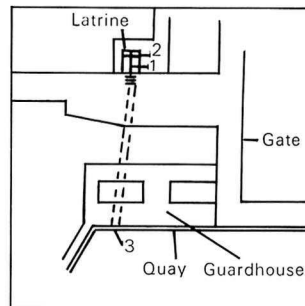
Sections of Dauphin latrine

Section of latrine drain at quay wall

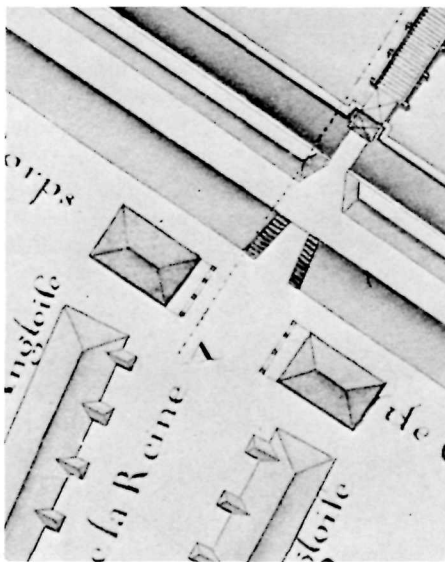
22 Historical plan of the Queen's Gate guardhouses, 1751. The officer's quarters and armoury are on the right and the soldiers' quarters and latrine are on the left. From a plan entitled "Plan des deux fronts de fortification, l'un d'entre le Bastion de la Reine côté 2, celui de Princesse côté 1, et l'autre d'entre de dit Bastion Princesse côté 1, et celui de Brouillan côté 10." (*Archives du Génie.*)

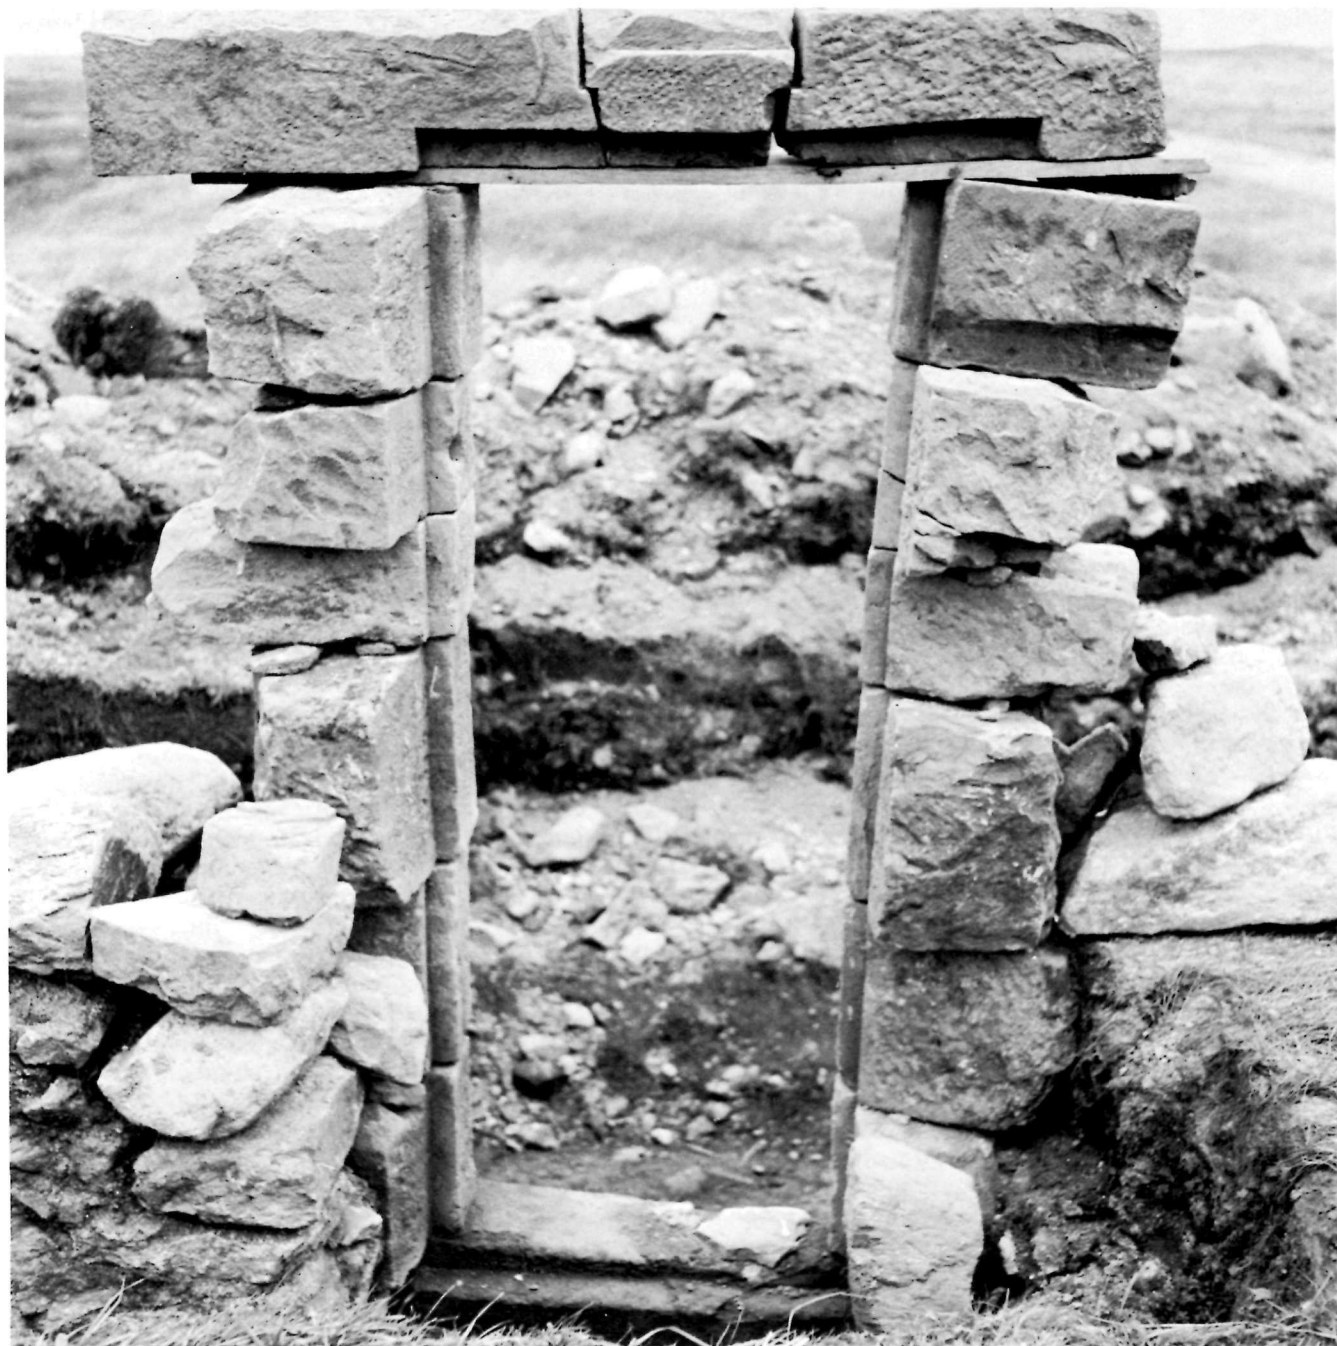
23 Re-assembled doorway of the armoury of the Queen's Gate guardhouses. The lintel does not properly fit the jambs. A stone from a lintel from another doorway probably has been incorporated accidentally in this re-assembly.

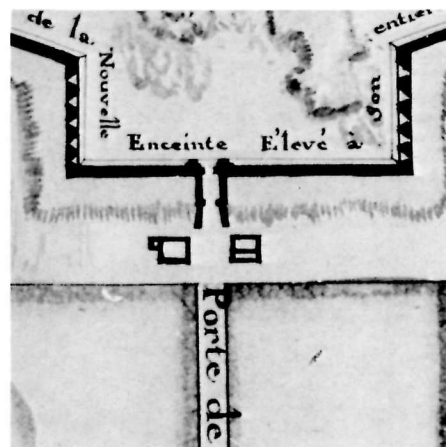
24 Historical plan of the Maurepas Gate guardhouses, 1741. The soldiers' quarters with the attached latrines are on the left and the officer's quarters and small armoury are on the right. From a plan entitled "Plan de Louisbourg Ou est Représenté en Couleur Jaune les Ouvrages a faire pour perfectionner la Nouvelle Enceinte pendant Lannée 1741." (*Archives Nationales.*)

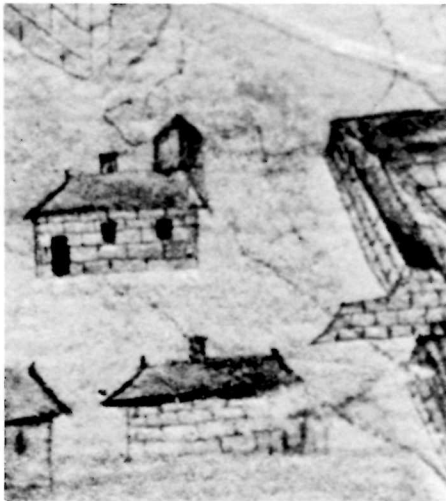
25 View of the Maurepas Gate guardhouses, 1758. The upper building is the soldiers' quarters and latrines. The lower building is the officer's quarters and armoury. From a view entitled "Plan du Cap breton dit Louisbourg Avec ces environs Pries par Lamiralle Bockoune le 26 juillet 1758." (*Library of Congress.*)

In the same year a large brick stove was installed and, like those in other guardhouses, it appears to have been removed each spring.⁴⁷ The 1758 view shows a projection through the ridge of the roof that was probably a stove-pipe.

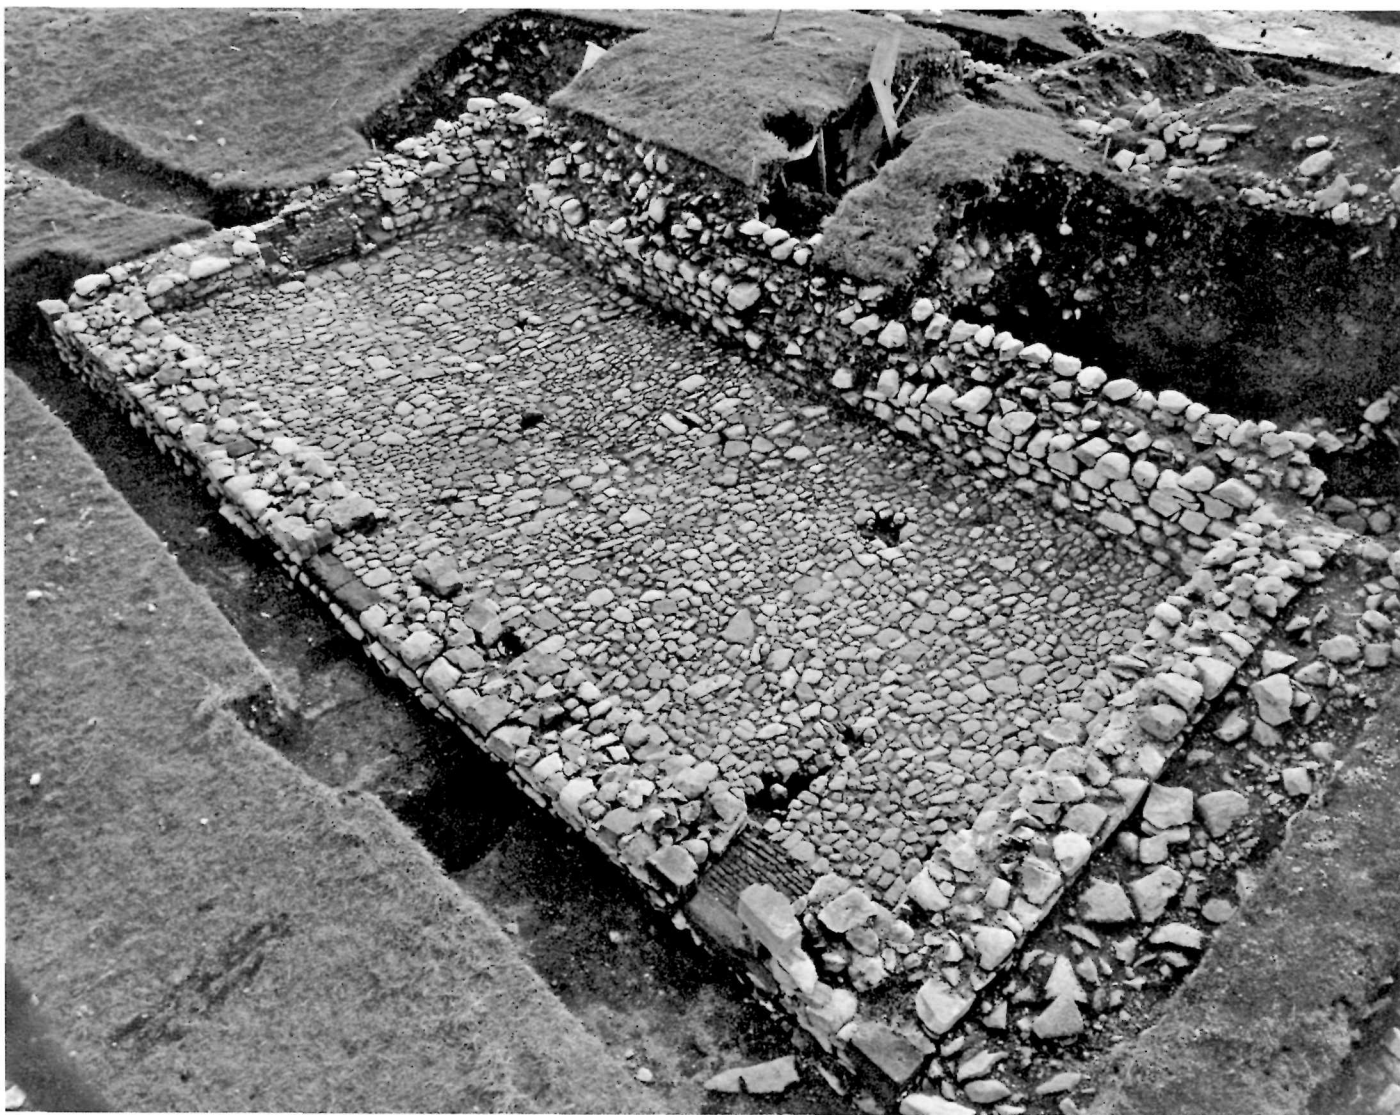
27 Excavated remains of the Dauphin Demi-bastion barracks/guardhouse.

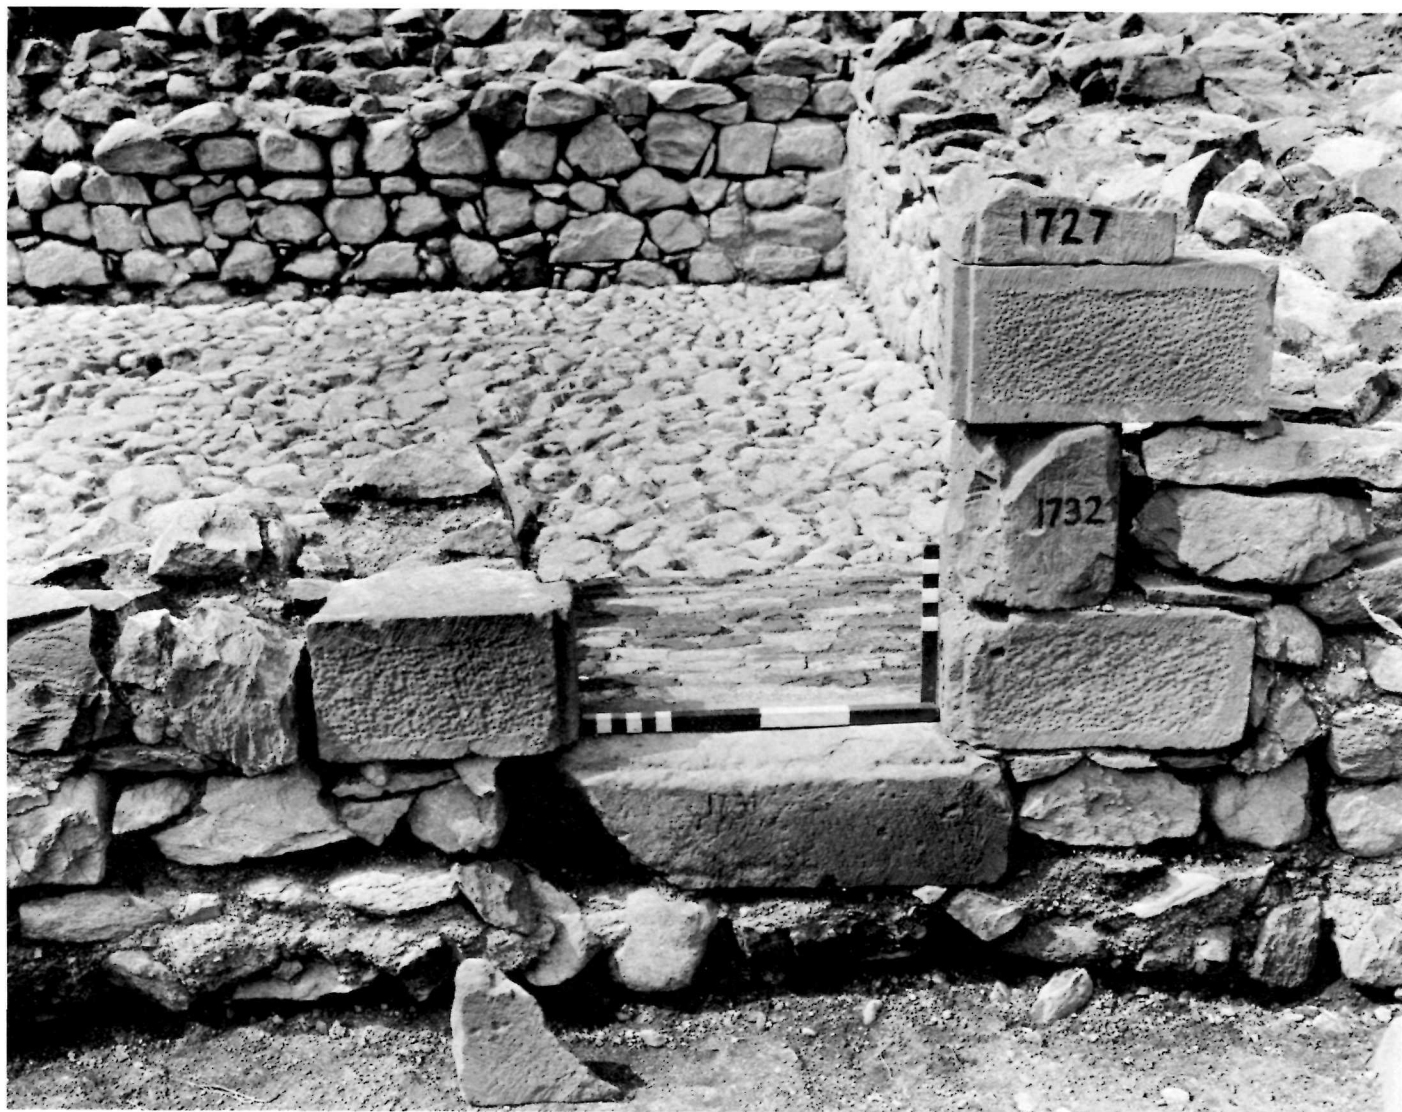
29 Fireplace in Dauphin Demi-bastion barracks/ guardhouse. The original fireplace with its dressed sandstone jambs and fireback was replaced by a brick stove built within its opening.

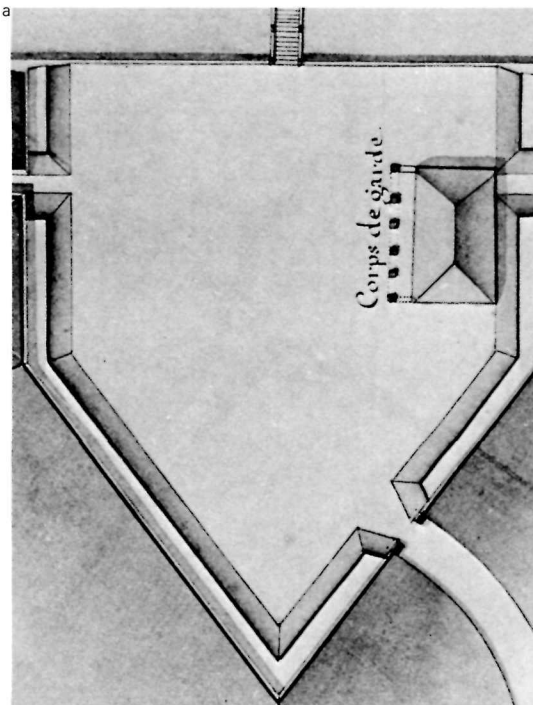
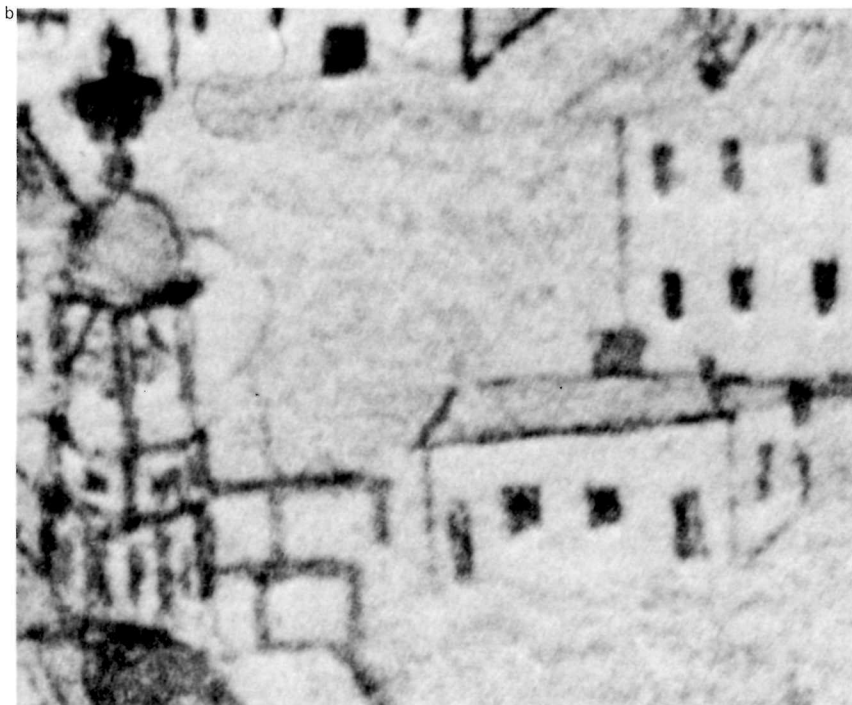
30 Historical plan and view of the Place d'Armes guardhouse. a, 1752. from a plan entitled "Plan du Bastion du Roy cotté 3, nommé communement le fort, pour servir au Projet de l'aggrandissement de la Place d'Armes" (*Archives du Génie*); b, 1758. from a view entitled

"Plan du Cap breton dit Louisbourg Avec ces environs Pries par Lamiralle Bockoune le 26 juillet 1758" (*Library of Congress*).

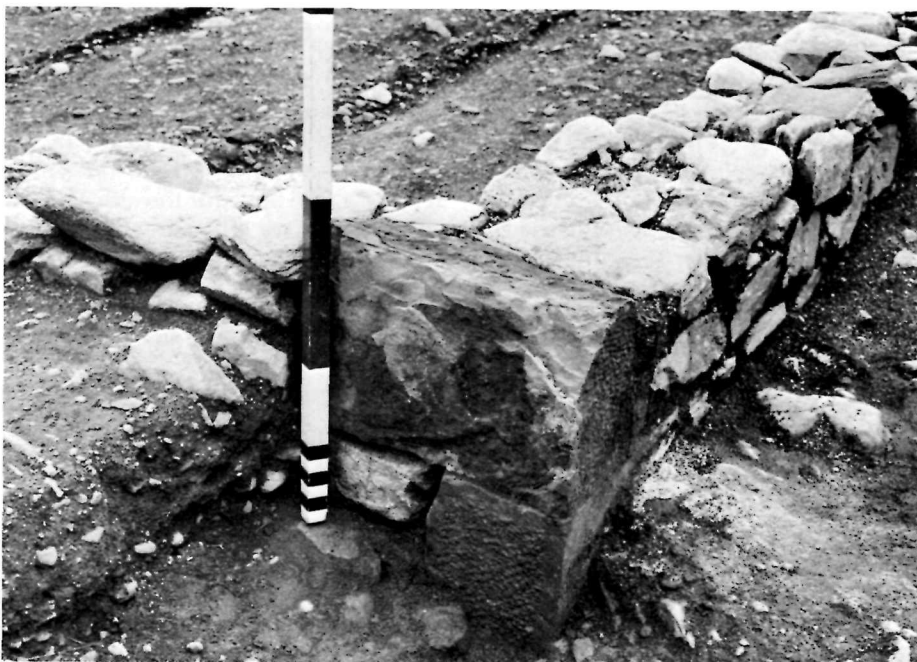
34 Quoin stones of the Pièce de la Grave guardhouse.

walls the construction trench dug through the gravel beach could be readily observed. As with other guardhouses the walls were covered with rough-casting in 1750.¹⁴ All four corners of the building had cut-stone quoins in various stages of decay (Fig. 34).
