- 5 **Lime Preparation at
18th-Century Louisbourg,**
by Charles S. Lindsay
- 47 **Louisbourg Guardhouses,**
by Charles S. Lindsay
- 101 **A Survey of Louisbourg
Gunflints,**
by T. M. Hamilton and Bruce W. Fry

Canadian Historic Sites:
Occasional Papers in Archaeology
and History – No. 12

Lime Preparation at 18th-Century Louisbourg

The equipment and techniques used in the preparation of lime for mortar in 18th-century Louisbourg are studied against the background of contemporary practices in France. Two basic types of French kilns and lime-burning techniques are identified, as are two methods of slaking the burnt lime. Parallels for all these structures and techniques are found at Louisbourg.

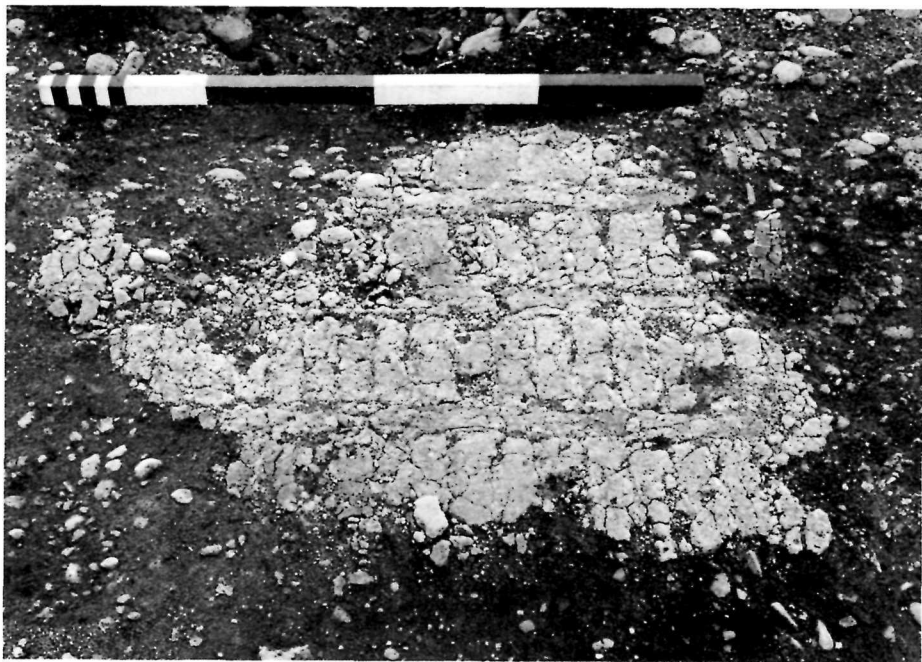
35 Mortar with impressions of edge-set bricks of a stove base in the soldiers' quarters of the Pièce de la Grave guardhouse.

In the soldiers' quarters there was apparently a stove from the beginning. Nothing is known of the original stove which was replaced by one built of brick in 1749. This was repaired in the same year and an estimate was made for constructing another of the same material.²² Excavation revealed a spread of mortar with brick impressions in its surface about 3 ft. from the dividing wall, opposite the officer's fireplace (Fig. 35). The boundaries of the mortar were irregular but over-all it measured 4 ft. by 3.5 ft. The impressions showed that the bricks were laid on edge in four rows with stretcher courses between the rows. The most likely interpretation of this mortar is as part of a stove base. Its position would allow it to share the chimney with the officer's fireplace.

What may have been the base of the original stove was found 2.5 ft. from the mortar toward the centre of the room. This consisted of a

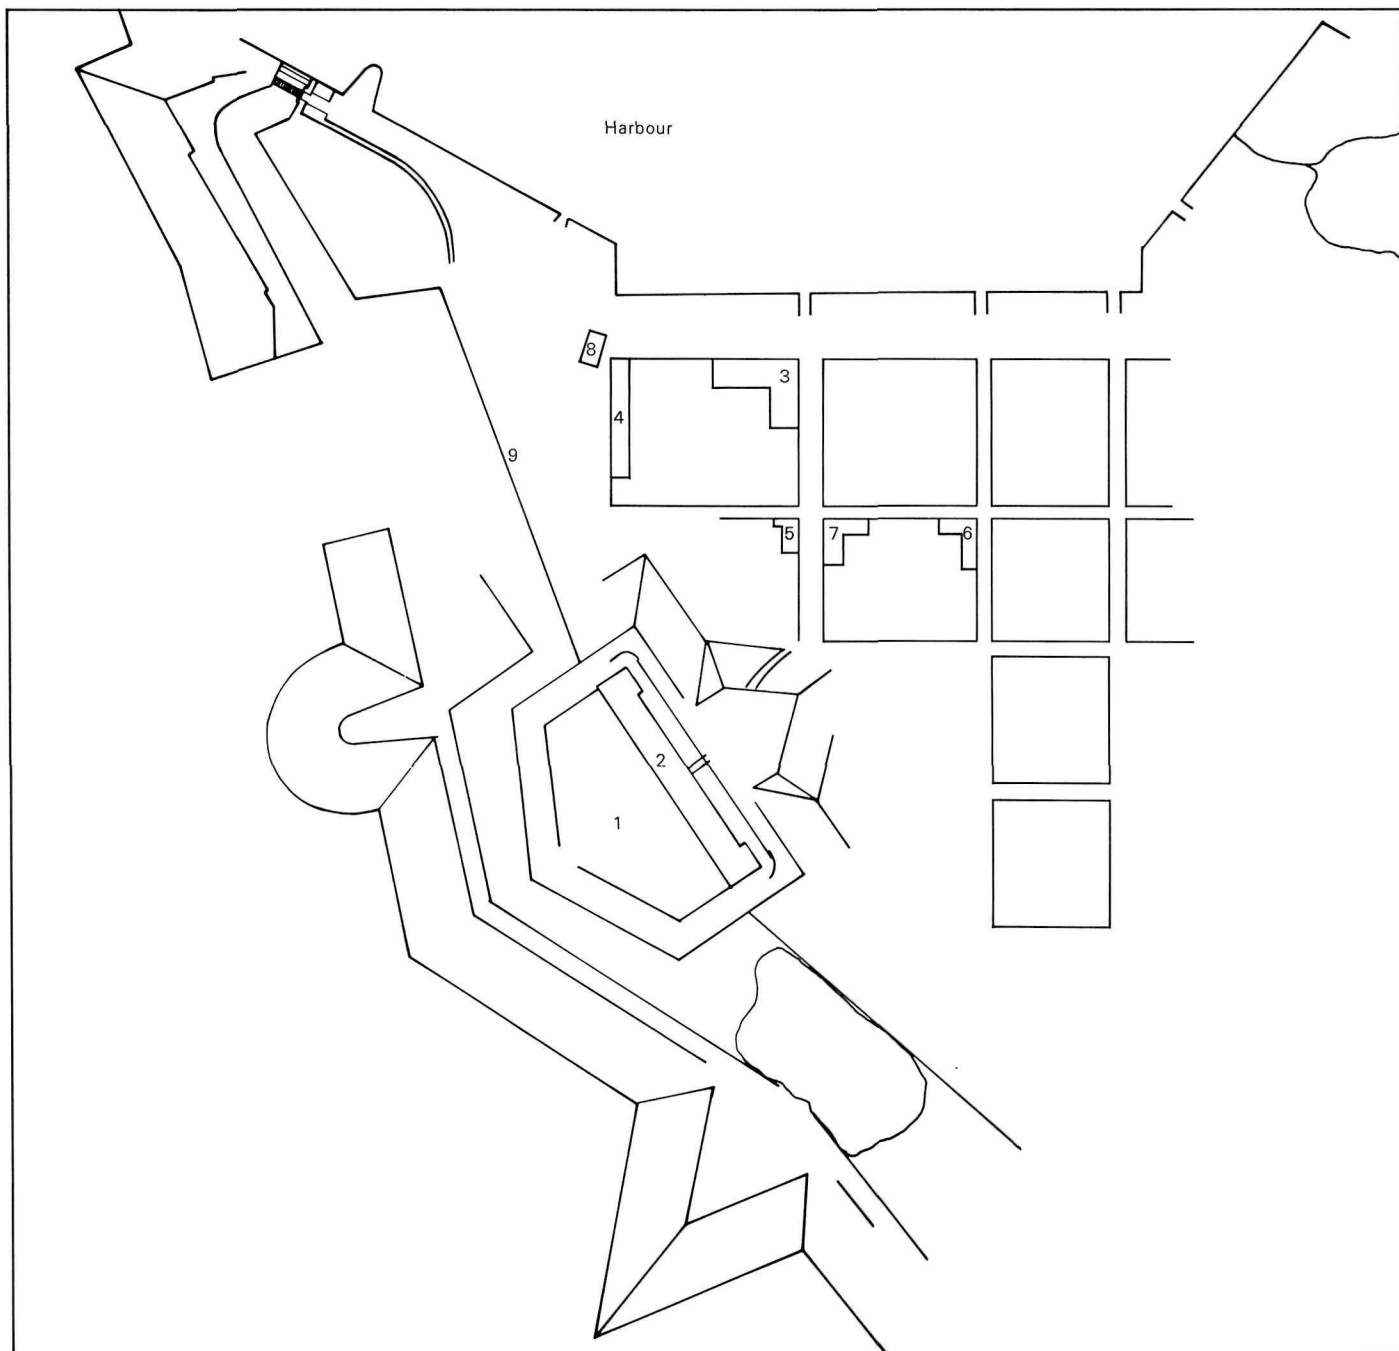
3 The town of Louisbourg, showing sites from which flints were studied. 1, King's Bastion; 2, Barracks; 3, Magasin du Roi; 4, Hangard d'Artillerie; 5, De Couagne property; 6, Villejouxin/Fizel and Richard properties; 7, De Pensens property; 8, Lartigue property; 9, Curtain Wall.

Because of the unusual nature of these flints, they were sent at a later date to the senior author for comment and study. Representative collections of flints recovered from excavations within the main fortress were also studied. The flints were selected from both military and civilian sites which had been fully excavated, a brief description of which is given below (for site locations, see Fig. 3).

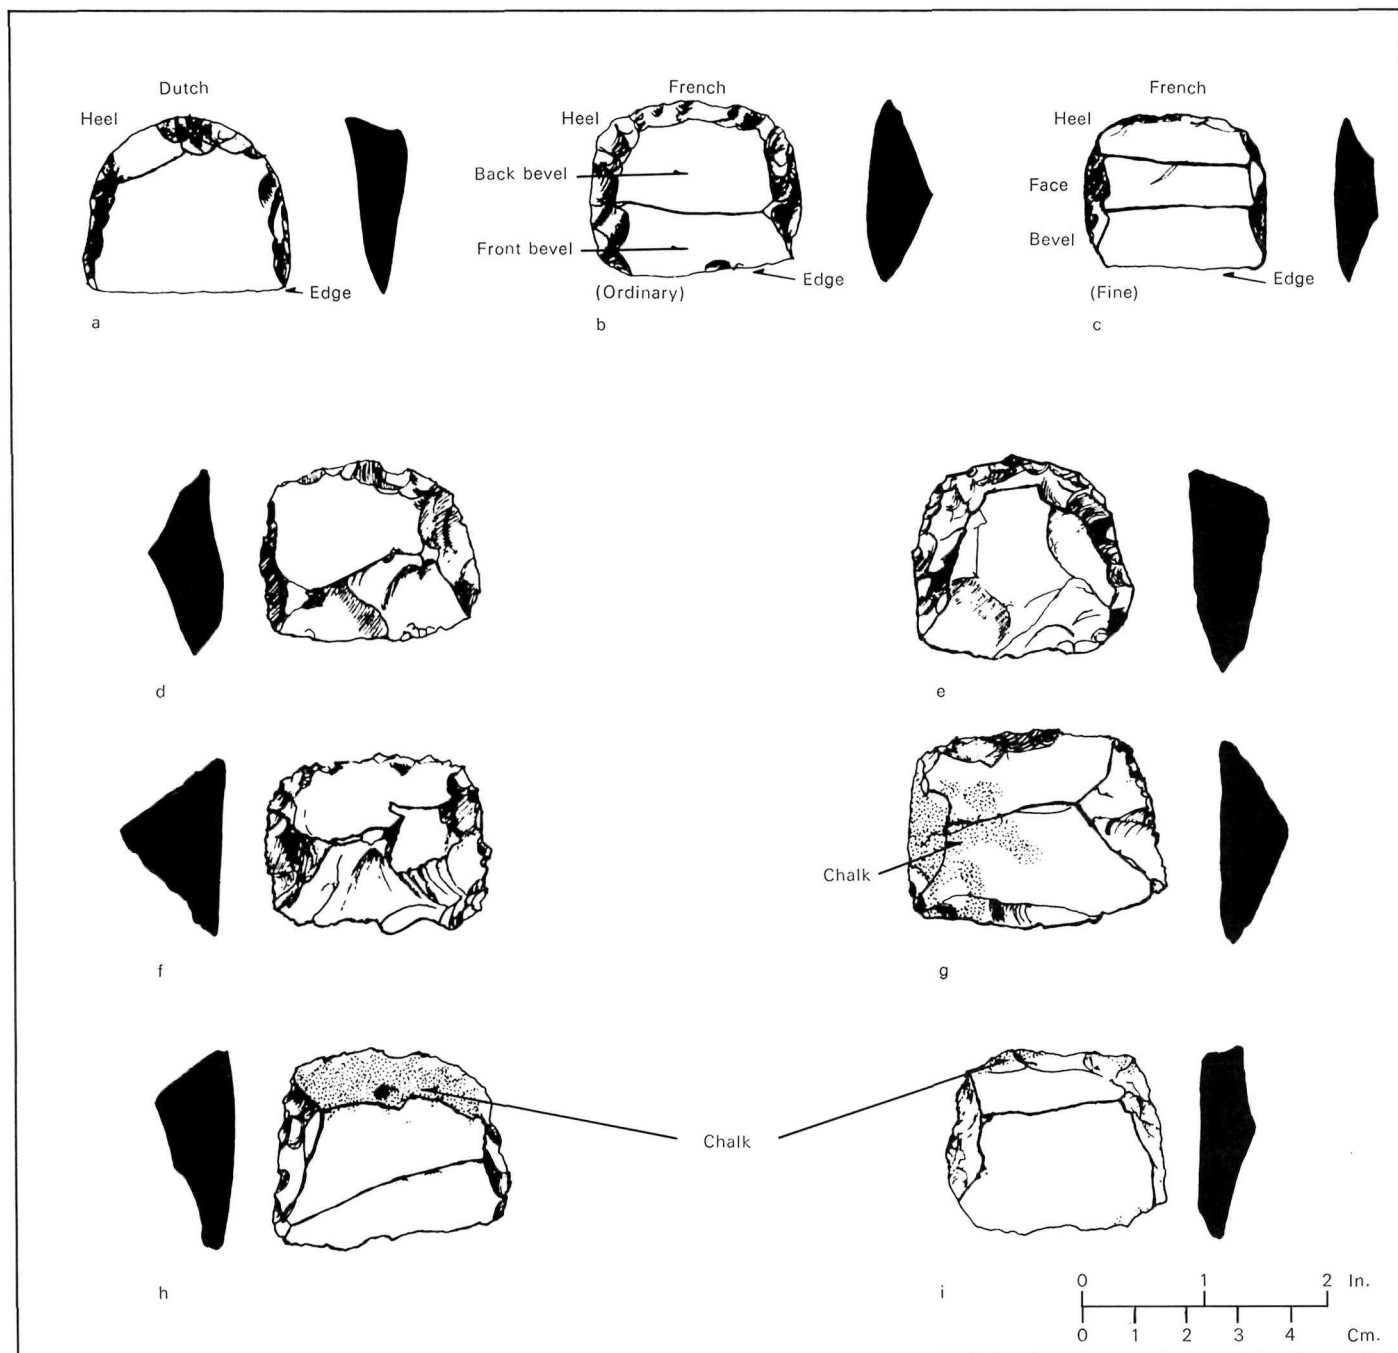
4 *a, b, c*, basic gunflint types found at Louisbourg; *d-i*, gunflints from Battery Island showing peculiarities; *d*, bulb of percussion with conchoidal surface on back bevel; *e*, roughly flaked front bevel; *d-f*, are roughly flaked; *g-i*, are chalk-heels.

face in the area of the heel, with the face sloping down to the edge. As shown in Figure 4, *a*, the heel and sides are shaped by secondary chipping. The bottom face or bed of the Dutch flint often shows the negative impressions of portions of other spalls previously removed.

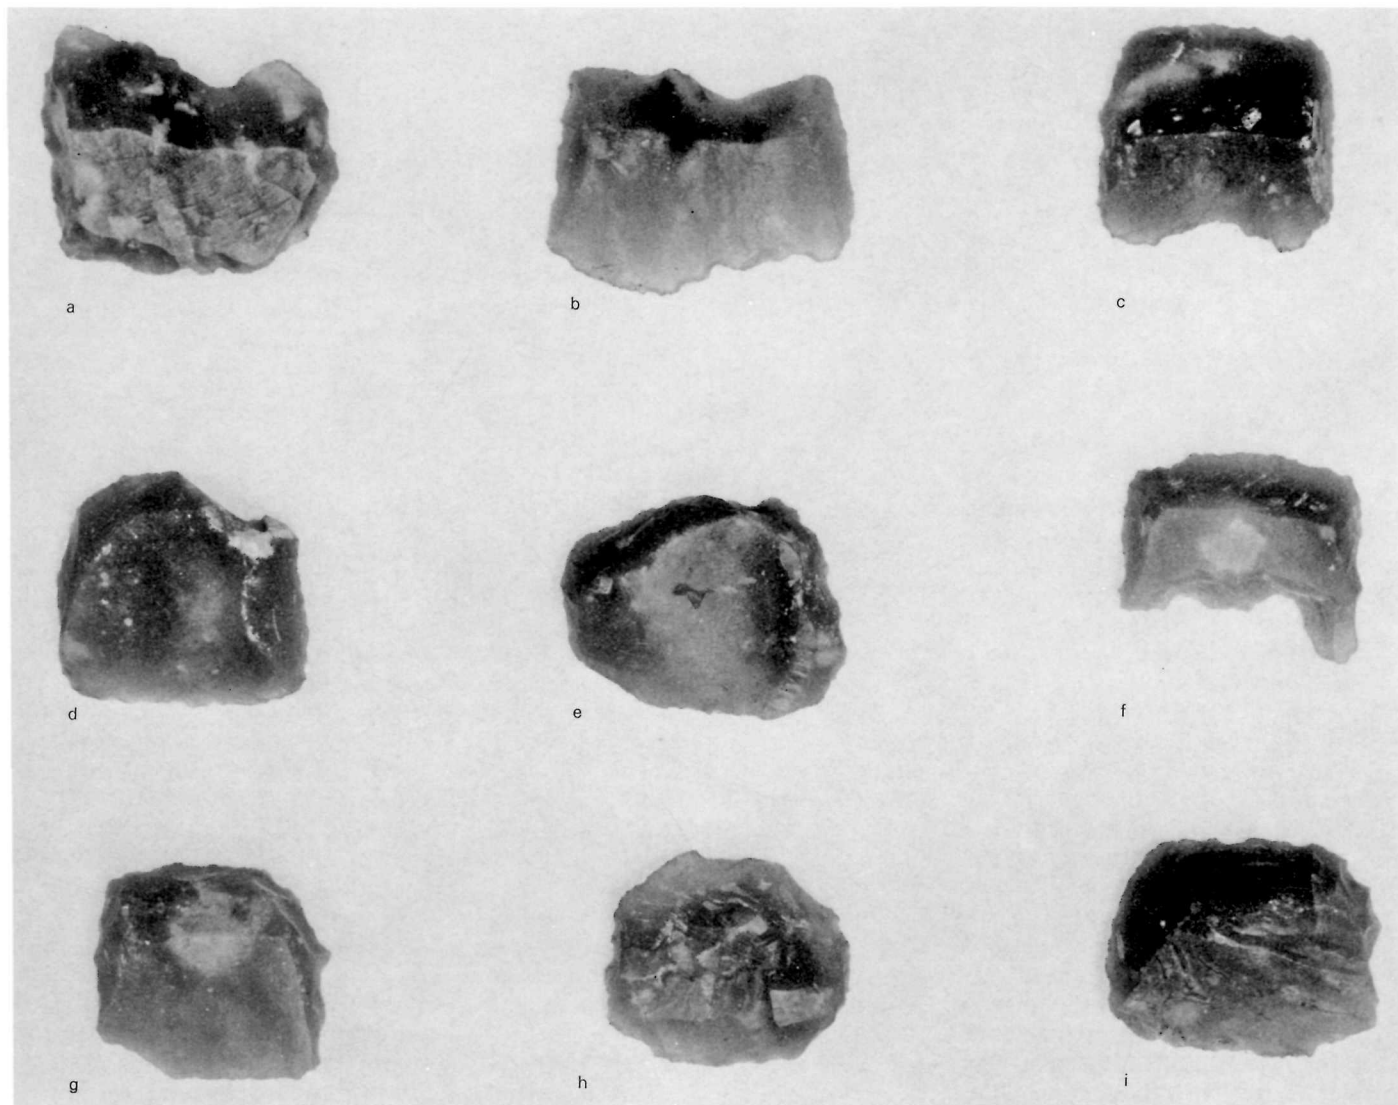
5 Gunflints from the Battery Island cache. *a*, roughly made gunflint, diminishing in thickness from left to right; *b*, double-edged form resembling a 19th-century fireflint; *c*, *f*, conventional French gunflints; *d*, *g*, pseudo-Dutch flints; *e*, *h*, pseudo-Dutch flints; *i*, roughly made flints.

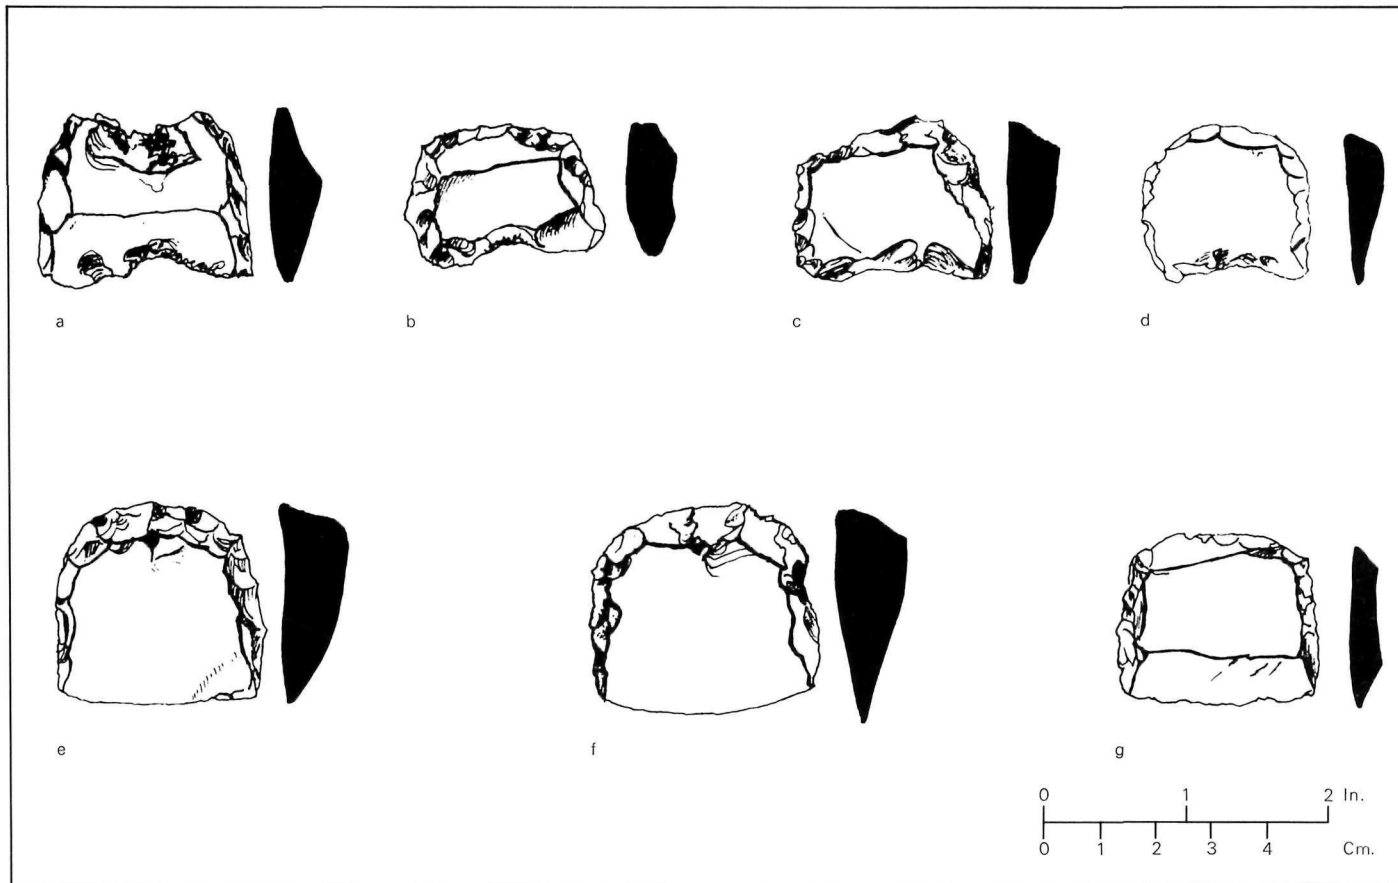
7 Gunflints from the town of Louisbourg, *a-d*, two French and two Dutch flints from the De Couagne property, used as fireflints; *e, f*, two large new Dutch flints from the Curtain Wall; *g*, an unusually thin French gunflint from the Hangard d'Artillerie.

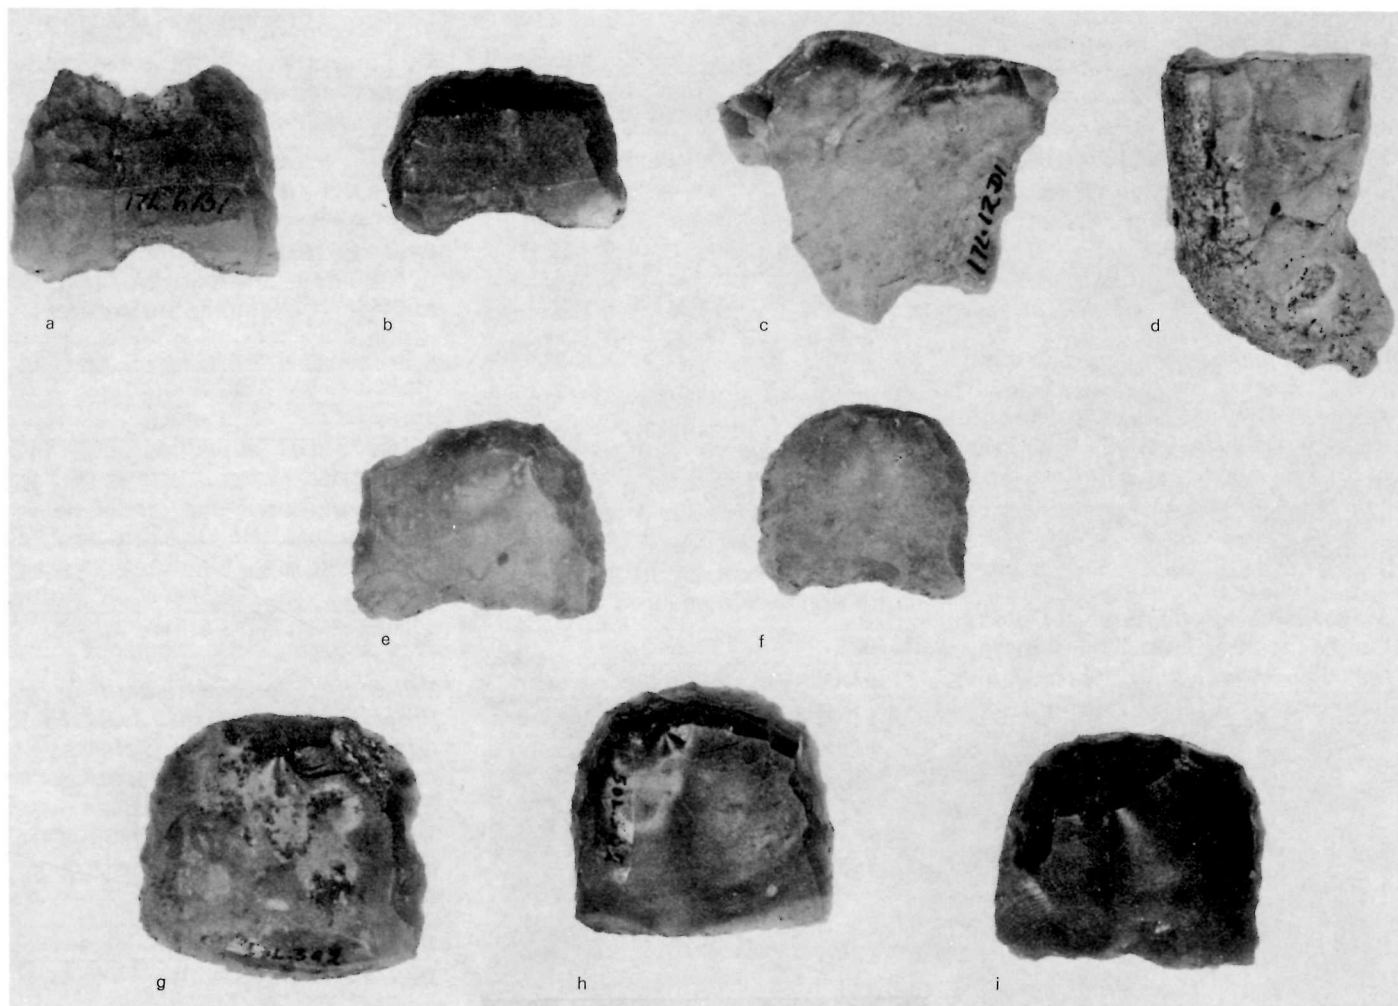
9 Flints from the town of Louisbourg (cf. Fig. 7).
a-d, two French flints and two unshaped flakes
used as fireflints, from the De Couagne property;
e-f, Dutch specimens used as fireflints from
the De Couagne property; *g-i*, three large
Dutch gunflints from the Curtain Wall.
