Maritime Engineering Journal

Canada's Naval Technical Forum

Winter 2021

Naval Galvanic Corrosion Awareness

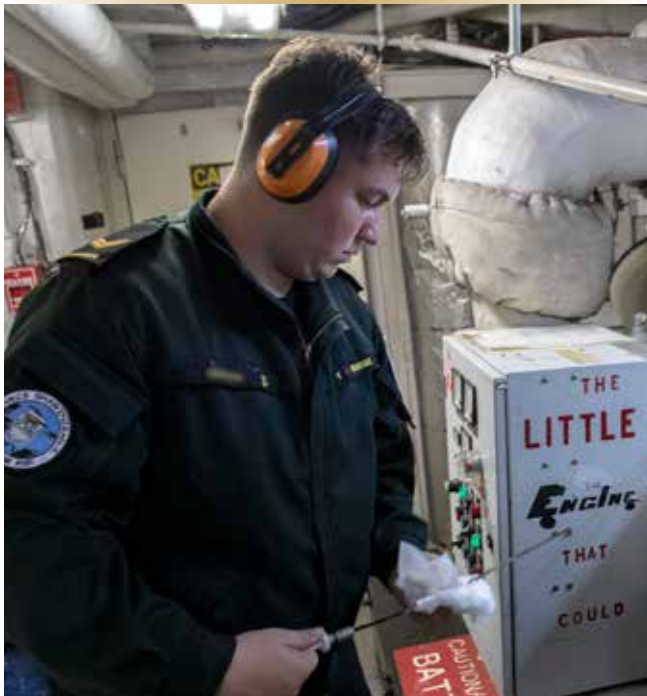
Pre-deployment preparations throughout the spring meant that *Shawinigan* was in a prime engineering state prior to departure for Op Caribe.

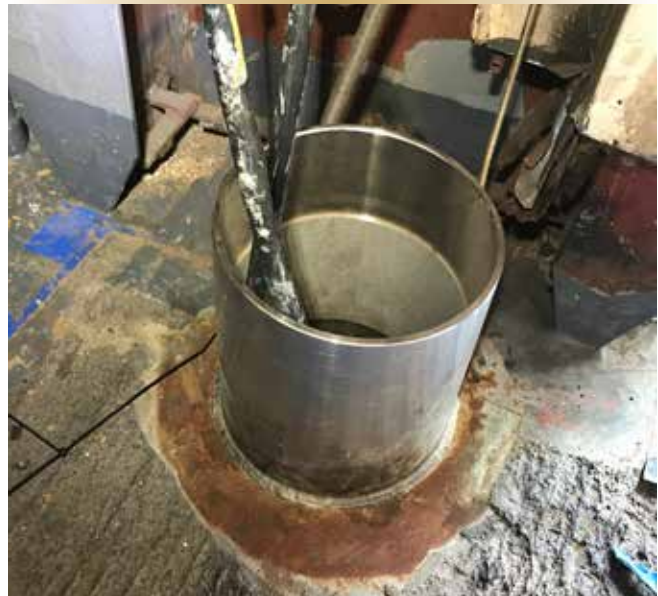
Figure 4. An uncoated stainless-steel sleeve welded to the mild-steel deck of a Halifax-class frigate.

surfaces. In 2011, due to corrosion failure of mild steel pipes and cable penetration transits, the use of stainless steel for exterior transits including multi-cable transits, single-cable transits and deck sleeves was permitted.

Since then, stainless-steel frames have been welded to the carbon-steel decks and bulkheads. Based on a calculated risk approach, corrosion of the parent material (i.e., the carbon-steel decks and bulkheads) was anticipated and minimized by implementing clear instructions to coat the transits, and by ensuring double-sided welds. Still, protective coatings can often get damaged or have imperfections upon application, thus increasing the risk of galvanic corrosion. Even though the stainless-steel transits remain intact, recent surveys confirm the presence of corrosion of the carbon-steel decks around the stainless-steel transits.

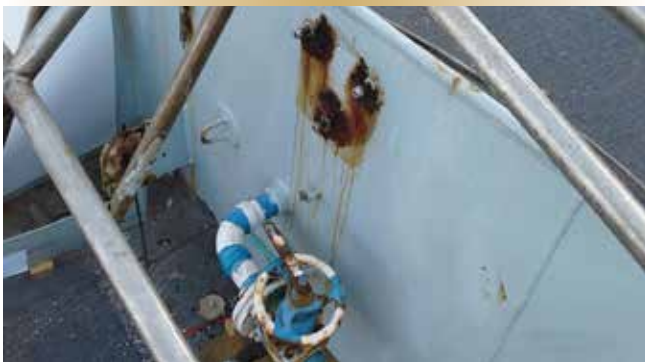
Figure 5. Dissimilar metal connections on the weather deck of a frigate.

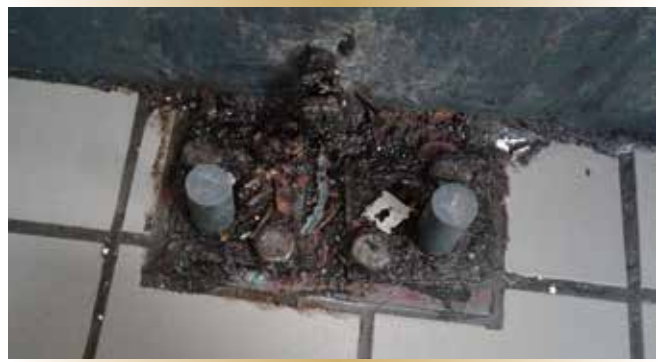
Figure 6. A severely corroded galley appliances connection.

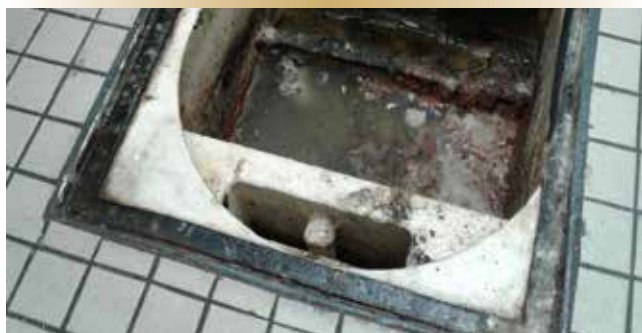
Figure 7. Galley grease trap coating breach and corrosion.

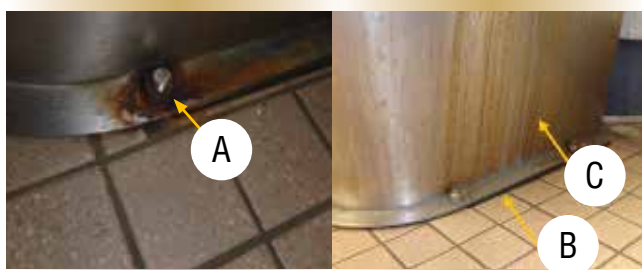
Figure 8. Corrosion on stainless-steel toilets.

During a separate corrosion survey of HMCS *Regina*, stainless-steel toilets showed minor corrosion around the mounting points. Figure 8 depicts corrosion that appeared to be caused by the use of washers or nuts of dissimilar metal in contact with the stainless-steel bolts and the bowl. While a rubber gasket was added between the steel deck and the bowl during installation to prevent contact between the toilet and the deck, potentially limiting galvanic corrosion, additional corrosion was observed on

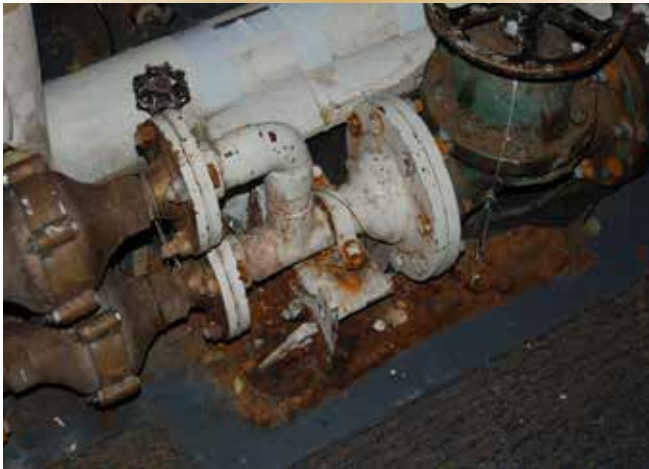
Figure 9. The problem with using dissimilar metals at connection interfaces.

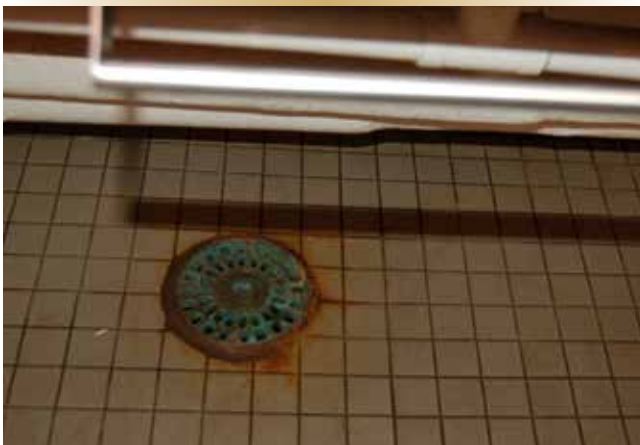
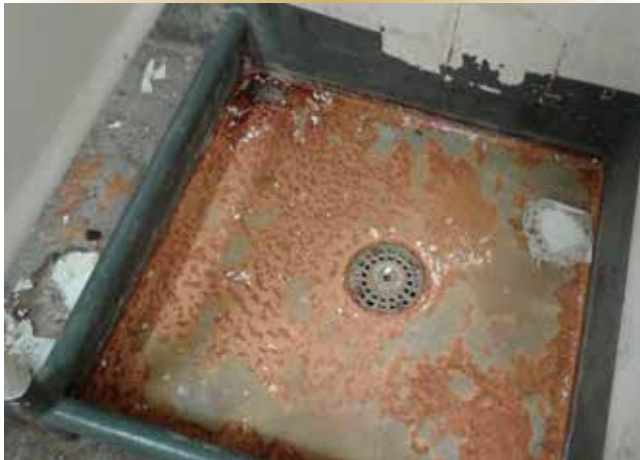
Figure 10. Hidden washplace drain corrosion where the bronze strainer interacts with the mild-steel decking below the tiles.

In some cases, corrosion can be hidden from view in areas where it takes place under a protective coating or covering material. Figure 10 shows that brass drains in particular are common sites of corrosion reactions. During a visit on board HMCS *Winnipeg*, leaky ceramic tiles around brass drains were removed in the ship's heads to validate that corrosion had spread to the surrounding metal, reducing its thickness. Grinding down the area and applying a fresh coat of protec-

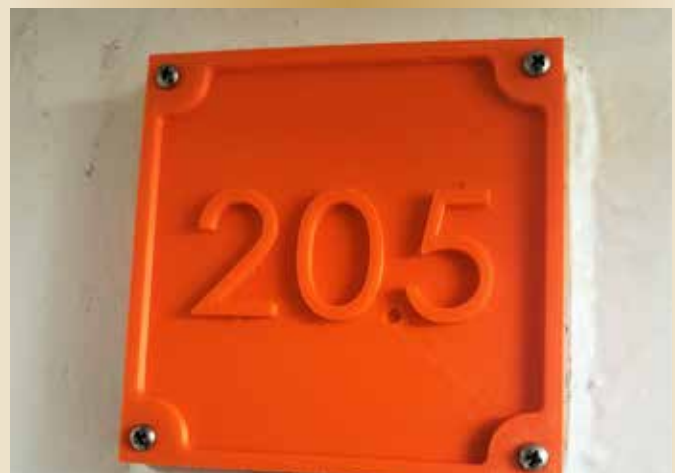
FMF Cape Scott is testing a suite of polymers for producing interior station tally plates. The orange tally plate shown here is made of ABS thermoplastic polymer. The grey plate shown being printed on the inside cover of this magazine is made of PLA, a bio-friendly thermoplastic.

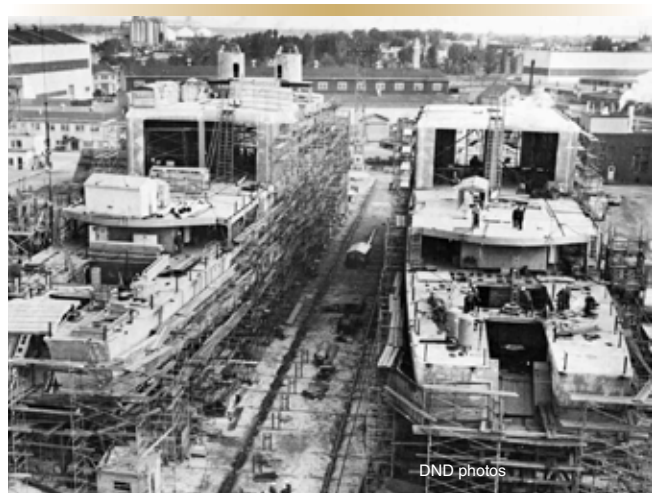
The DDH-280 Tribal-class destroyers *Iroquois* (left) and *Huron* under construction at Marine Industries Ltd., Sorel-Tracy, Québec circa 1970.

Construction of *Iroquois* got underway on Jan. 15, 1969; *Huron* would be laid down months later on June 1. As the initial construction units were being fabricated under cover from the weather, keel support blocks for the two hulls were set up outside in the yard adjacent to MIL's marine railway. Once completed, each construction unit was moved out of the shed and welded to the adjoining unit already on the blocks, and in this way the ships gradually began to take shape as the TSD staff monitored the shipbuilder's operations.

The shipyard had implemented a quality management system manual, prepared in the Naval Central Drawing Office in Montréal, and published as QUAL-1-01. The Canadian naval standard was designed to ensure that work proceeded well and progress was documented. The TSD staff was impressed by the fine work being performed by the MIL team, and as the months went by, *Iroquois* and *Huron* really started to look like warships. Many of the ship compartments now contained equipment and systems, including the propulsion engines, gearboxes, flexible couplings, shafting and variable pitch propellers. Electrical and other cabling, and piping, were being installed as the units came together.

Once the shafting and propellers were installed, construction reached the point where the hulls needed to be set into the water temporarily to establish the line of shafting and positioning of intermediate bearings. Blocks with wheels were installed under the ships' hulls to allow the two ships to be traversed onto the marine railway cradle to be prepared for the launch. While it was not as glamorous as seeing a ship slide down the ways with banners flying and crowds of dignitaries in attendance, that preliminary launch was quite significant. With the afloat configuration readings for the shafting established, the ships could be pulled from the water for final positioning of the A-brackets and other shaft supports. The ships were eventually launched formally on Nov. 28, 1970 (*Iroquois*) and April 9, 1971 (*Huron*).

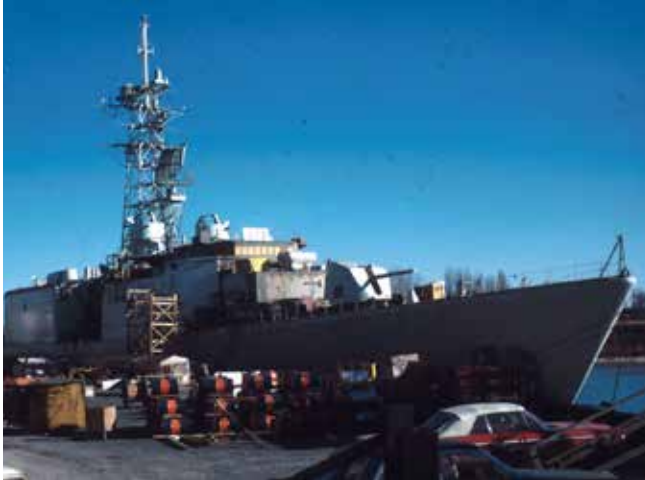
Iroquois fitting-out alongside at the MIL shipyard.
