RESEARCH REPORT

ICE DAMMING FIELD RESEARCH:
ICE DAMMING SOLUTIONS

Ice Damming Field Research Ice Damming Solutions

Ottawa, ON

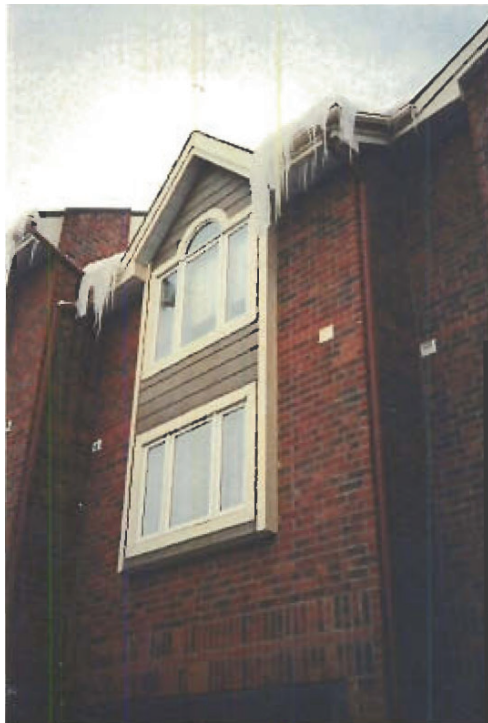
Photo 30: Site 3, Typical (past years) Ice Build-up

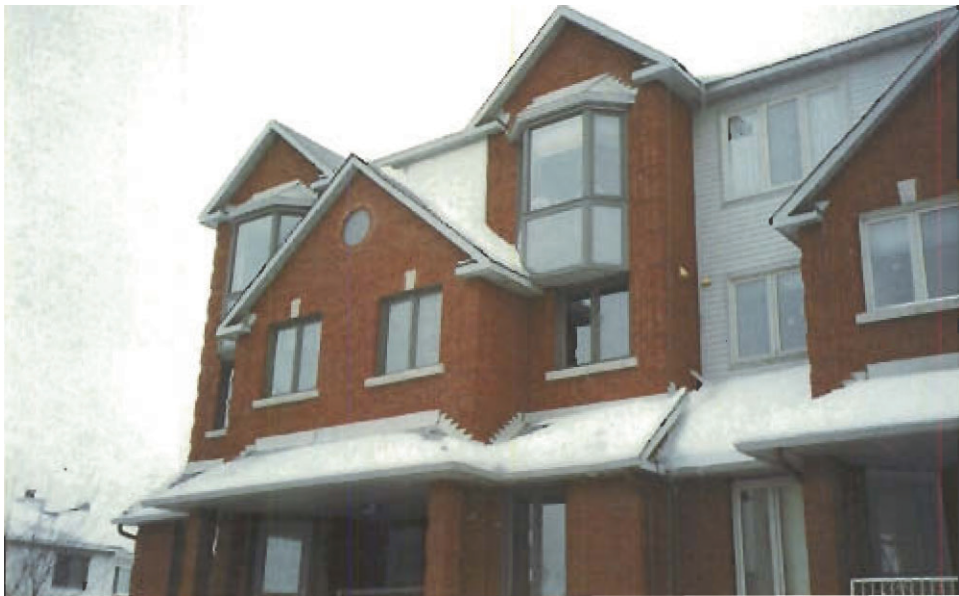
Photo 40: Site 4, Snow and Ice Build-up (past)

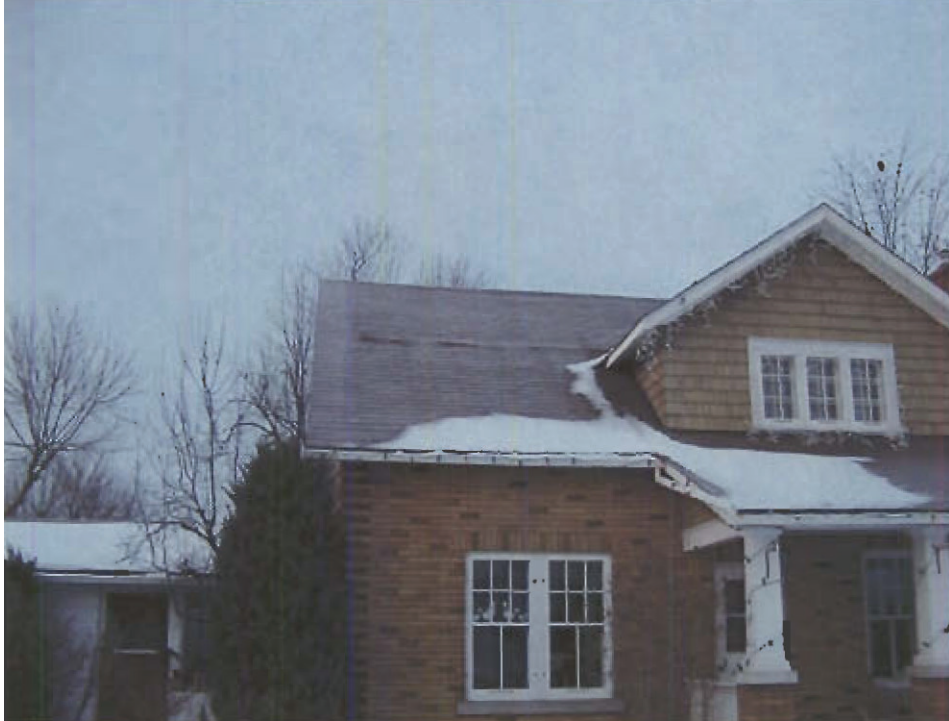
Photo 51: Manotick, Snow Melt Patterns (front of house)

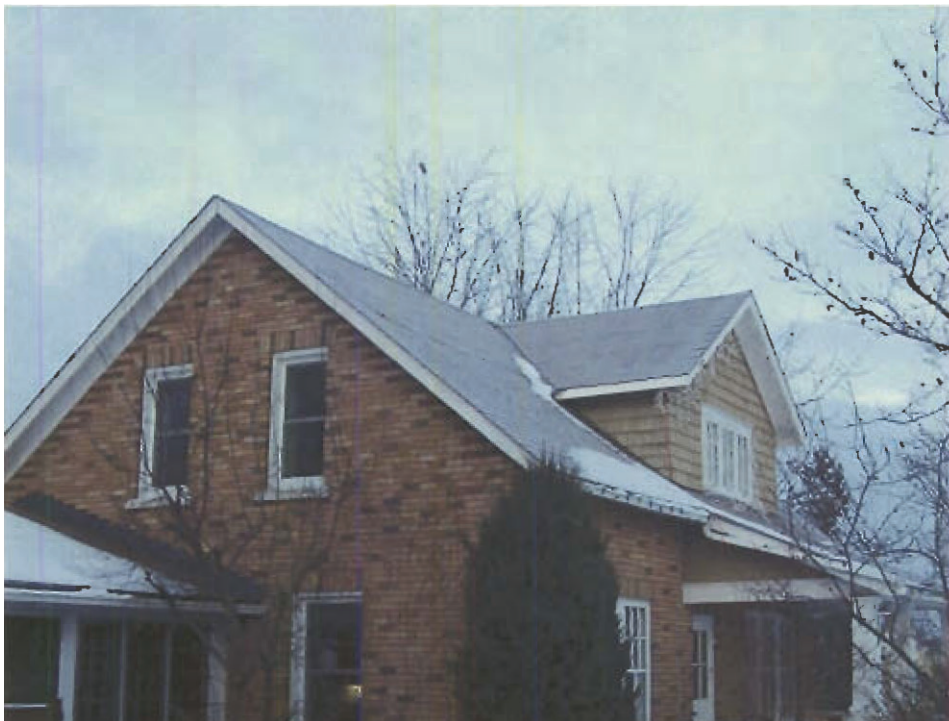
Photo 52: Manotick, Snow Melt Patterns (front of house)

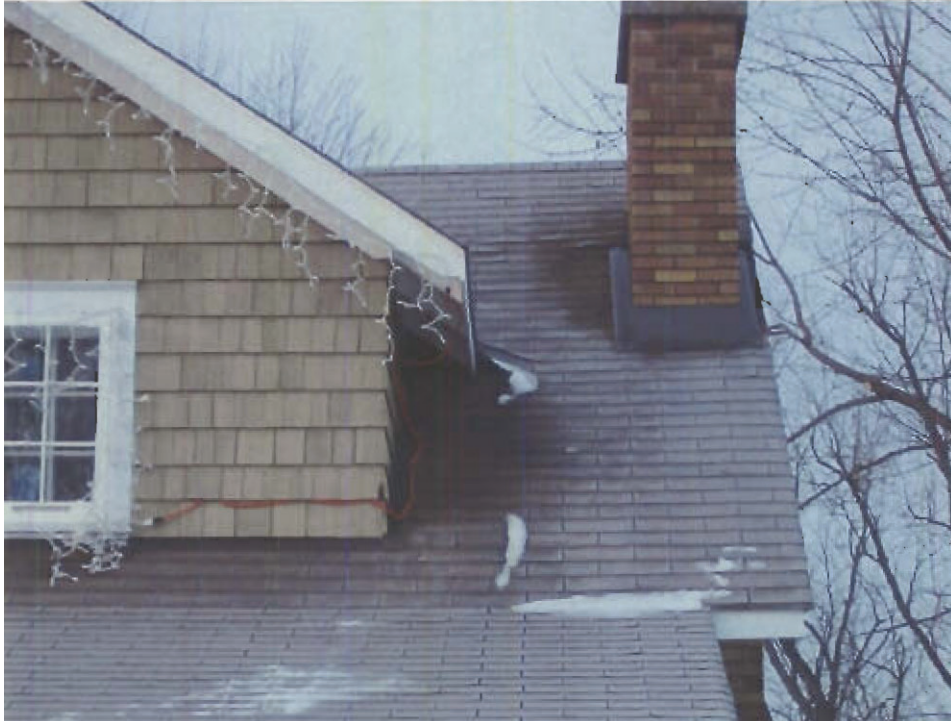
Photo 53: Manotick, Snow Melt Pattern (front of house)

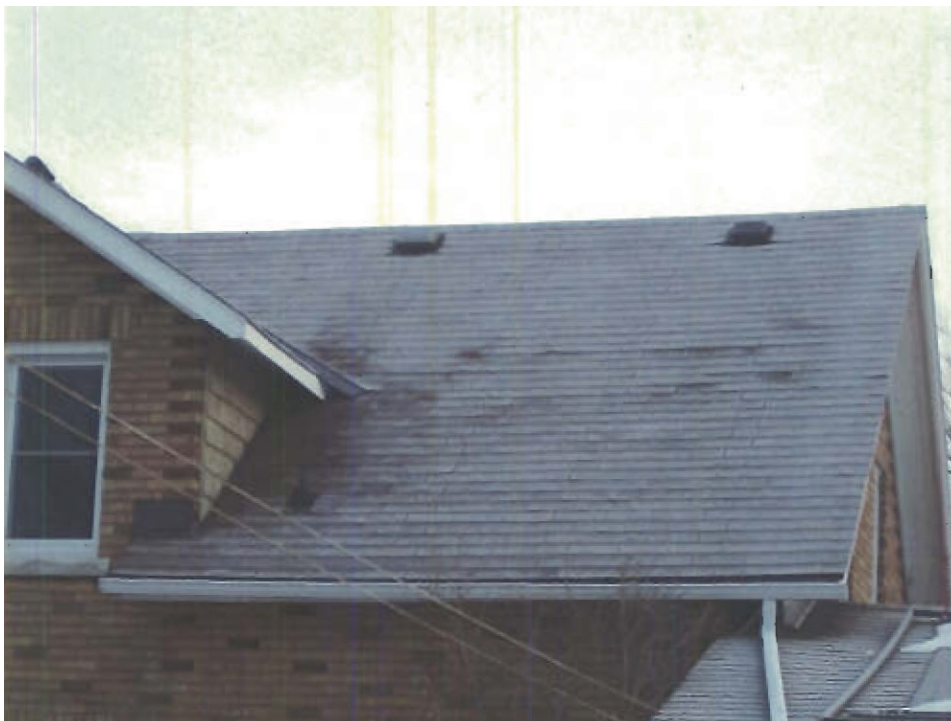
Photo 54: Manotick, Snow Melt Pattern (back of house)

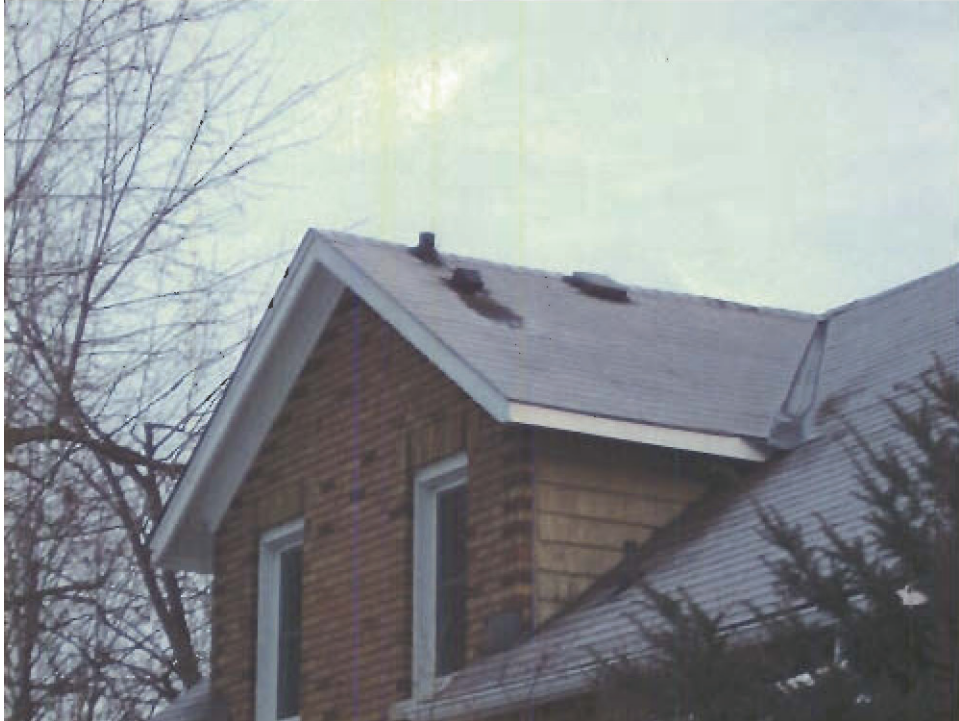
Photo 55: Manotick, Snow Melt Patterns (back of house)
