Institute for
Research in
Construction

The 1989 Loma Prieta (San Francisco Area) Earthquake: Site Visit Report

Internal Report No. 594

Date of issue: May 1990

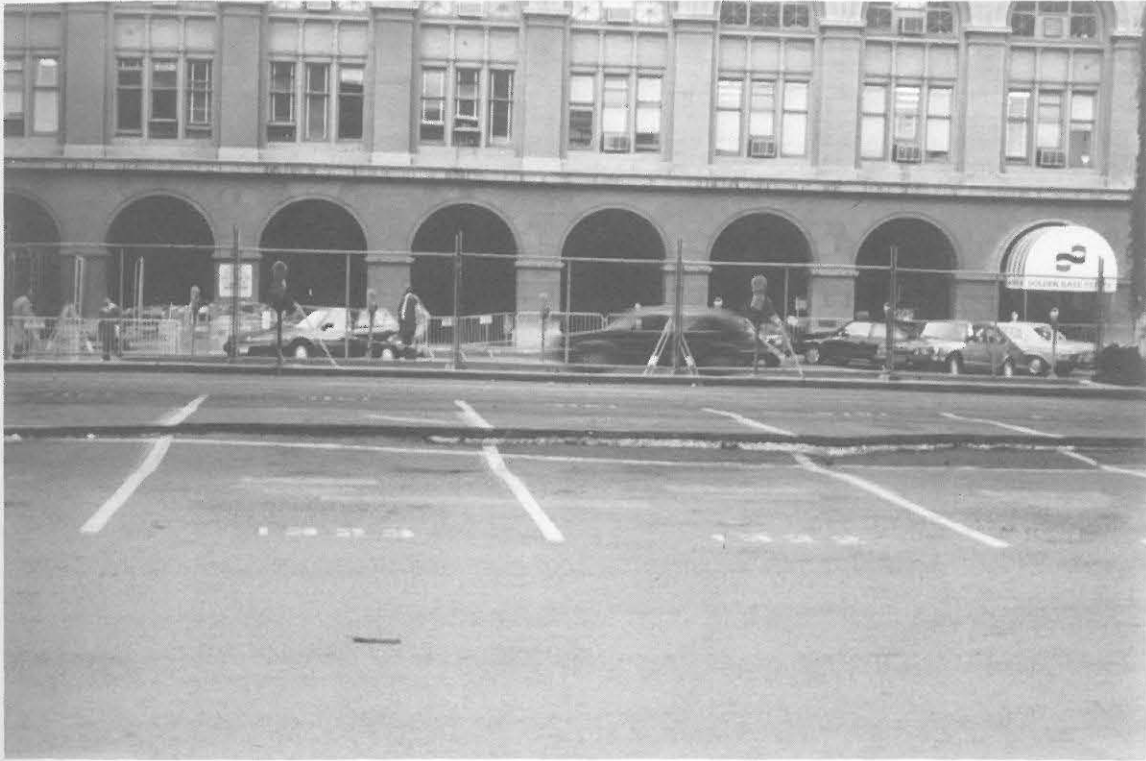
Loose granular deposits, both saturated or unsaturated, may densify leading to considerable settlement even without the phenomenon of liquefaction. A good example is found at Embarcadero Freeway on the northeastern coast of San Francisco. Here fills were placed on top of Bay mud. The structure of the freeway was damaged to the point of near collapse again due to ground motion amplification. The paved ground surface at one location showed a differential settlement of about 15 cm because of densification of the fill (Fig. 2.7).

Fig. 2.7 15-cm differential settlement under the Embarcadero Freeway

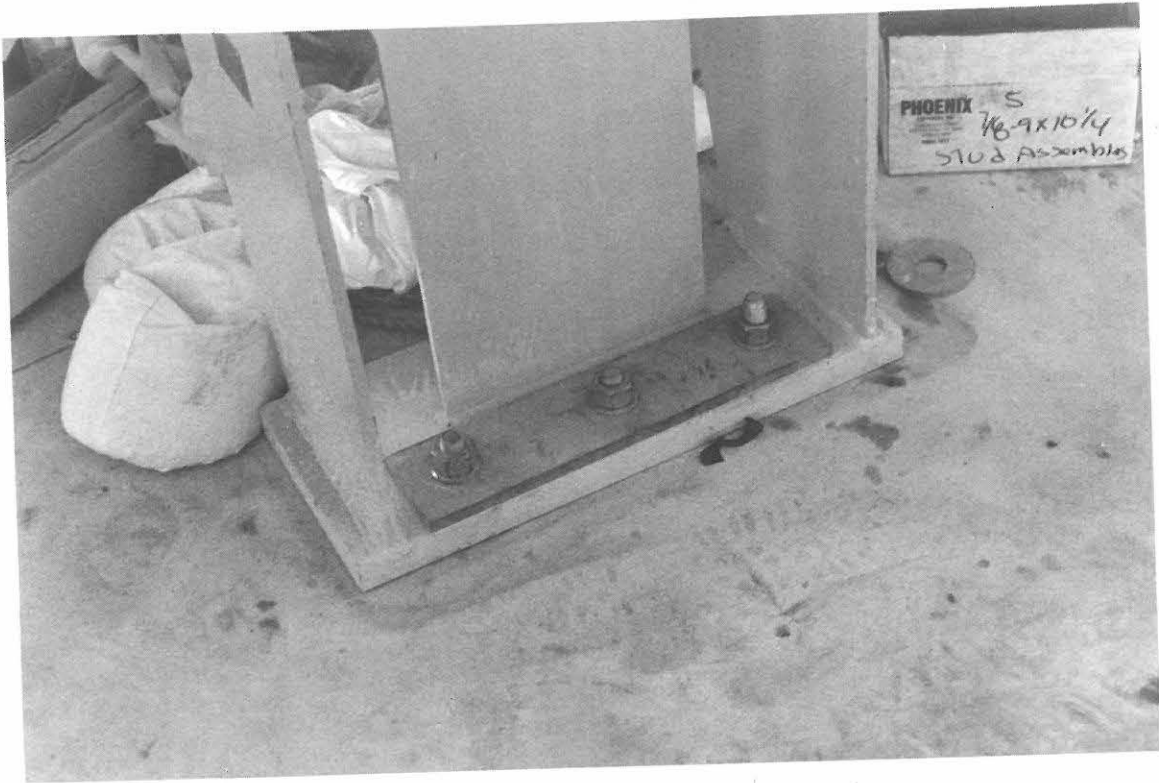
Fig. 5.34 New anchoring device concept of the 500-kV SF6 circuit breaker support

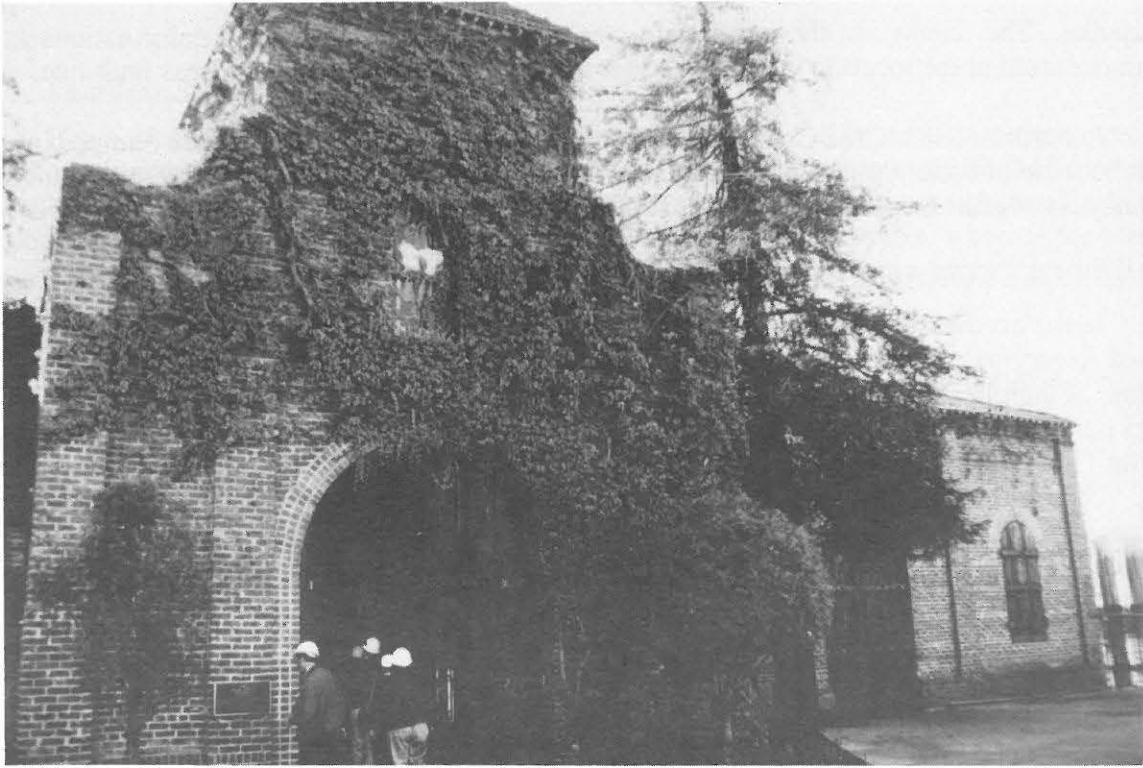
The bottling and hospitality building is an old reinforced brick structure with a wooden truss roof, built in the 1930s (Fig. 6.1). This structure was extensively damaged during the 1984 Morgan Hill earthquake which had a magnitude 6.2 [3]. After that earthquake, the damage was repaired and the structure underwent a seismic retrofit program. The retrofit program primarily concerned the use of steel plate and long bolts to hold the bricks of the pilasters together, as shown in Fig. 6.2. The roof beam was also tied down to the steel plate of the pilaster, preventing the loss of support for the roof beam during earthquakes. The upgraded system performed well during the Loma Prieta earthquake. A 1/2-in. (1.2-cm) gap between the nuts and the steel plate around some pilasters was observed. The roof of the structure suffered some damage. Particularly, the ceiling tiles at the corner were cracked, and many of them had broken loose. Other damage inside the bottling building involved mostly broken or dislocated pipes and shifting of equipment.

Fig. 6.1 The winery bottling and hospitality building

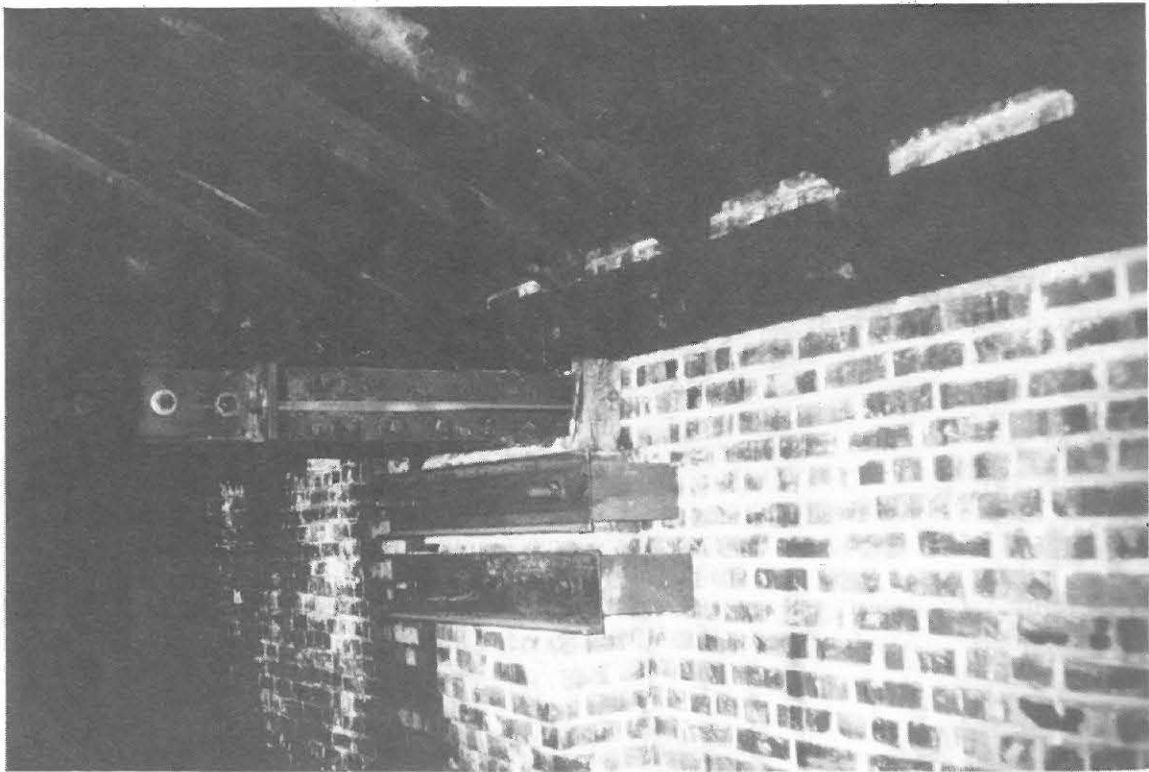
Fig. 6.2 The retrofitted roof beam - pilaster connection
