Cost and Design of Housing For Disabled Persons: Case Studies

**COST AND DESIGN OF HOUSING
FOR DISABLED PERSONS
CASE STUDIES**

Prepared for
Canada Mortgage and Housing Corporation
by
Associated Planning Consultants

CASE STUDY 1
Apartment
Module 3: Purpose-built - Upgrading
Recommended

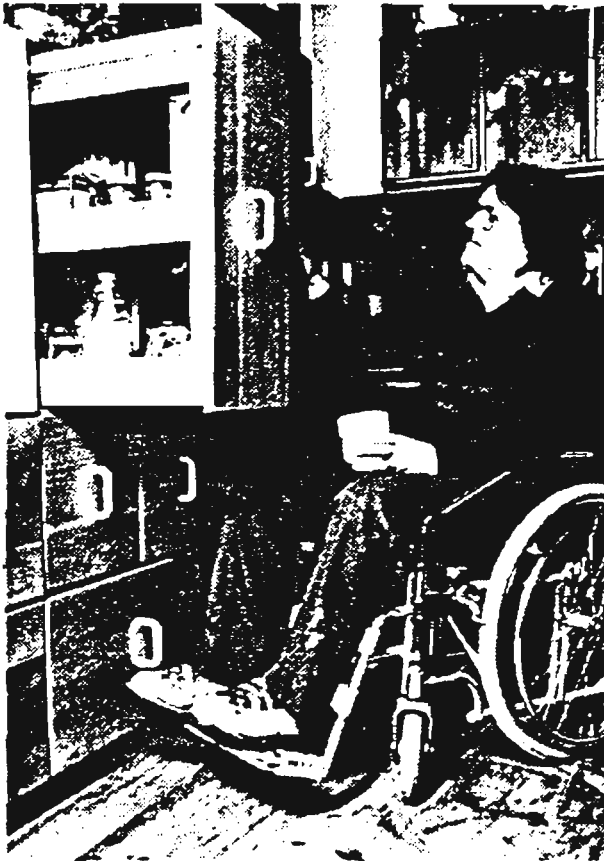
Roll out units provide
storage space at user
level.

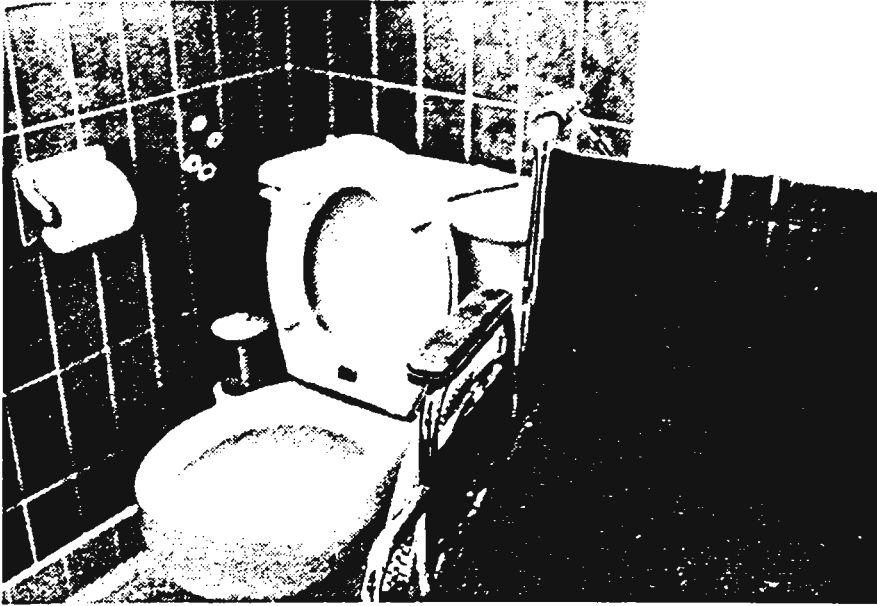
Toilet relocated
to permit wheel-
chair transfer.

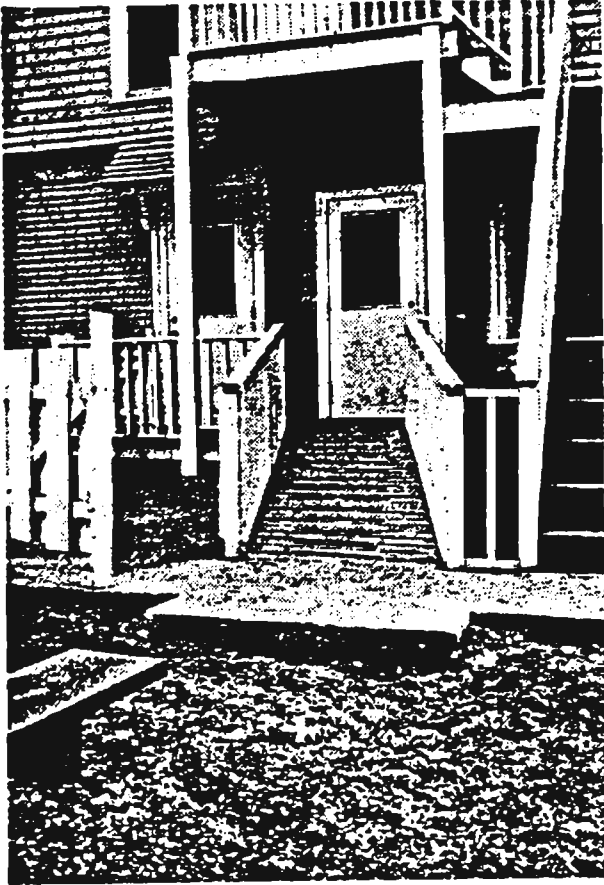
Wooden ramp at rear of house with handrails and concrete landing and sidewalk.

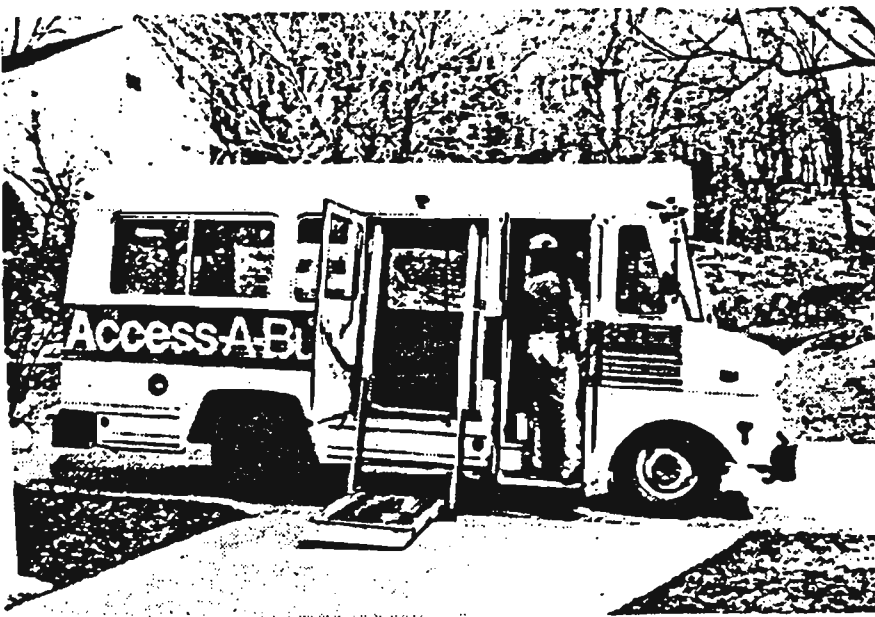
"Access-a-bus" service with electric lift pick-up, at side driveway entrance.

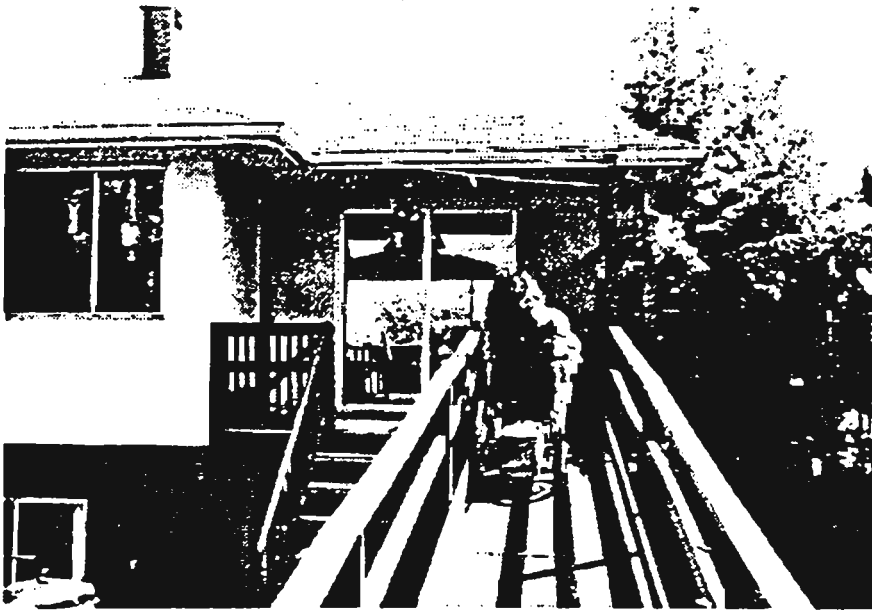
Wooden ramp and handrails added to back deck with grade level rear entry to basement.

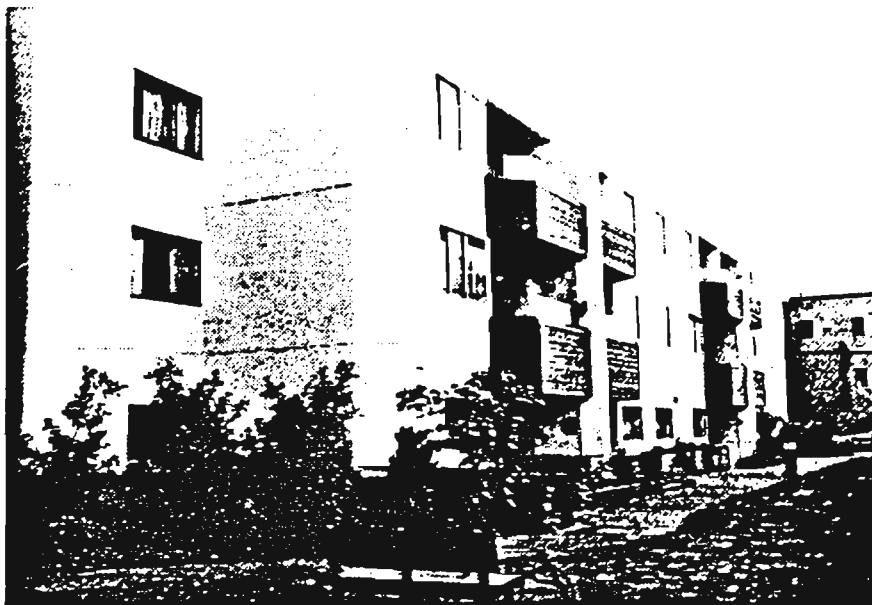
Deep balconies
with clear
plexiglass upper
guard providing
excellent visibility
for a wheelchair
user.

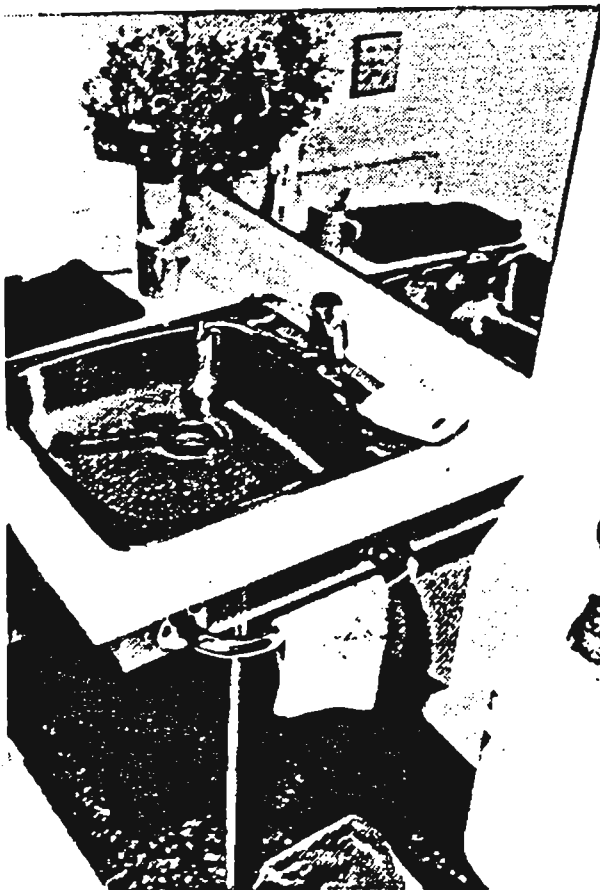
Shallow wash basin with
knee clearance and lever-
handle faucet.

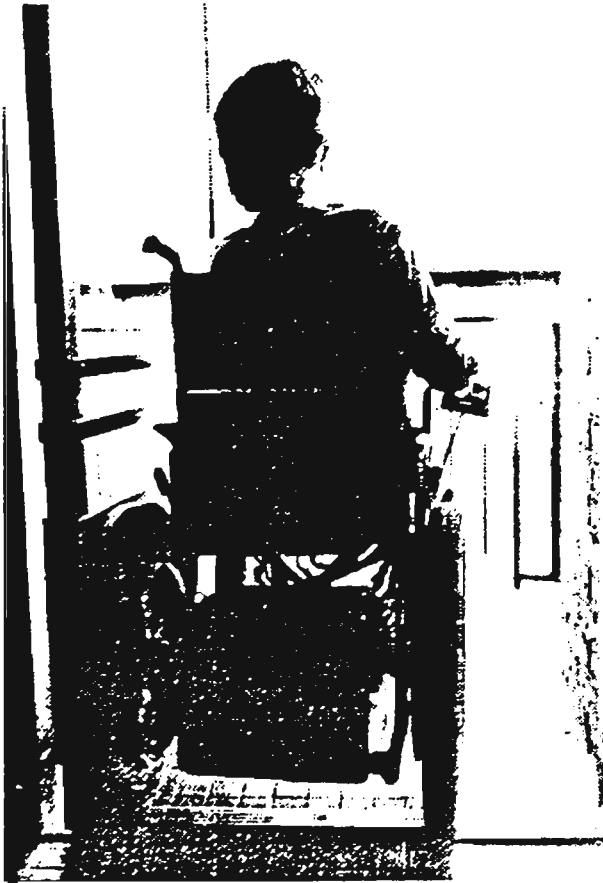
Main entrance with two-way swing door, low door pushes and stainless steel wheelchair guard.

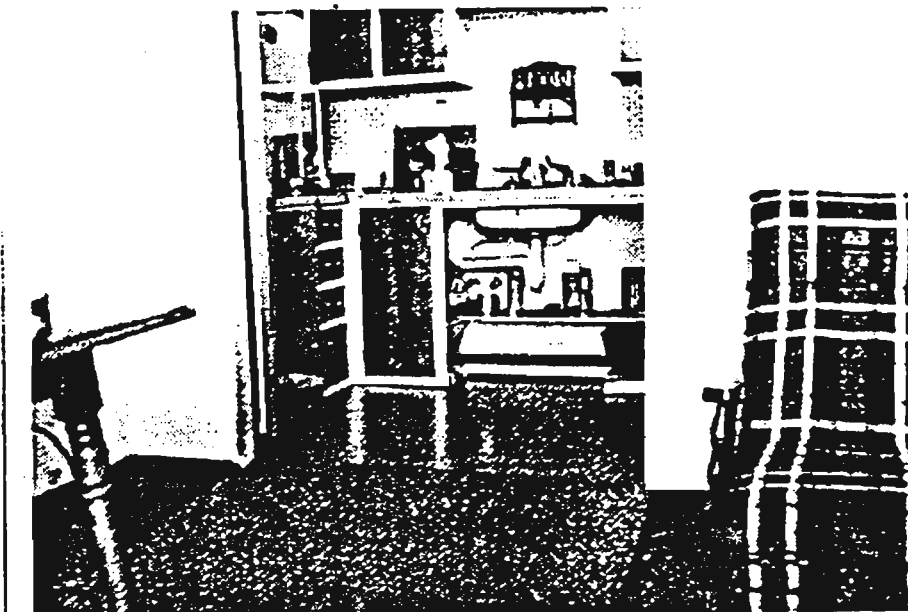
Raised kitchen floor with ramped entry. Cabinets under sink removed to permit knee clearance, and pipes insulated. Lever handle faucet added.

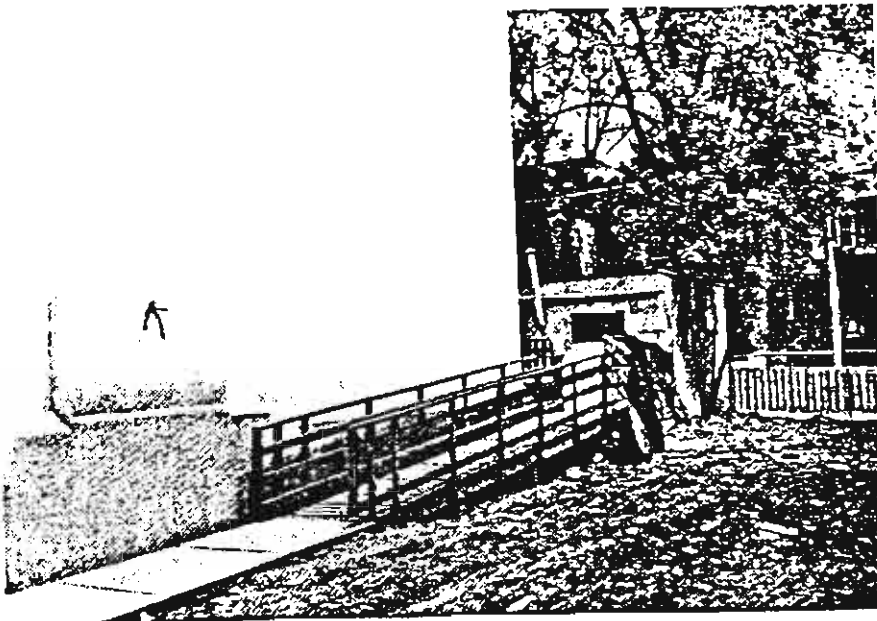
Side ramp and
sidewalk to
back deck
entrance.

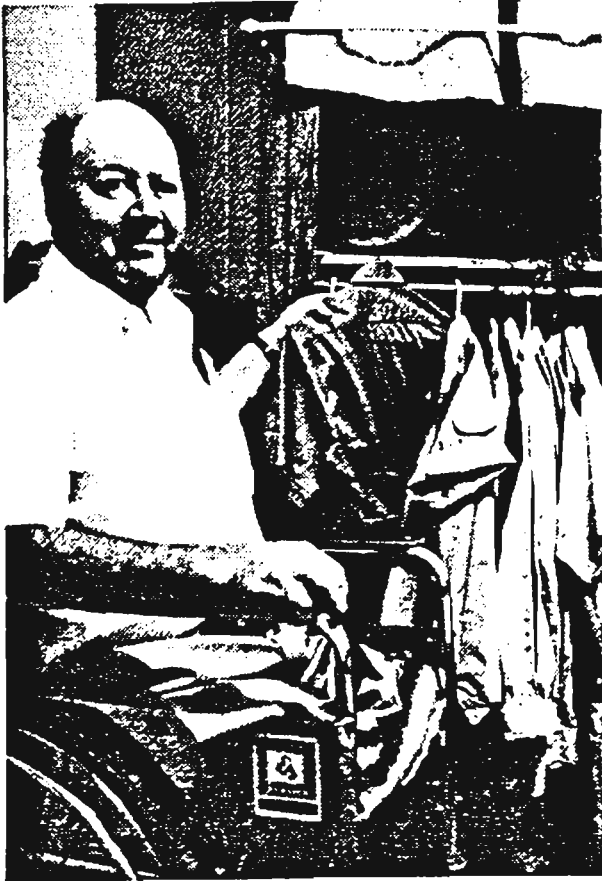
Low clothing rod and shelf in user's bedroom.

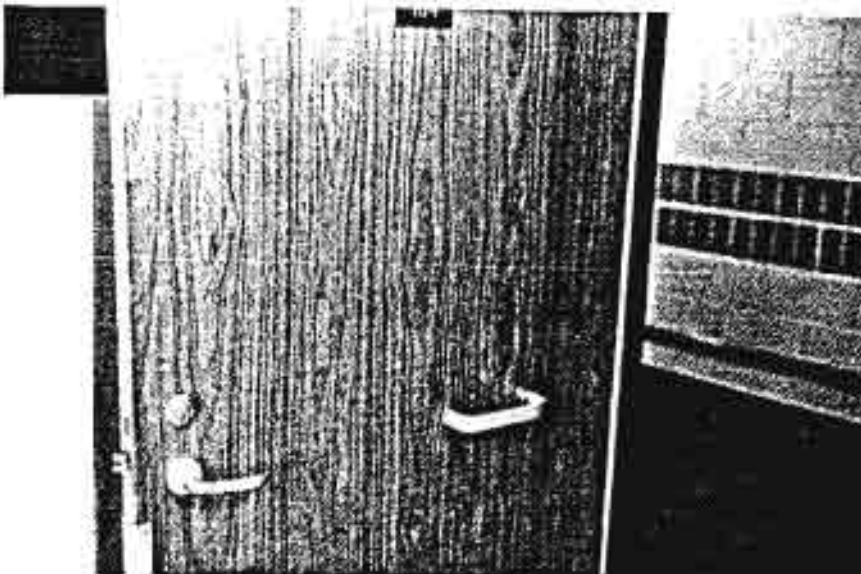
Low lever door
handles and
additional door
pull.

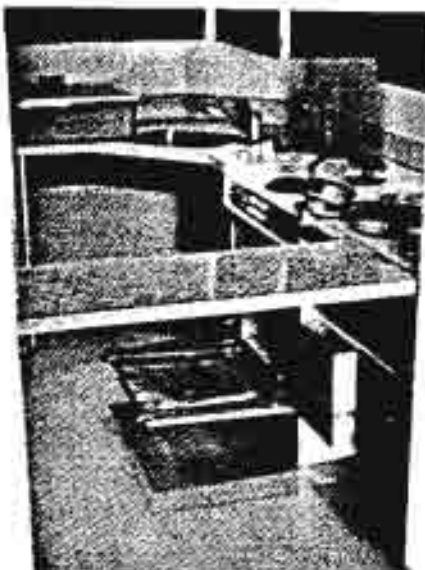
Drop leaf pass-
thru and eating
counter in
kitchen.
