APPENDIX 3 TO MAIN REPORT

STUDY OF APPLE HILL
ENERGY EFFICIENT HOMES

TASK D - THERMOGRAPHIC SCANNING

FEBRUARY 1984

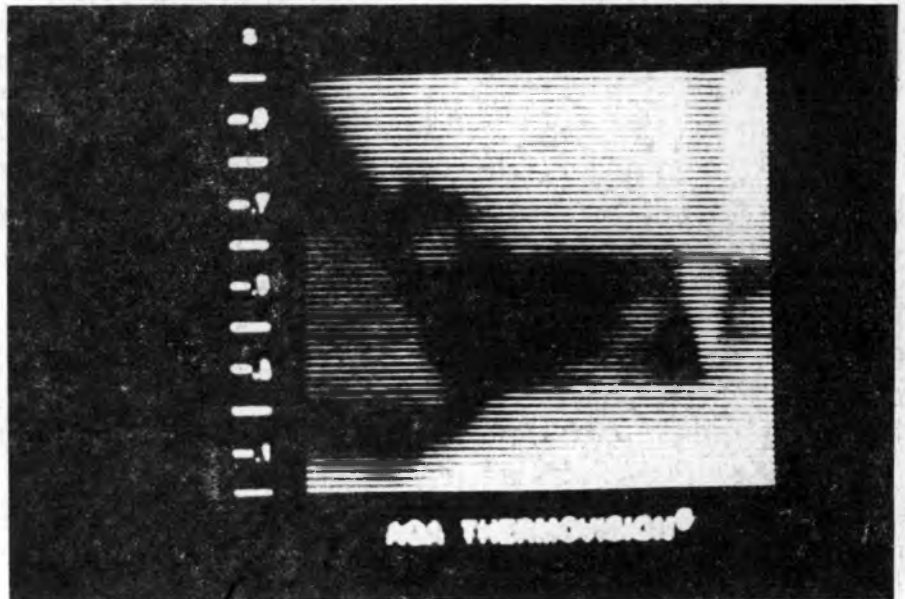
Basement Header

Cold spots at insulated vent and joist header resulting from poor A/V Barrier seal.

4. A major trouble spot on all of the homes was the header/joist area at the top of the foundation wall. A foam gasket was used underneath the sill plate. This foam gasket does not seal adequately wherever there is rough concrete, window frames or plumbing, and ductwork and wiring penetrations. The amount of air leakage into the finished wall cavity is such that all basement wall outlets and trimwork are very leaky.

The difficulty of firmly attaching a polyethelene A/V barrier along the joist/sub-floor topography should not be underestimated. The evidence of condensation problems along the header joist (band joist) suggests that a considerable amount of vapour is diffusing into this area. Any moisture that does reach the band joist is likely condensing, and has accumulated for several reasons:

A. The band joist is inadequately insulated with 37 mm of Glasclad insulation sheathing;

C. The basement wall AV barrier is applied to the warm side of the header space fiberglass resulting in partial vapour lock. This last condition requires immediate corrective action to maintain the integrity of the header joist. This problem is illustrated in Figure 5.1.

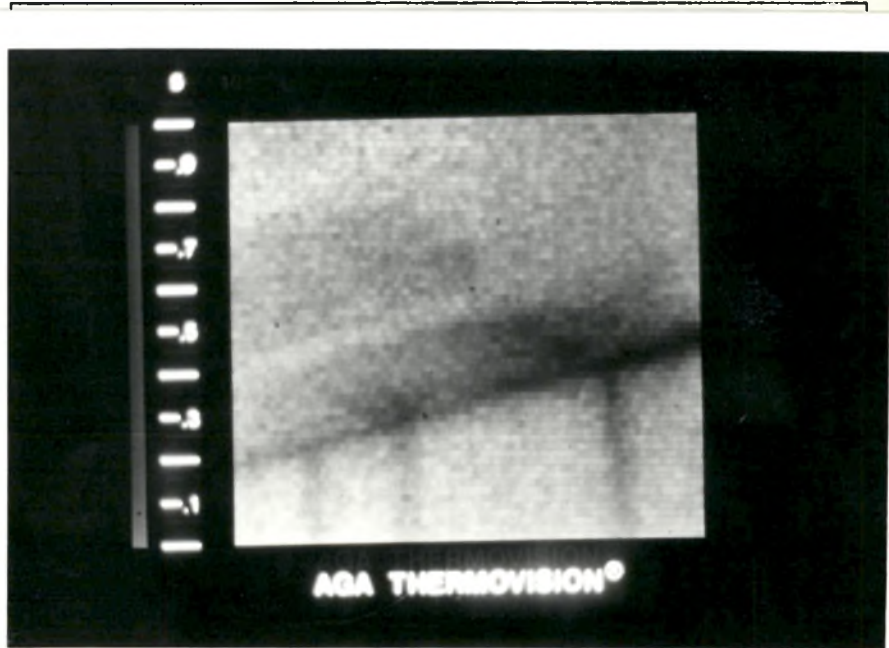
M. BED. - EAST
WALL

Inadequate
A/V barrier

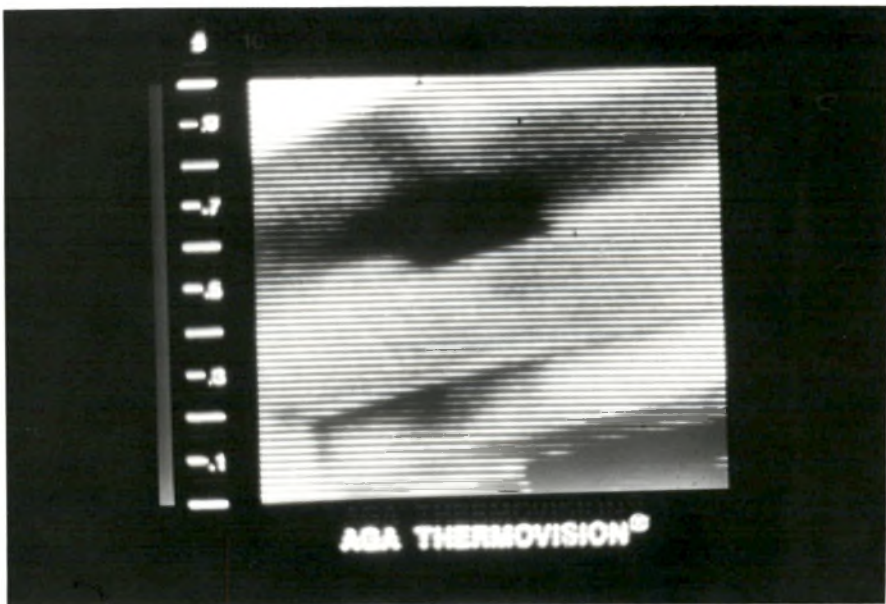
Severe leakage at
ceiling fixture and
down outside wall.
Moisture buildup
in ceiling.

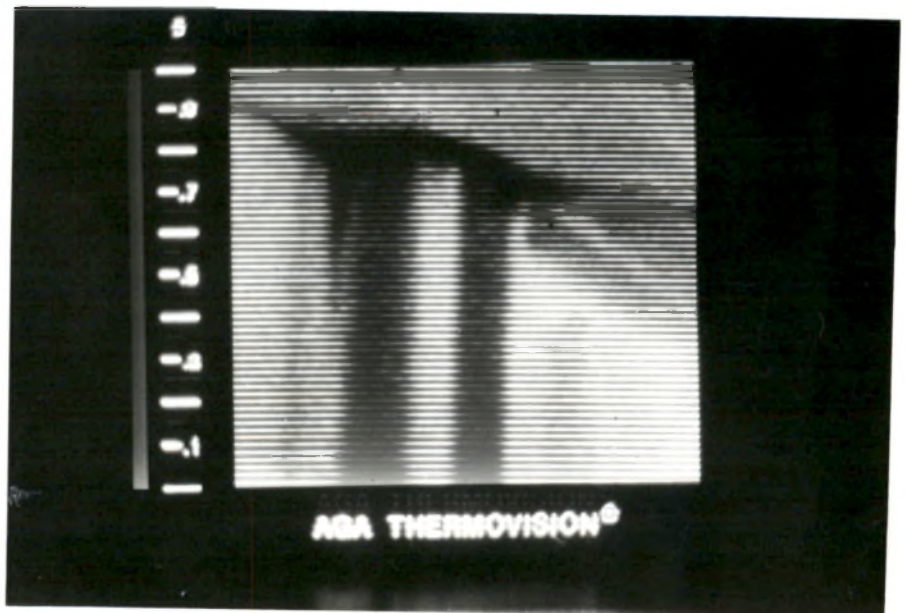
Family Room -
Chimney cavity on
North Wall.

Cold air flow
through chimney
cavity which has
also infiltrated 2nd
Floor cavity.

No air seal at
2nd Floor ceiling or in furnace
room allowing cold
air to infiltrate and
flow through cavity
and infiltrate 2nd floor.

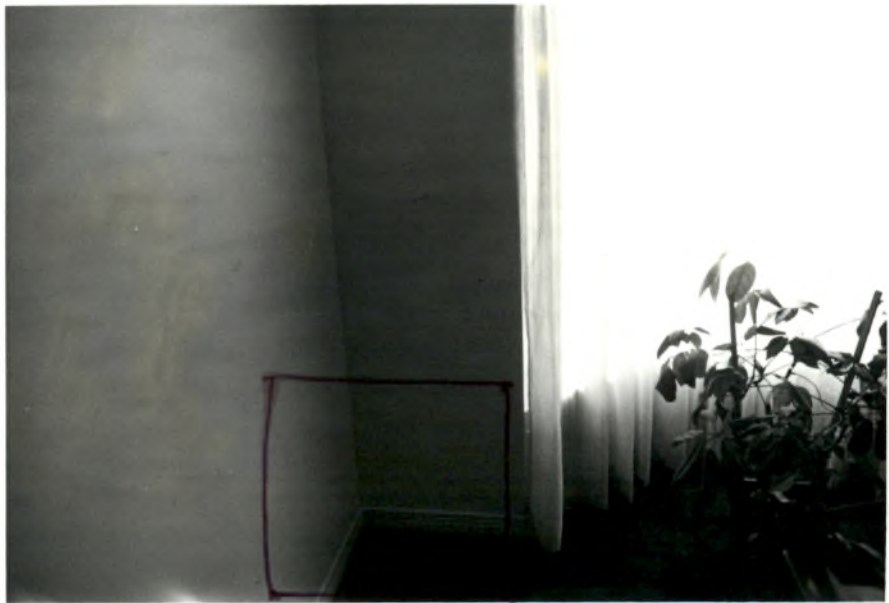
Eating Area - Kitchen
South Wall

Air leakage at
baseboard

Air leakage due
to ineffective A/U seal
@ joint/heads causing
air leakage at
baseboard.

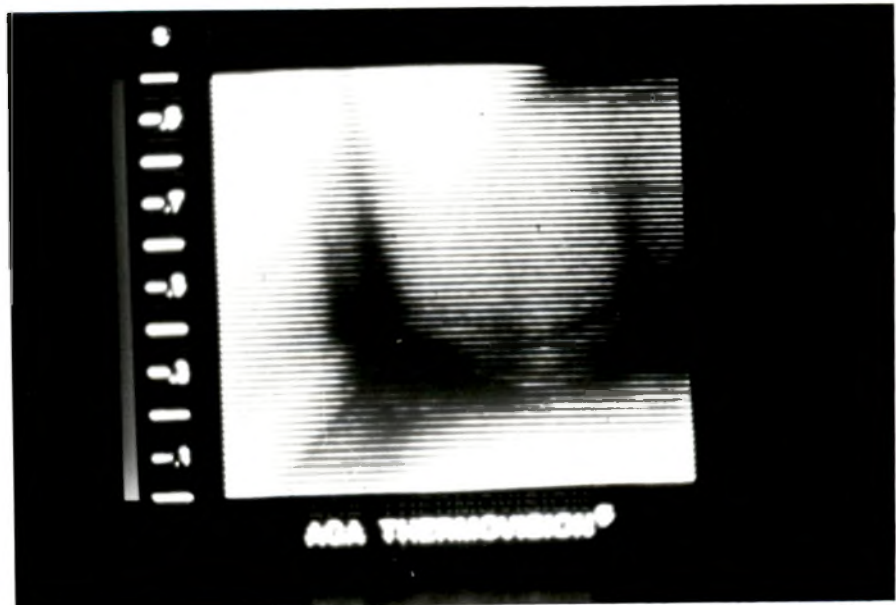
air leakage at baseboard

caulk quarter round and baseboard

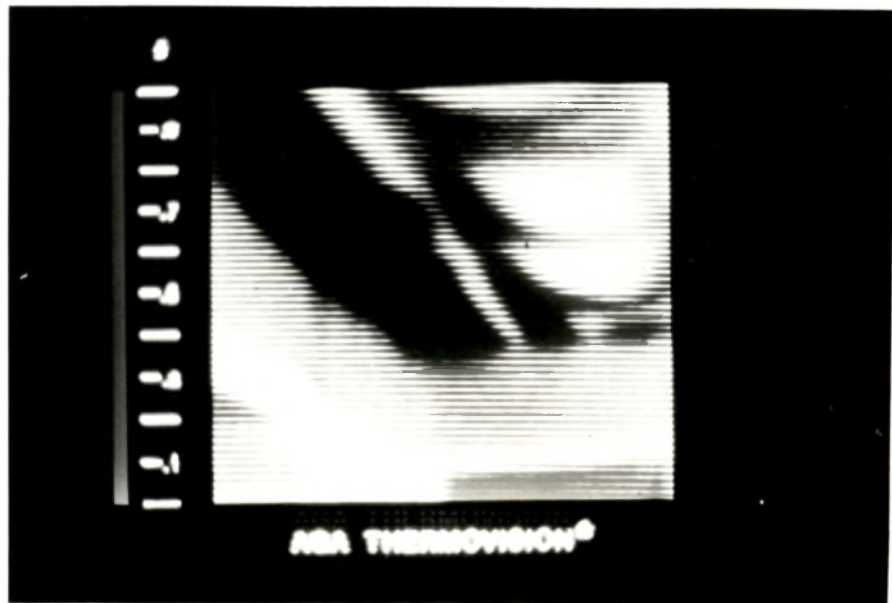
Ceiling in second floor hallway

cold features on ceiling due to air infiltration + condensation

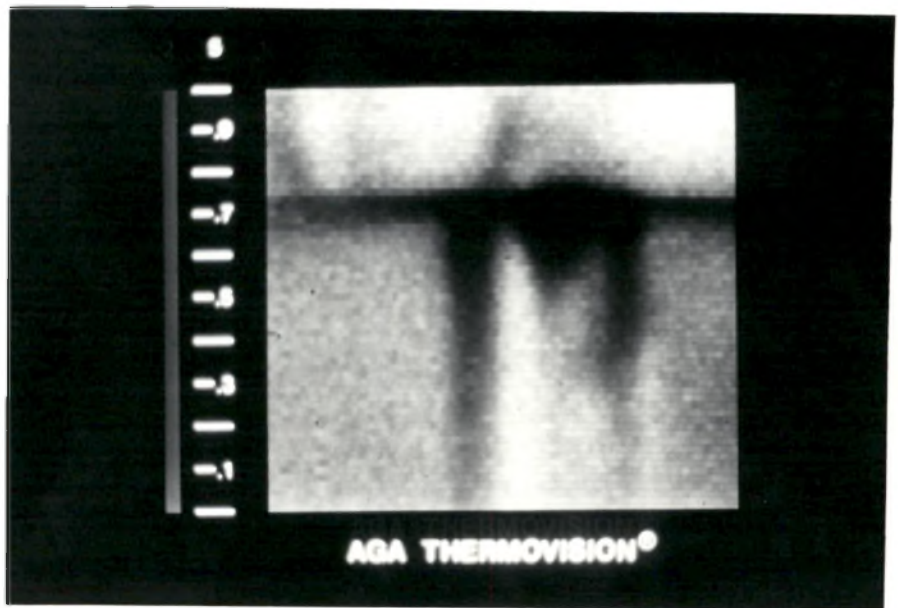
EAST WALL - LIVING ROOM

Air leakage down wall from 1st floor plate

POOR A/V SEAL AT THIS POINT. CONSIDERABLE AIR LEAKAGE.

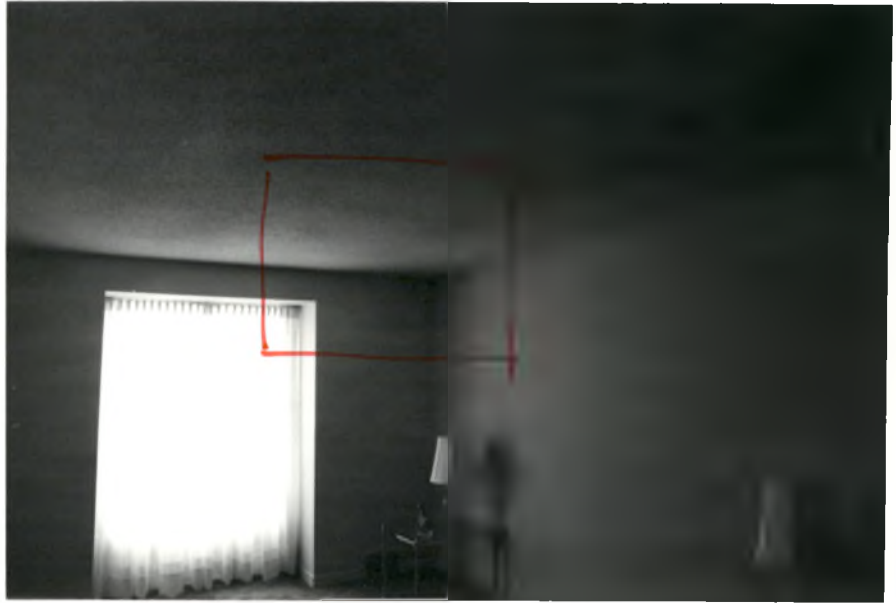
likely insufficient
vapor barrier causing
some air leakage and
condensation

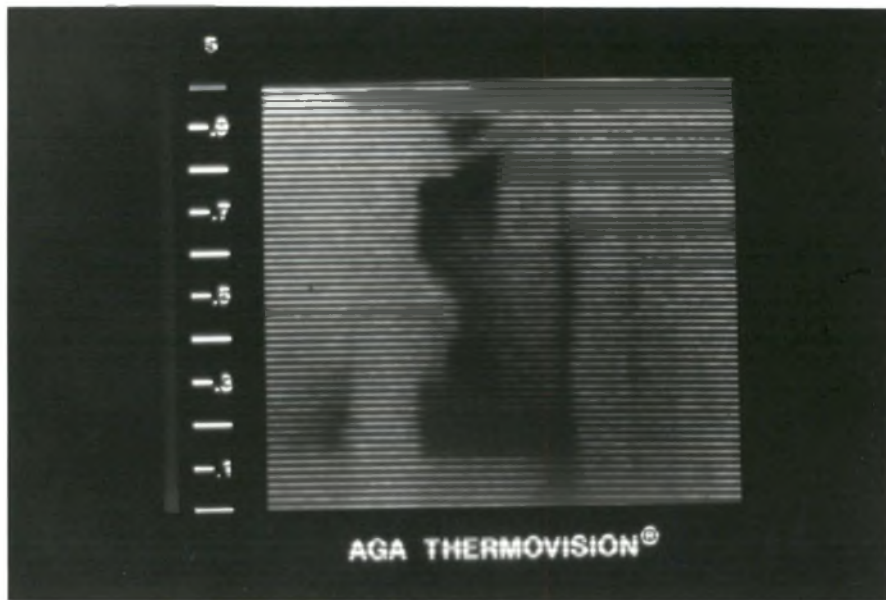
air leakage at
back of fireplace

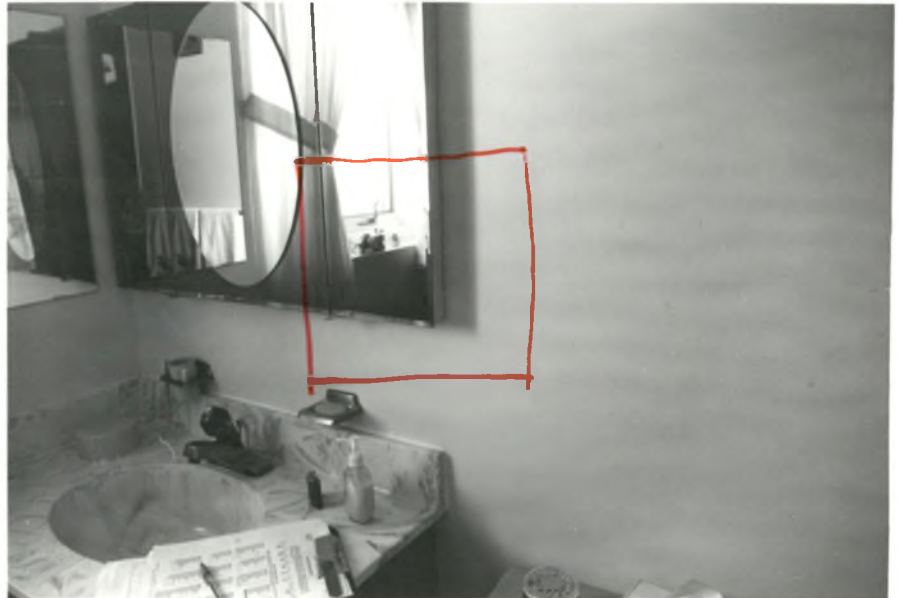
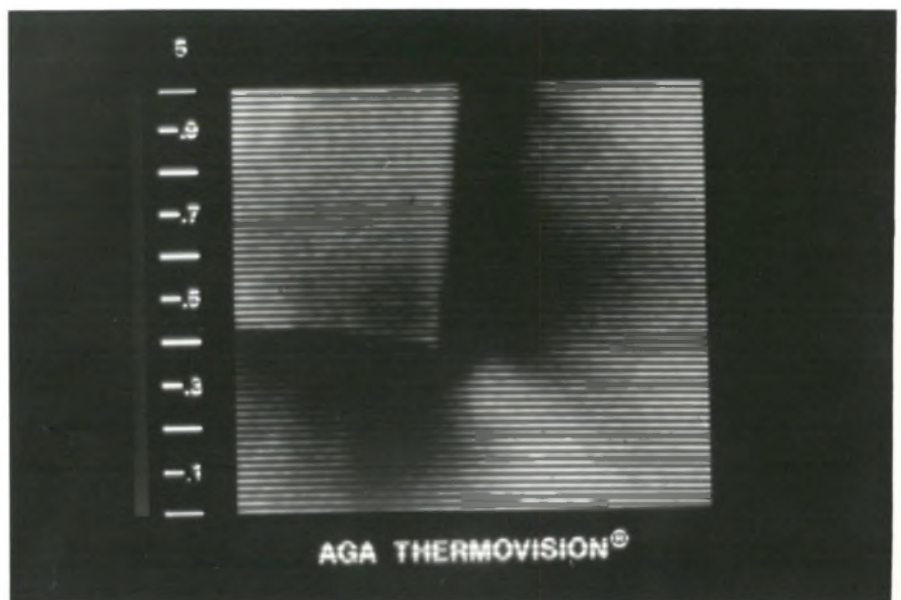
Air leakage at medicine cabinet.

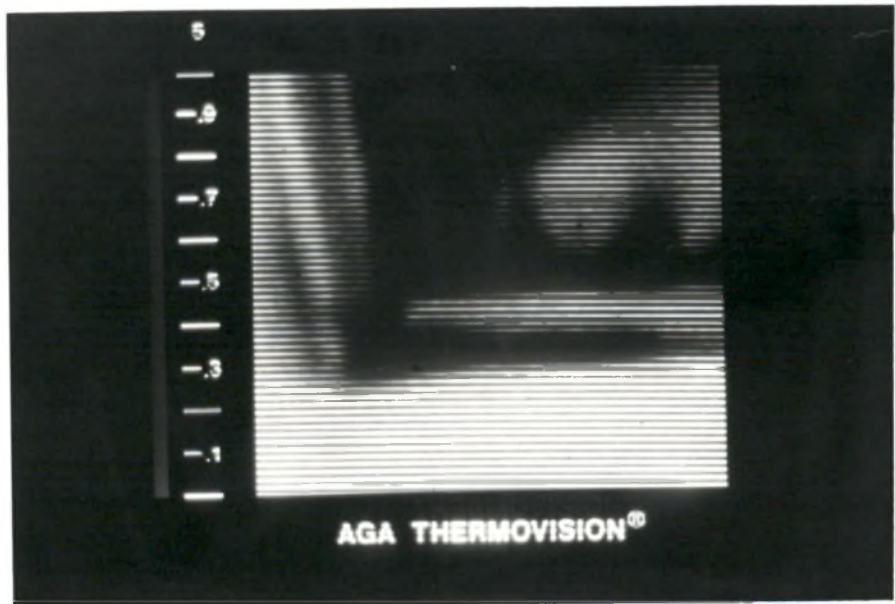
Attic hatch in
closet ceiling

Air leakage at
attic hatch

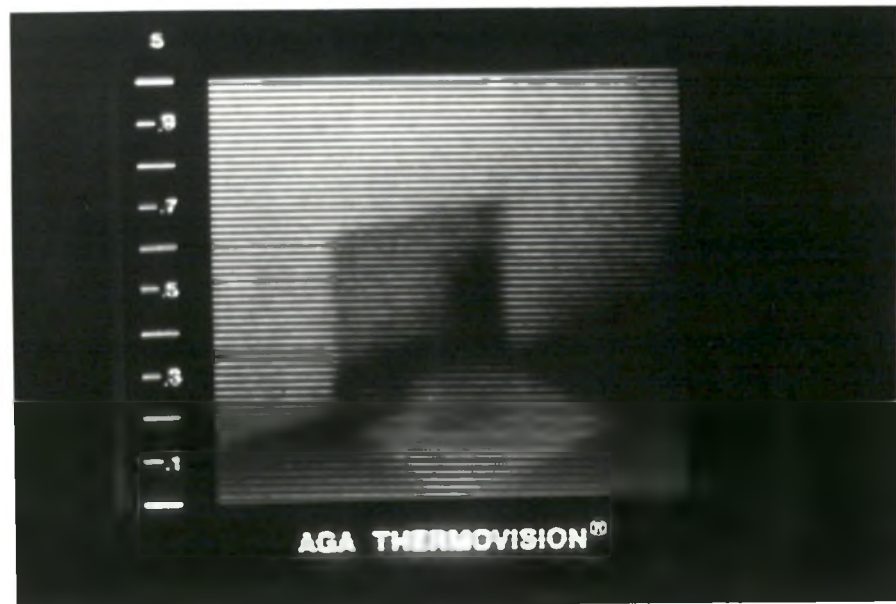
cold air leakage

caulk + insulate

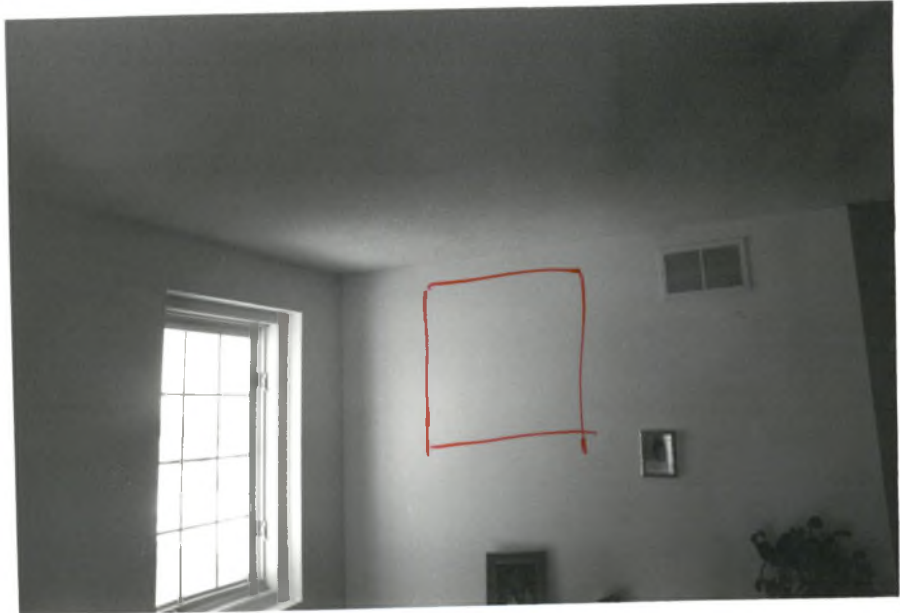
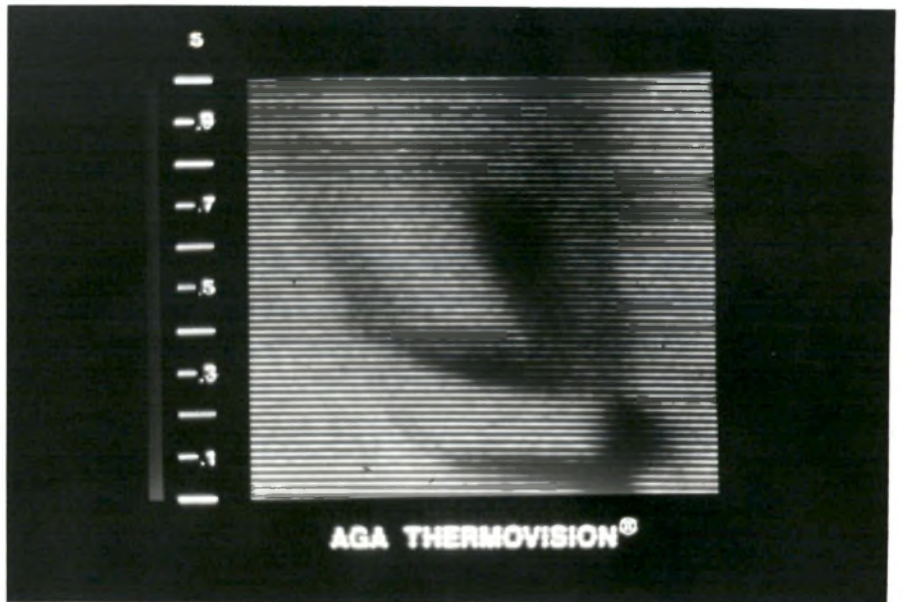
Master Bedroom -
North wall

cold voids on
wall
