Nanaimo River Chinook Salmon Recovery Plan Habitat Assessment Report

D. R. Clough

Canadian Contractor Report of Hydrography and Ocean Sciences 59

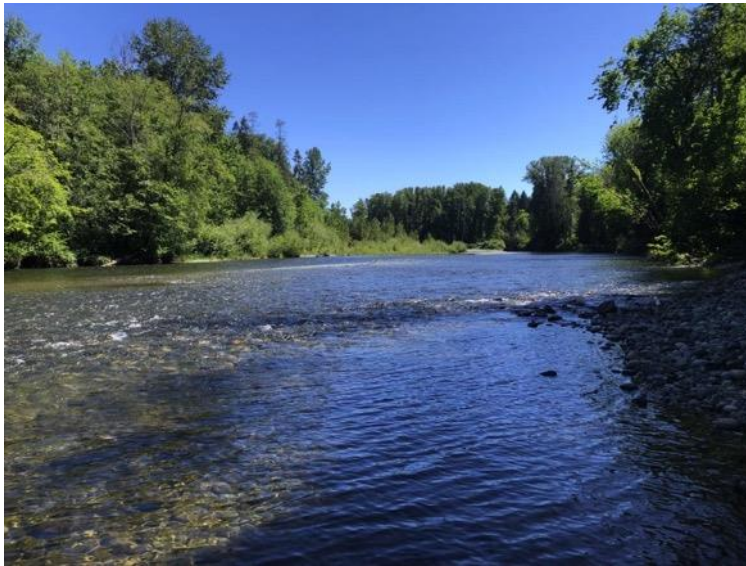
1.) Riffle 1 Placemark 7, Morden Trail head, clean gravel

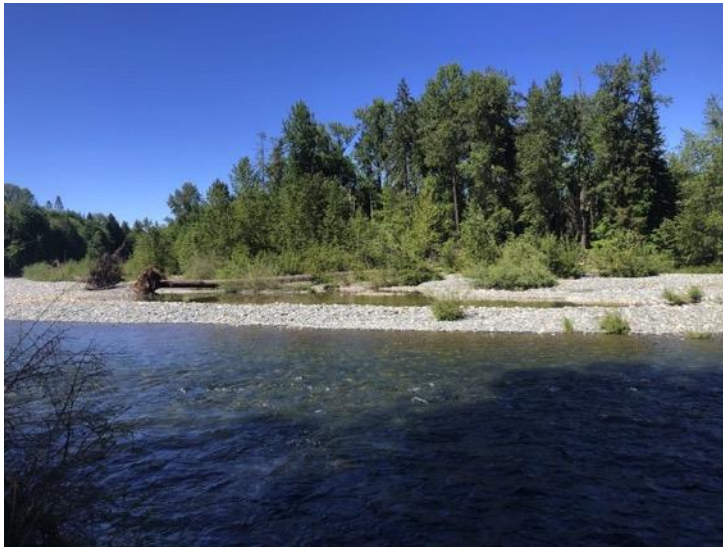
3.) Riffle 2, right bank island with dry flood channel and LWD.

A lack of LWD. There were only five second growth fir/cedar washed on to bars (Photo 3) in the 1679m survey length. These logs offer bar stability but little fish cover. No old growth size logs were observed.

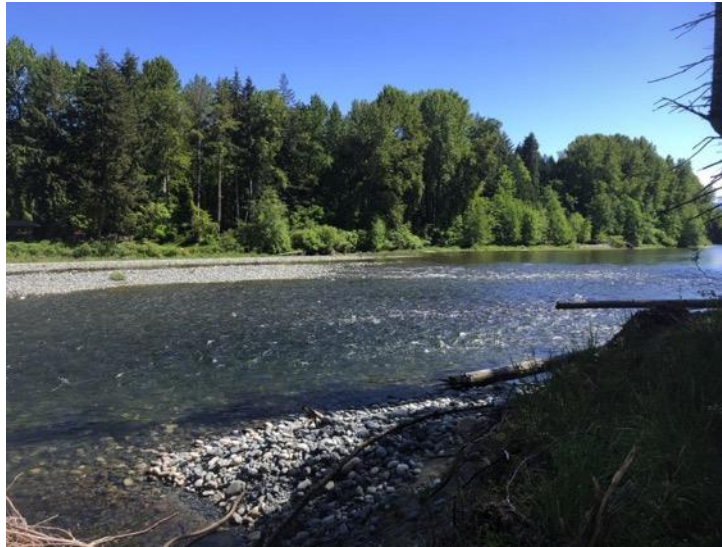
5.) Riffle 3 Placemark 14, clean gravels no boulders/LWD

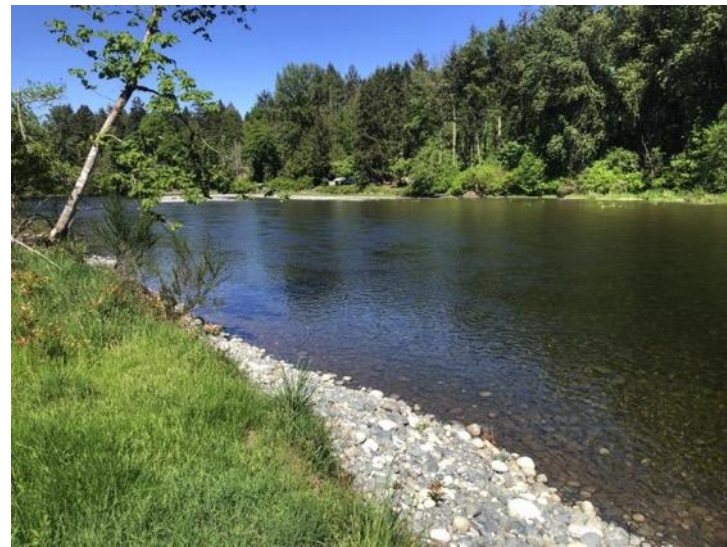
6.) Glide 2 is 55m wide, 115m long, no instream cover

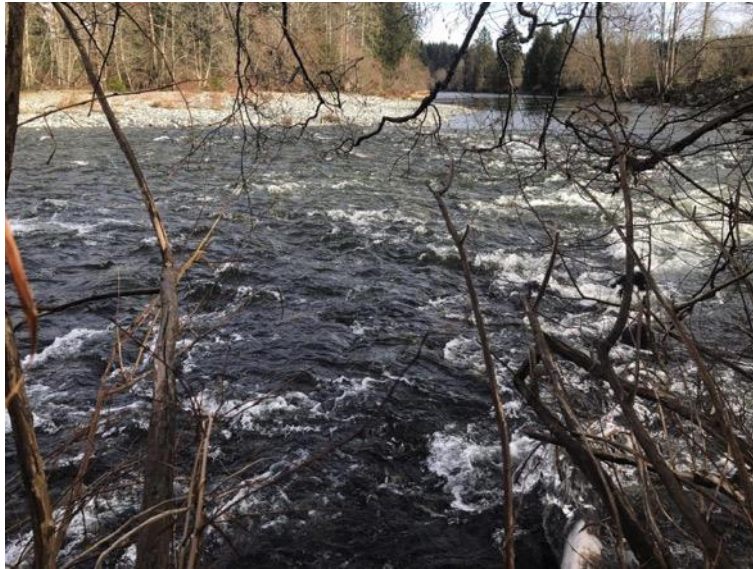
1.) Riffle 1 looking downstream with Haslam Creek on right

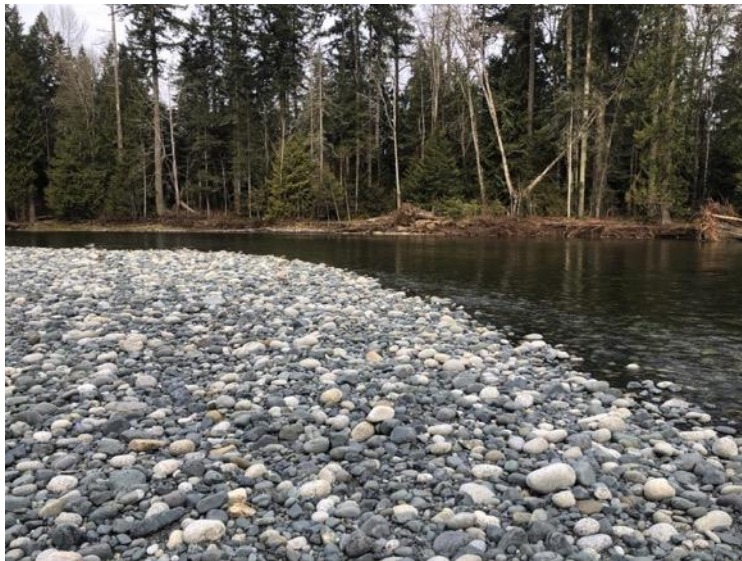
3.) Corner Glide - left bank spills into Frey Rd Sidechannel

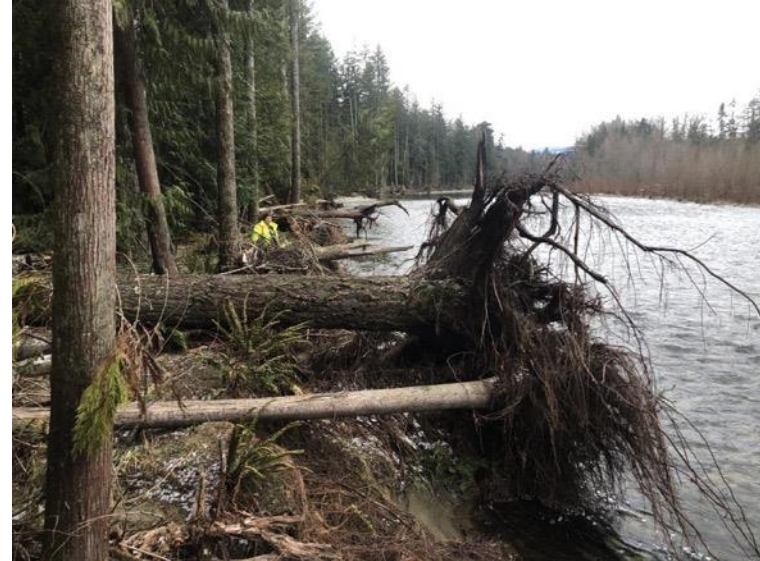
4.) Glide 4 in new route - tree/LWD swept aside.

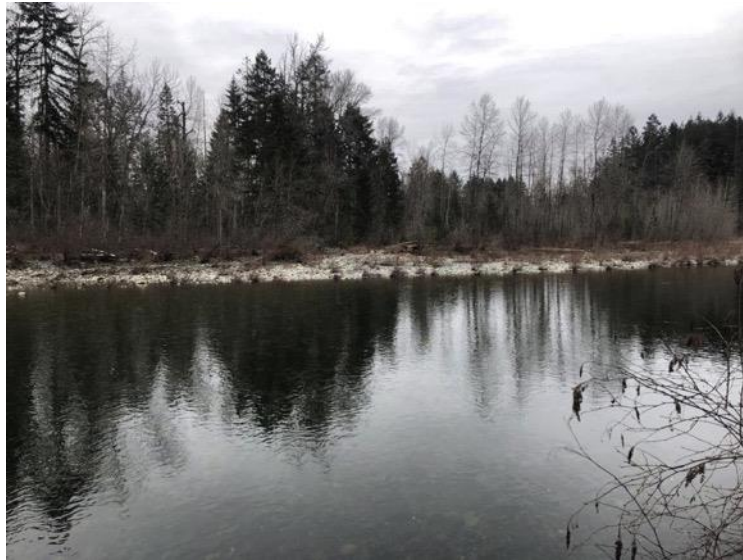
5.) Glide 5 looking at LB sidechannel entrance

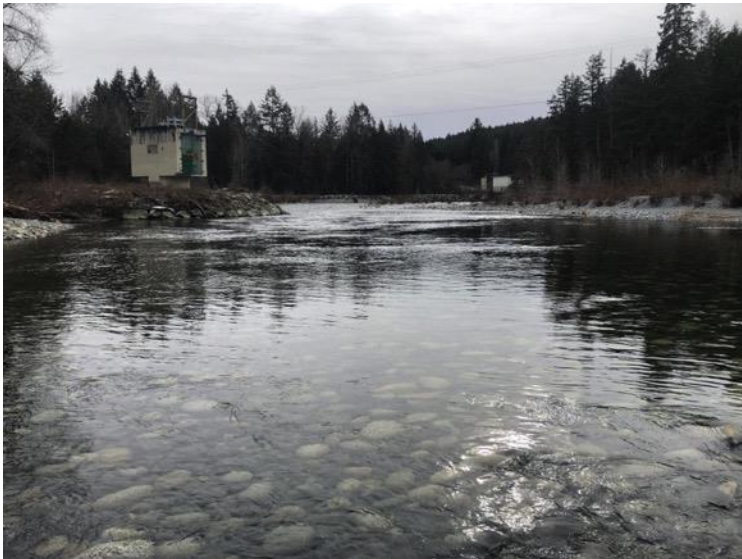
7.) Pool 3 tailout is cobble and boulder limited gravel

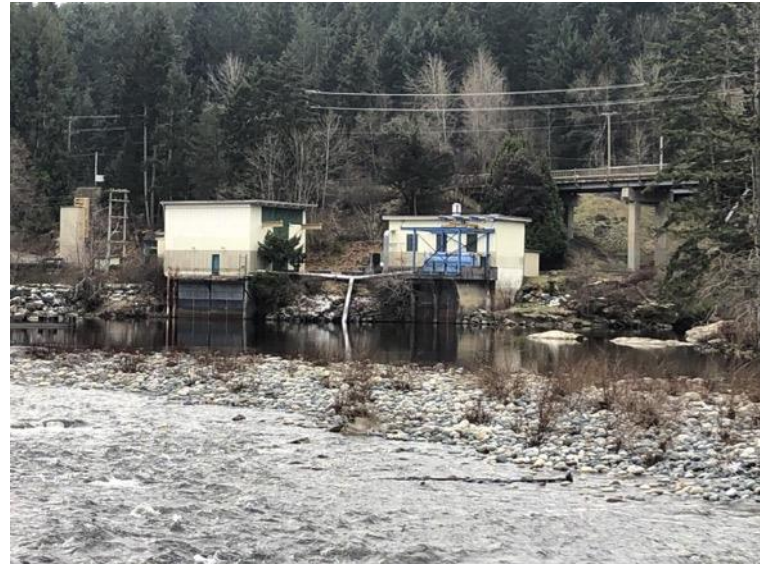
8.) Riffle 8 and Pool 4, pump house at end R4 at Hwy 1.

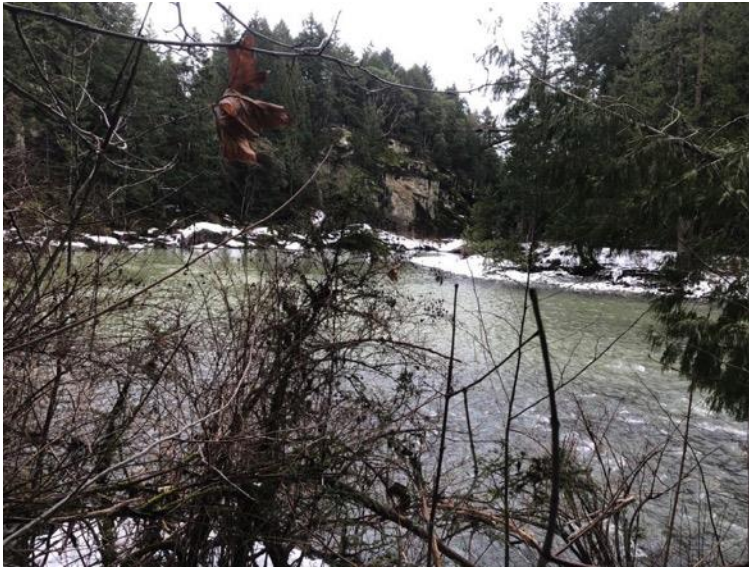
1.) R4-Pool 3 looking downstream to Bungy Zone/Hwy.

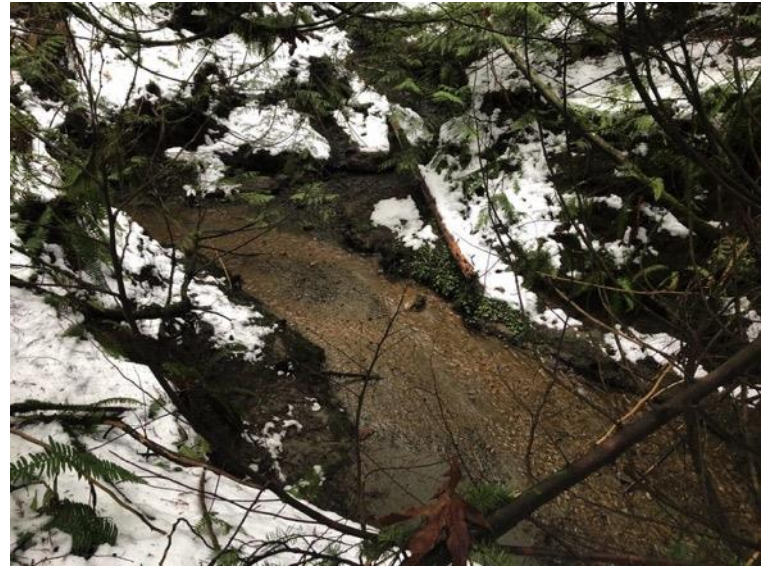
2.) R4- Accessible tributary enters Pool 3 from pit side

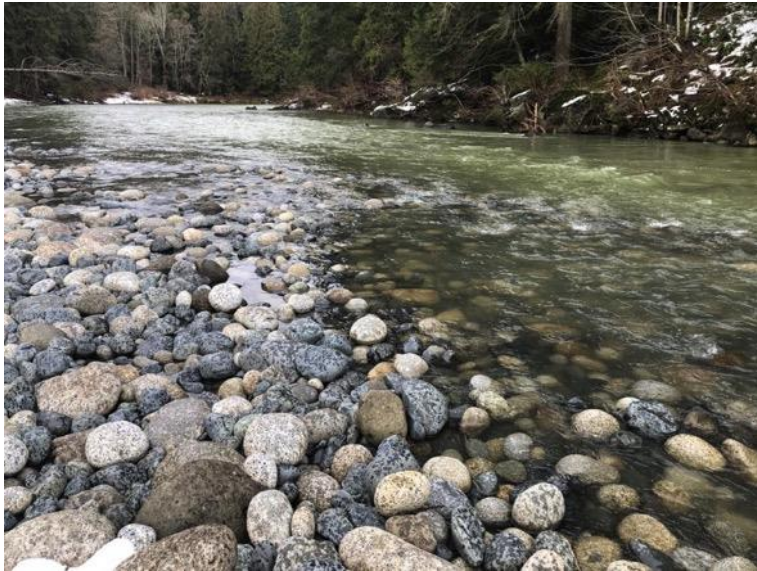
3.) R4 – Glide 2 at potential spawning gravel site.

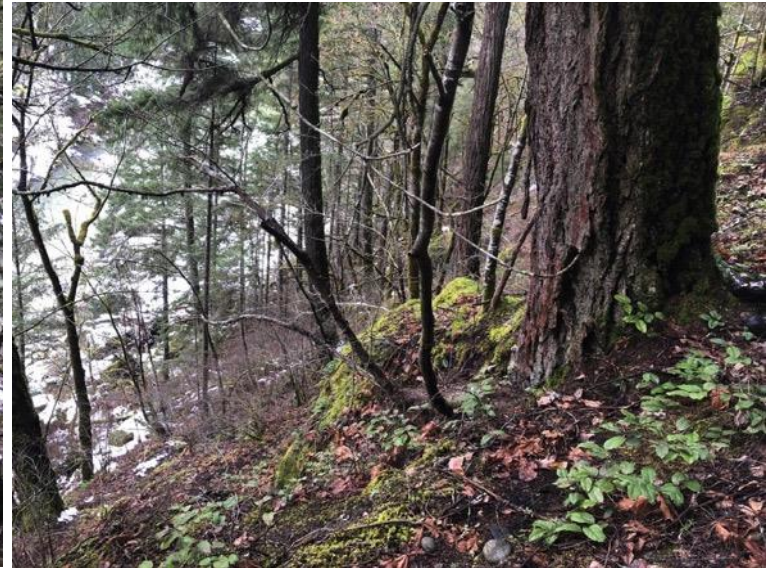
6.) R4-Most trees are 60-100 yrs with occasional vet. (shown)

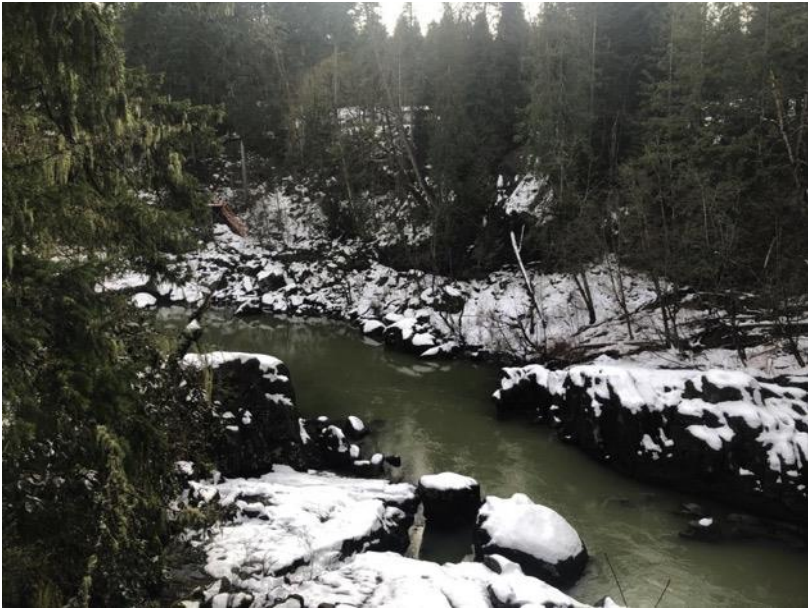
7.) Pool 4 is coloured after snow melt.

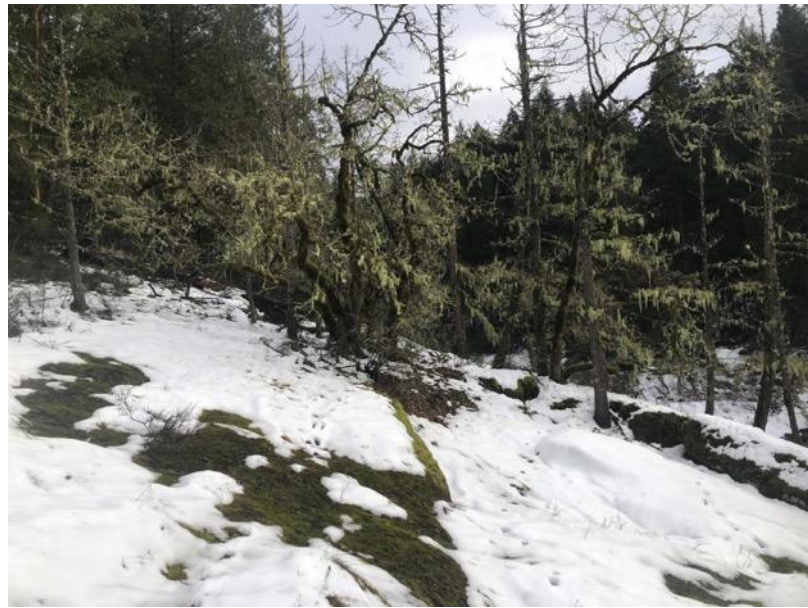
8.) Garry Oak bench along left bank (Placemark 12)

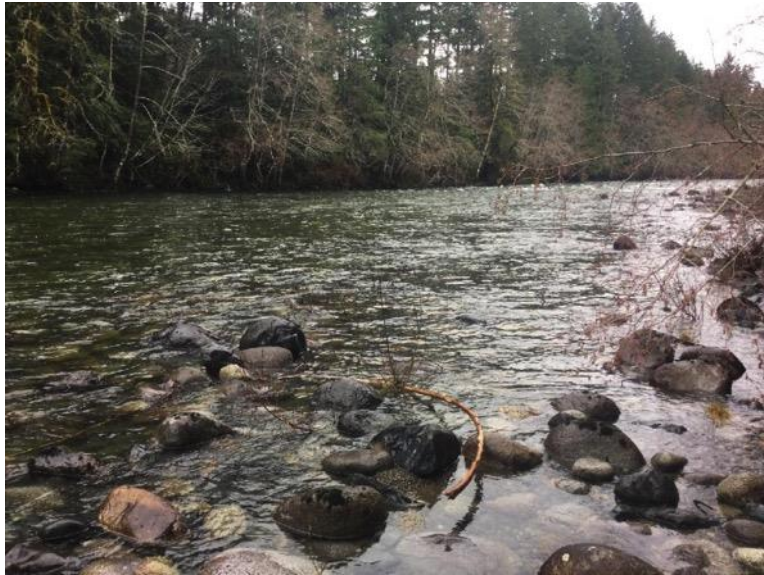
1.) R12- Glide 1 Boulder/cobble upstream at south bank

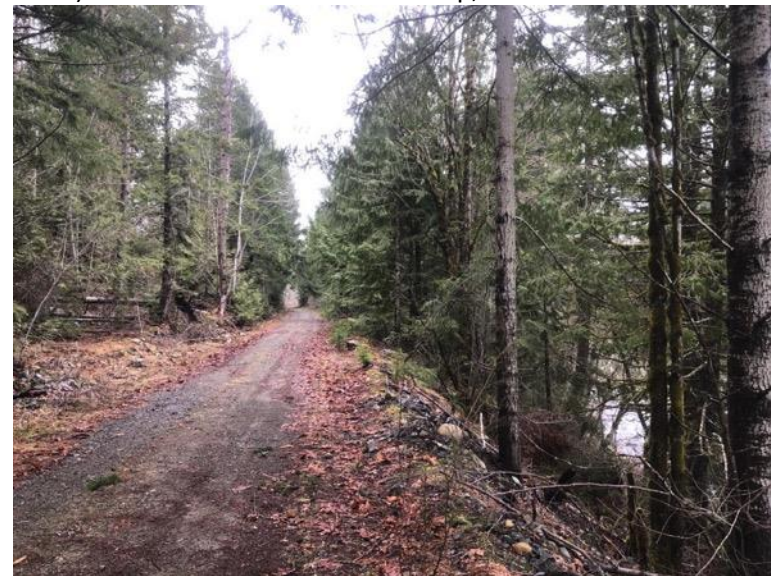
4.) R12 – Glide 4 -start of Rail grade in riparian

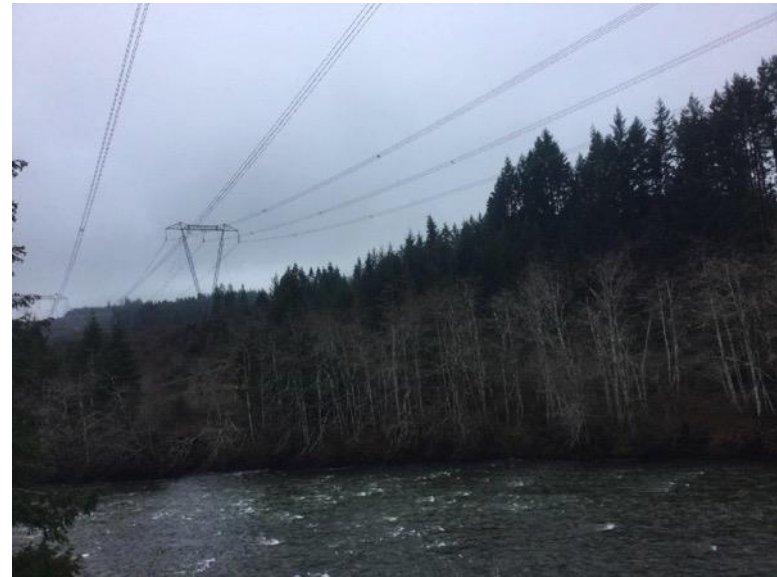
6.) R12- R2 Hydro Line crossing, Riparian is shrubbery/Alder.

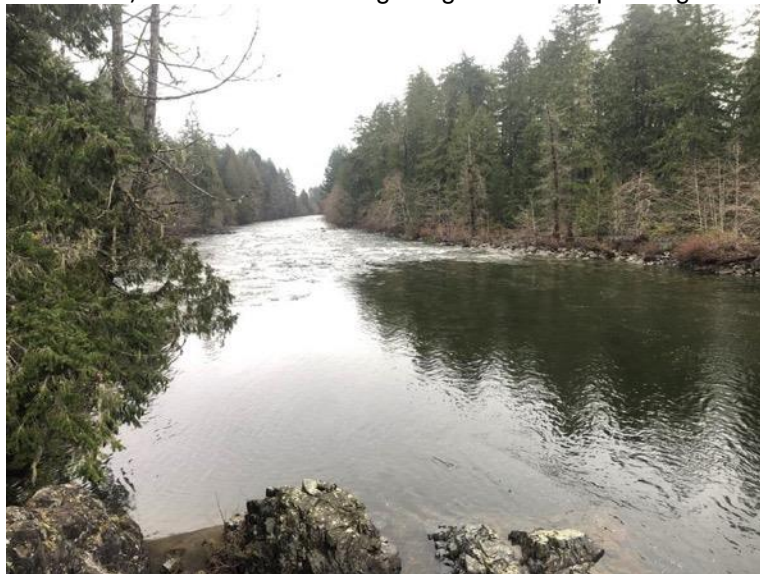
7.) R12- Pool 1 (Jump Ck) looking downstream at reach.

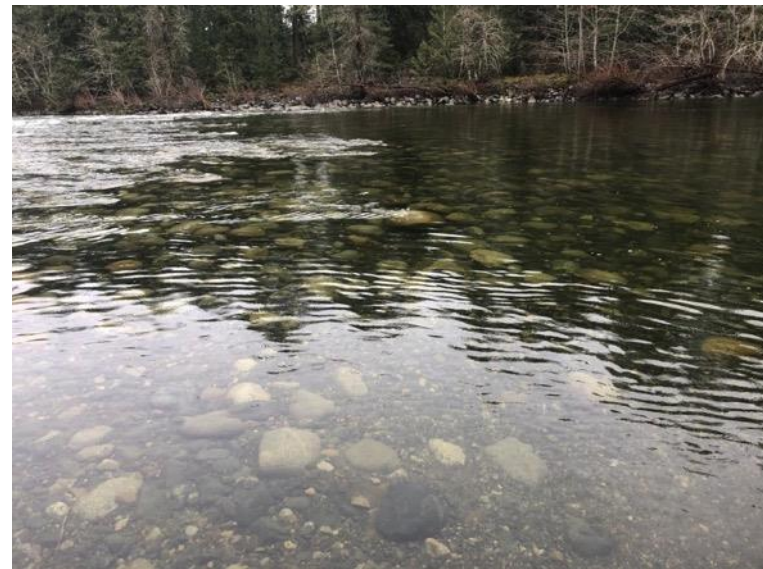
8.) Pool 1 Tail out lacks spawning gravel.

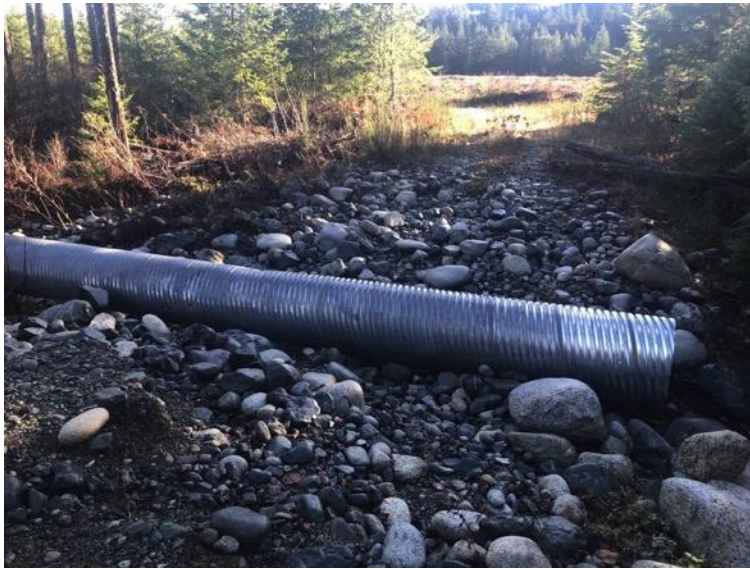
9.) Sidechannel top end near inlet is seasonal and 5-6m wide

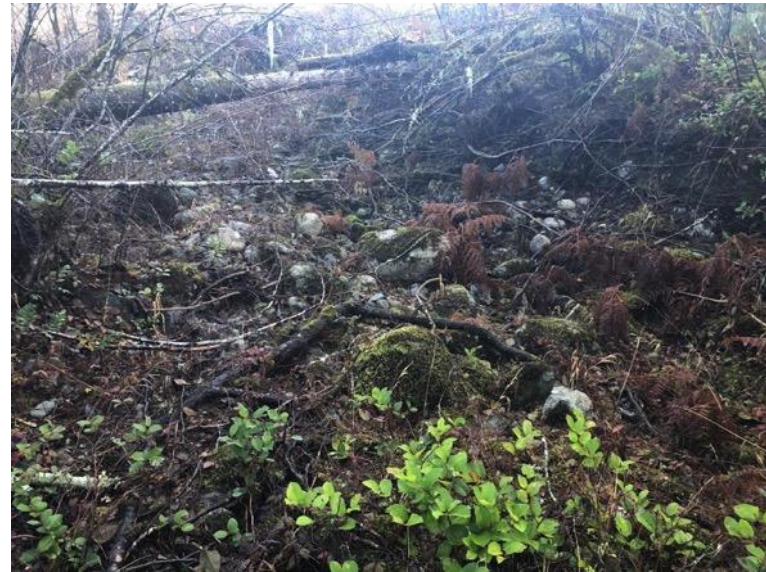
10.) Sidechannel goes across old road.

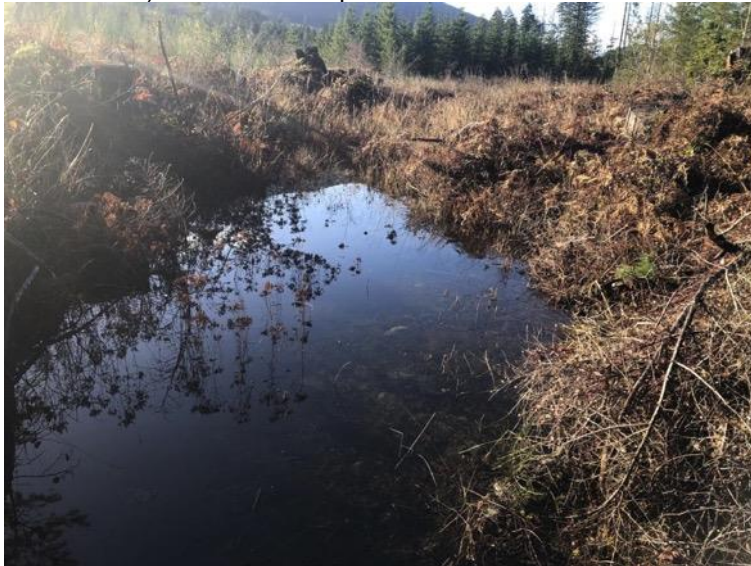
11.) Midreach seasonal pool formed at junction

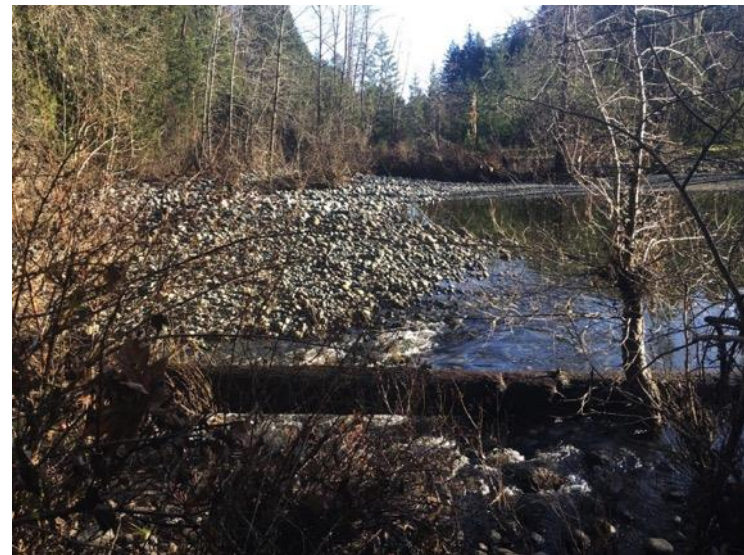
12.) Outlet joins mainstem in corner pool Reach 11.

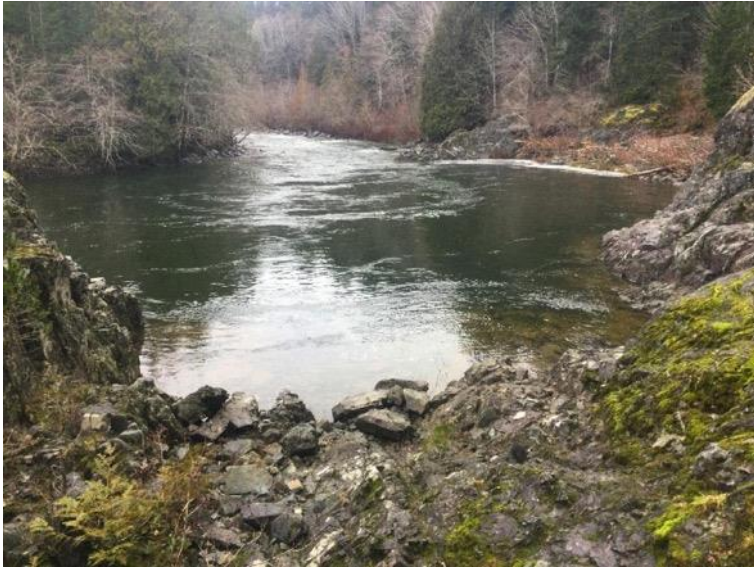
1.) R13- Pool 4 above Jump CK is deepest pool in reach (4m)

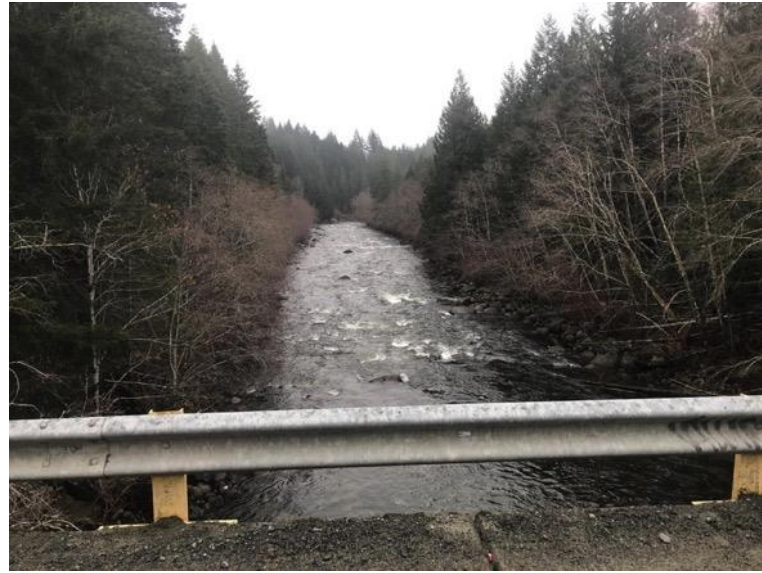
2.) R13 – At Jump Mainline Bridge looking at lower reach

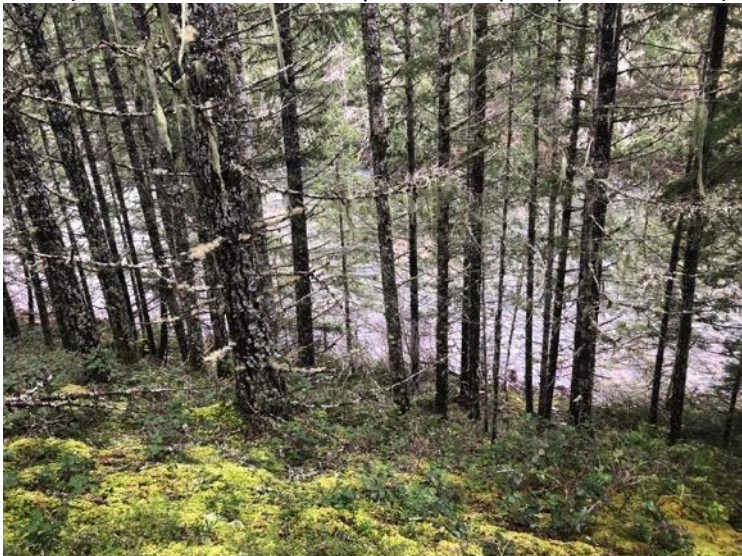
3.) R13 confined reach with steep slopes

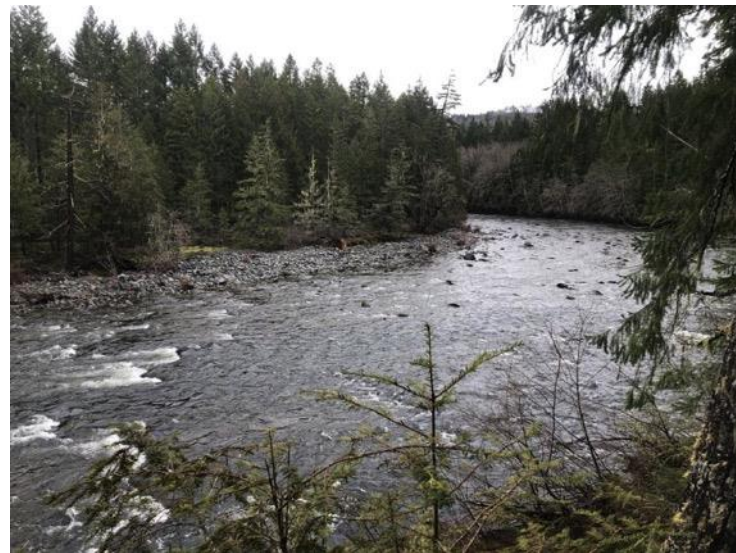
4.) R13 – Riffle 3 below Wolf Creek in big bend

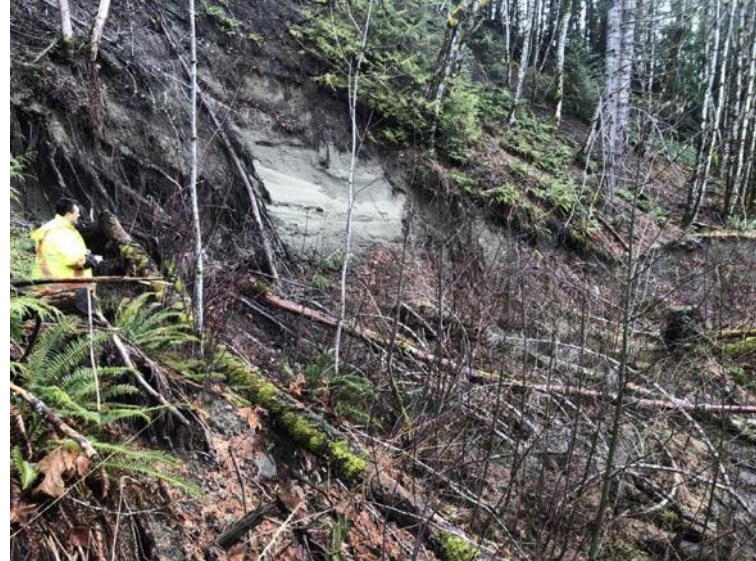
The habitat summary results in a Fair score. The Good rating for erosion is due to the fact the river bed is washed down to hard substrates. There are rail culvert washouts (Placemark 9 & 10) that are eroding off steep slopes into the river that need remediation. The Good rating for Obstructions such as log jams is because they must have been removed or historically washed away as none exist. Some residual log debris is observed in the narrow floodplain trapped amongst tree stems. The Alterations to the river are historic: the logging railway ceased operation approximately 60 years ago. The rail bed is in surprisingly good condition given there has been no sign of maintenance. Erosion was low for the overall length but two sites were observed along the rail grade. There is a plugged culvert at Placemark 9 has that needs cleaning. Downstream at Placemark 10 there is a bank failure approximately 30m wide eroding sand down to the river.

2.) R13 – Placemark 10 slide track from rail line

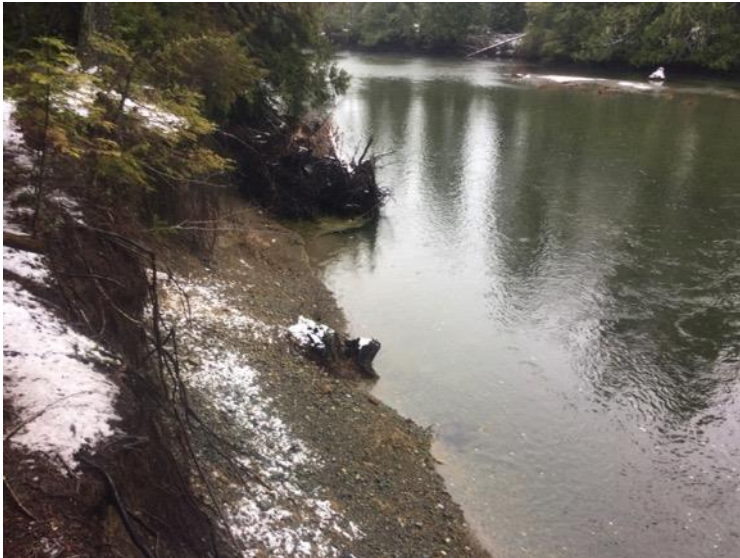
- Erosion and Bank Stability scored Fair. There was 160m of bank erosion in this 2km reach (8%). The main type was trees falling in from undercut banks (i.e. Glide 2 Big Cedar) . The trees were lesser strength second growth (60-80 yrs) and it was more evident in areas where the channel had head cut. The old rail grade culverts are sources of sediment; there was a failure at Pool 3 with loss of fill. Wolf Creek culvert is a concern.

5.) R14-Glide 2 – 20m left bank erosion

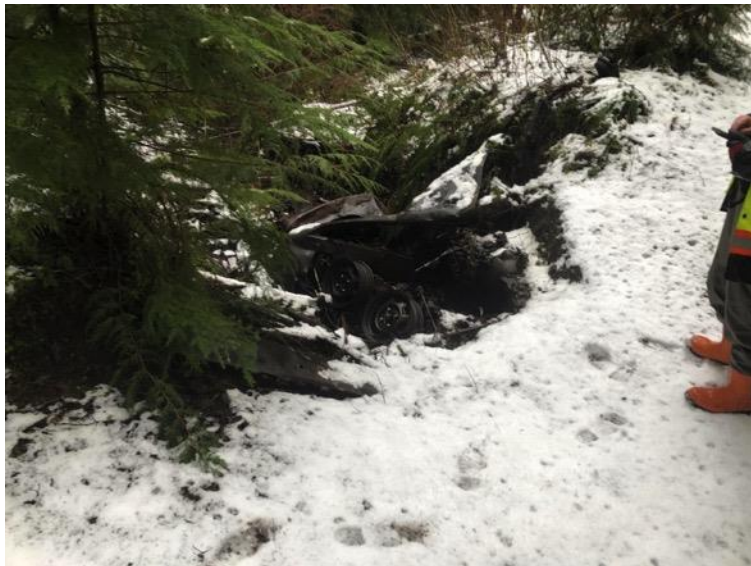
7.) P4- Plugged culvert along rail grade with old car body debris

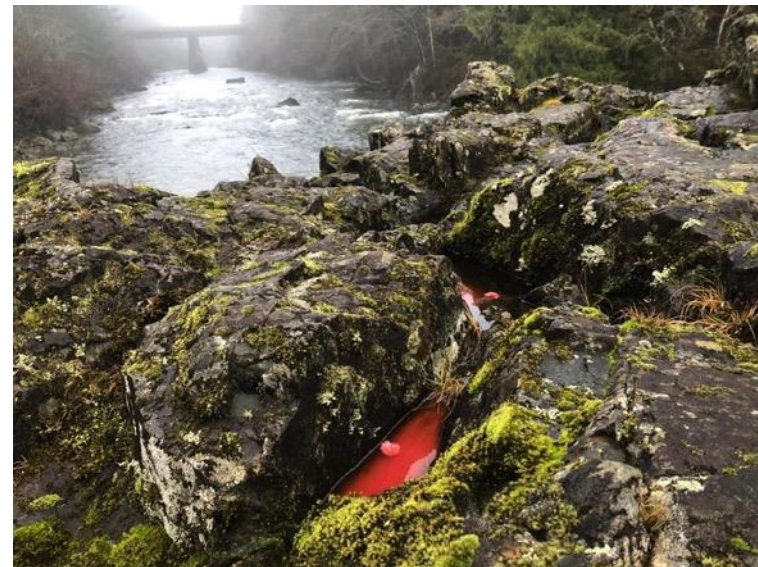
4.) Popular angler site and trail in R16, site cleanup of gear.

There are no other significant opportunities observed in the reach but small restoration activities that could be done with stewardship groups given the high public use in the area; such as water quality sampling, garbage clean up and planting disturbed areas at angling sites (Table 25).

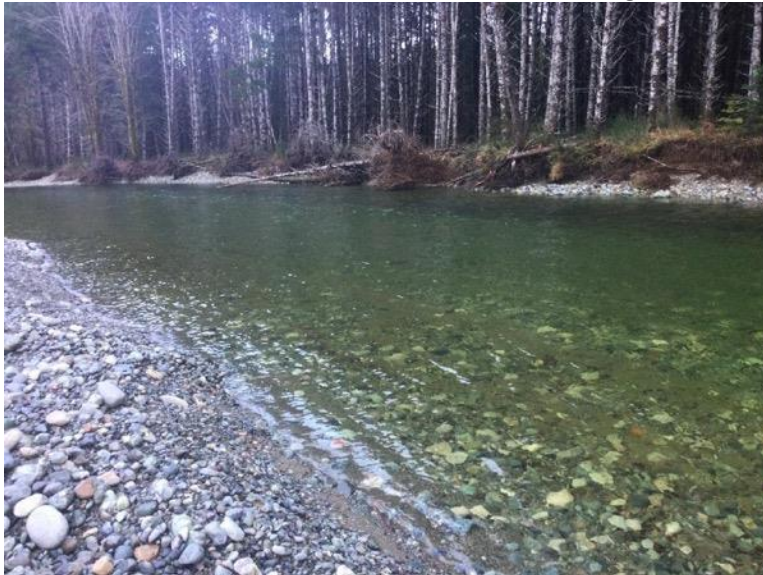
3.) R22 Pool 1 formed by meander scour on right bank erosion 4.) R22 Glide 3 erodes right bank along the alluvial fan

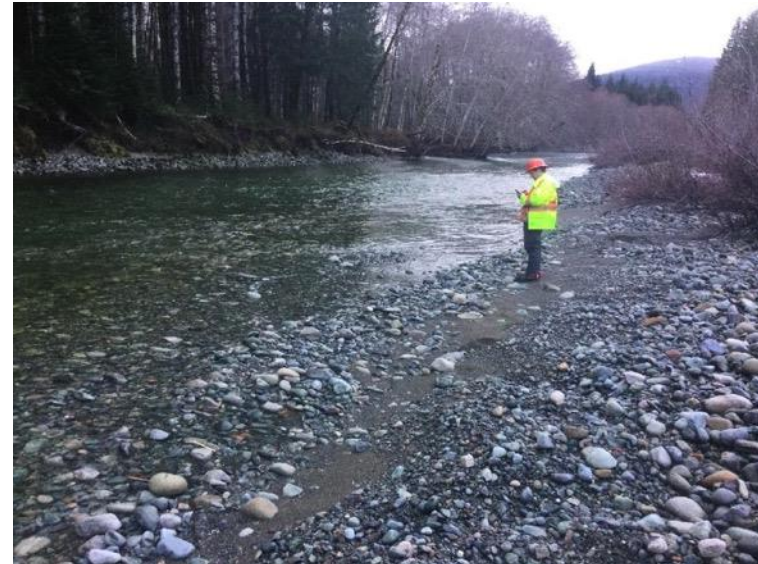
- Erosion - The large deposition fan is the product of several influences; Green Creek enters 100m upstream and the trail of debris from the creek makes it an obvious supply of sediment. The main fan in the reach is 400m long and over 100m wide. The sediment deposition is increasing the erosion on the right bank of the mainstem. The fan is recommended to be live staked and planted to stabilize the sediment.

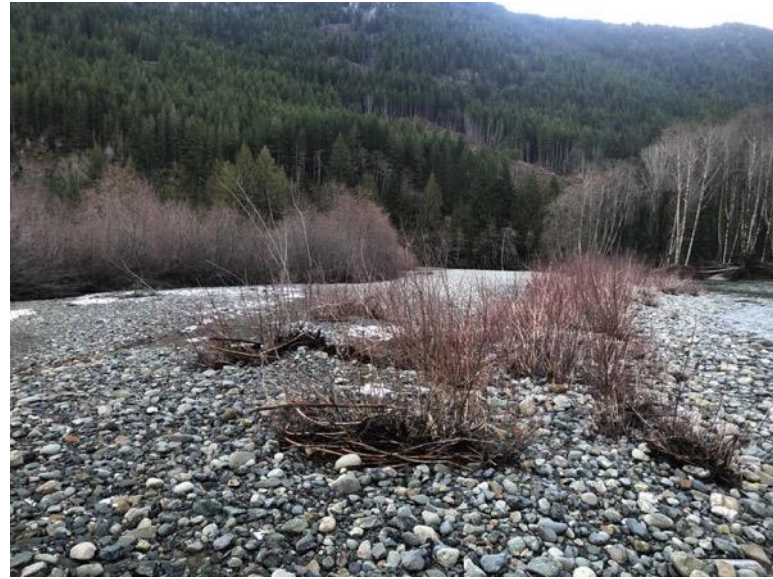
2.) R22 – Gravel bar looking downstream 400m

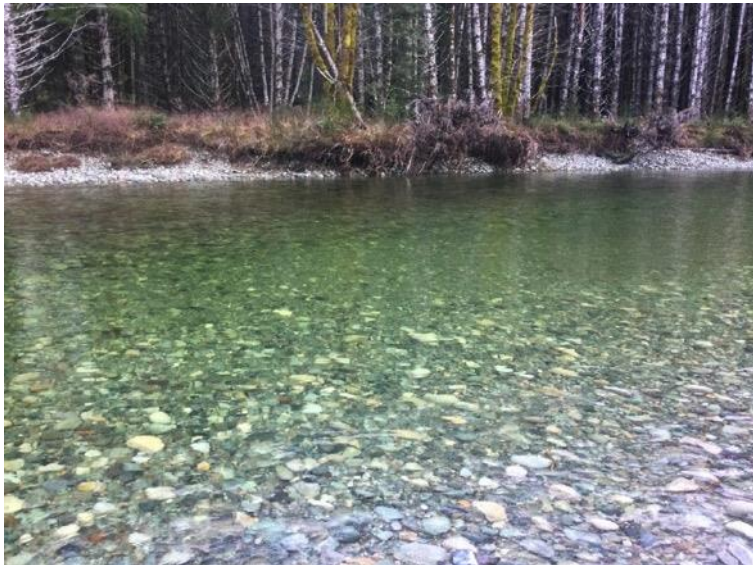
3.) R22 Right bank (Stn 33) erosion and undercutting trees.

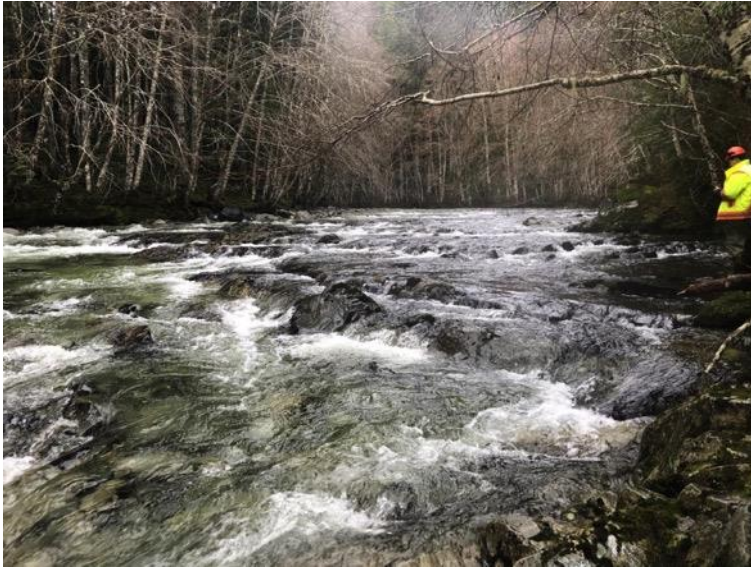
1.) R23- Riffle 1 was very productive with aquatic insects

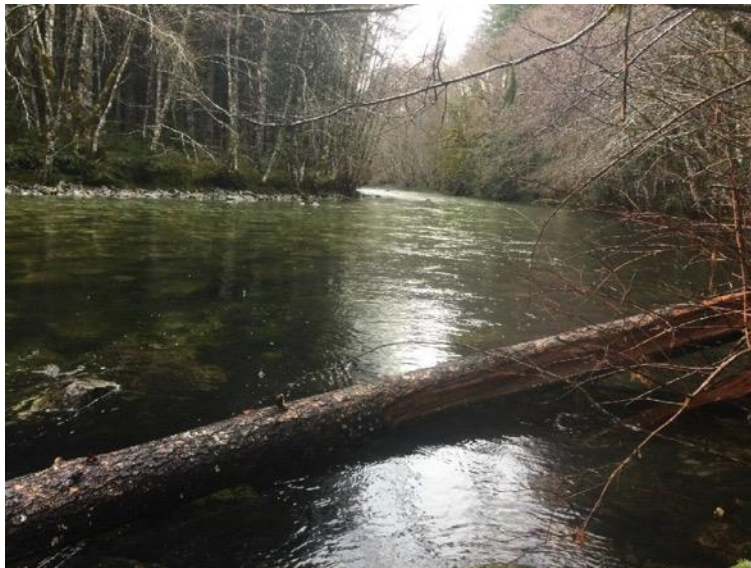
3.) R23 Glide 2 with Boulder cover and limited LWD

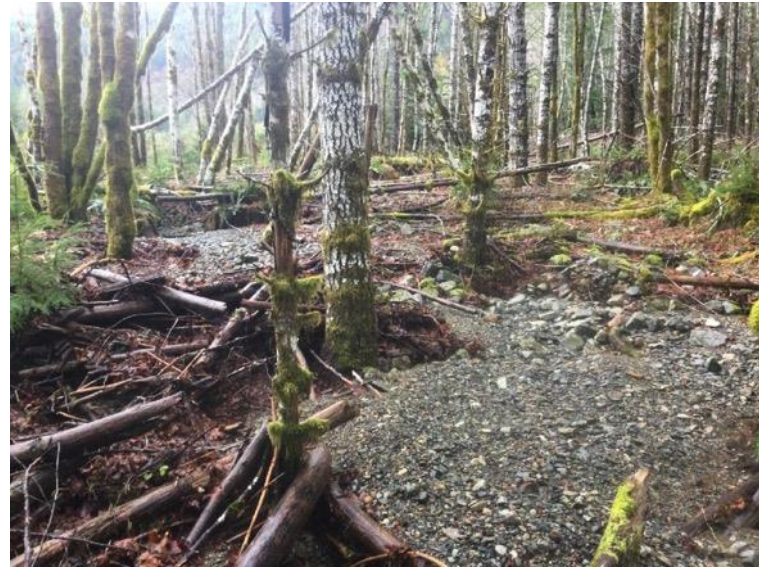
2.) R23 – Left bank Tributary channel disturbance (Site 21)

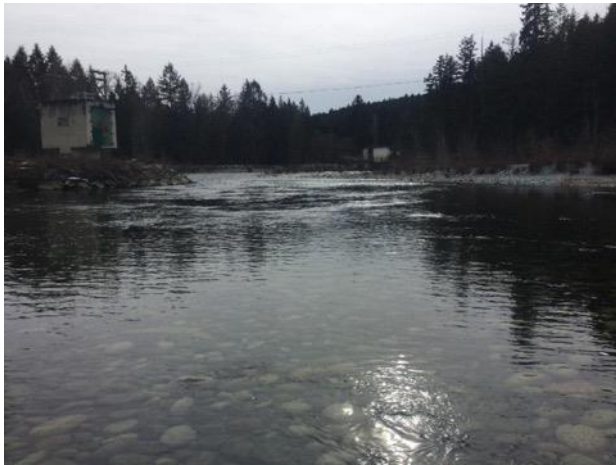
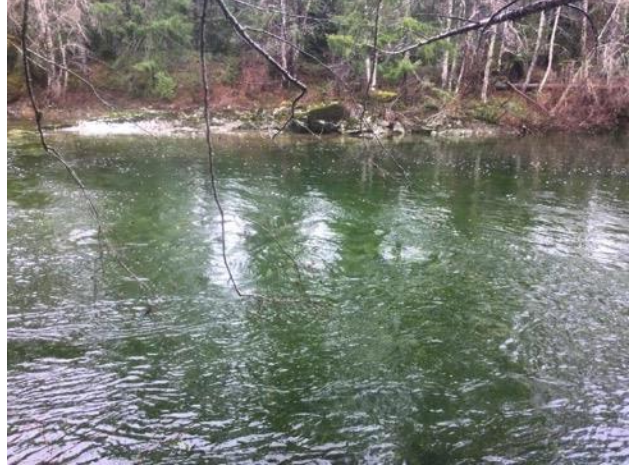
Cover in pools was ranked by percent wetted area with expected ranges of 5-20% of wetted area. Cover components included LWD, Vegetation, Rooted Bank undercuts and Boulders). The results of the survey were 2-7% total cover with a Poor rating in all but reaches 5 and 16 due to small amounts of Boulder cover. Cover in pools offers juvenile and adult salmon refuge as well as food supplies as the surfaces support invertebrates. The lack of cover is for the same reason as discussed above in the LWD section; the material has washed away. During our survey, despite higher water levels, pools were visible to the bottom, there was no cover blocking the view. Restoration efforts to improve cover include addition of LWD, Vegetation, Boulders or planting Vegetation. These items are best done in pools with high fish use and opportunity for success. Installation of LWD in Reach 3 and 22 is recommended. The Nanaimo hatchery (Napoleon) sidechannel was not included in the assessment but visual observations suggest the need for more LWD and/or brush bundles.

Reach 3 Pool 3 and Reach 18 Pool 1 have a lack of cover (LWD, Veg. Undercuts, Boulders)

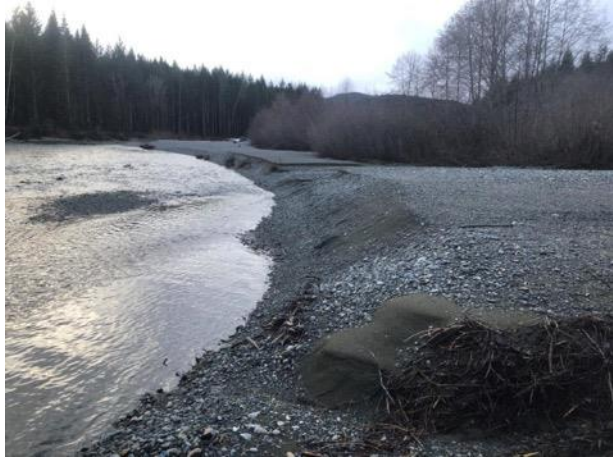
- Cover – Lack of cover throughout the reach was evident. The only functional cover was Boulders.
- Erosion – There is significant bank failure in the upper reach area resulting in loss of riparian forest and a 400m long deposition bar. There is bank erosion on 20% of the survey length. The erosion is caused by flood scour into weak gravel banks. There are many trees along the banks but the second growth Douglas Fir do not have adequate root development to resist the erosion. Several old growth Red Cedar stumps still remain on the river left bank as examples of the greater flood erosion resistance that old trees have.

Reach 22 erosion/deposition bar

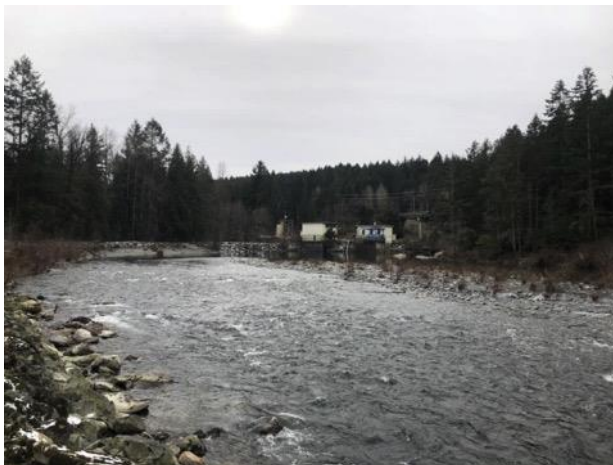
Alteration features in the river were relatively few but significant (Poor) in Reaches 3 and 16. Reach 3 has a 435m long alteration of the south bank from the concrete and rock Pulp Mill water intake infrastructure. This site has virtually no trees and no natural stream bank. Reach 16 above First Lake has a bridge footing and associated dredging and 80m of bank armoring.

Reach 3 has over 400m of armoured bank

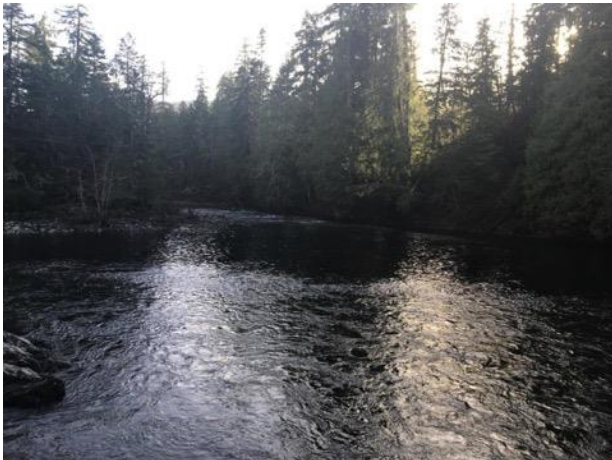
The only Pool in R12 is Jump Creek confluence pool

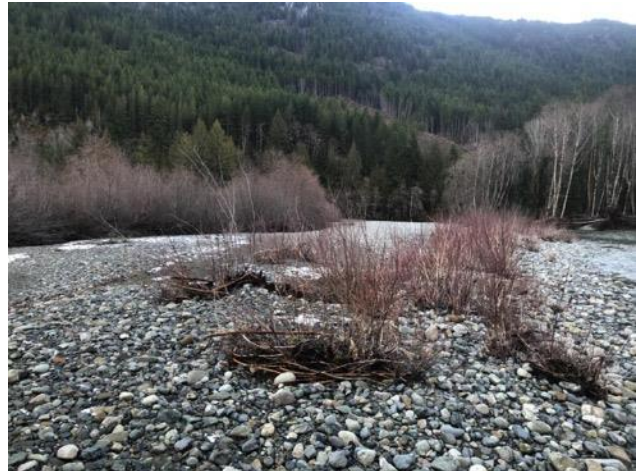
The wetted area of Reaches 2,3,4,16 & 22 scored Poor. The wetted area is a comparison of bankfull channel width to wetted width. Reduced wetted area directly affects the living space and

Reach 22 – Dry river bar in winter.
